Research paper

Safety issues related to the use of closed profiles in steel girders

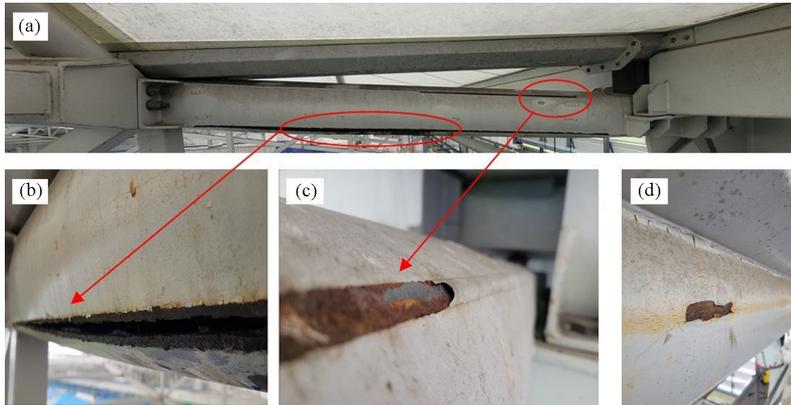
In the first damaged girder, deformation of the cross-sectional shape of the upper chord profile was observed – walls were “pushed out” outward over a length of four consecutive spans from A to E (Fig. 2). These deformations were sectional, occurring along the sections of the chord between successive nodes. In the nodes, the section is “constrained”: in the plane of the girder by columns and bracings, out of the plane by node plate stiffeners.

Fig. 2. Deformation of the tubular profile of the first of the inventoried girders and damages caused by deformations: (a) view of the end span AB of the upper chord, (b) crack along the lower edge of the bend, (c) chipping of the paint coating and corrosion on the upper edge of the bend, (d) cracks and chipping of the paint coating on the wall BC section profile

A continuity loss of the upper chord profile material was also found in the extreme span as a crack along its lower bend edge (Fig. 2b). This crack was approximately 950 mm long and about 12 mm wide at its widest point. Water seeped from the crack, revealing signs of corrosion on the tube's inner surface. Swelling of the paint coating was observed on the profile edge (Fig. 2c) and peeling of the paint layers on the side walls was noted (Fig. 2d).

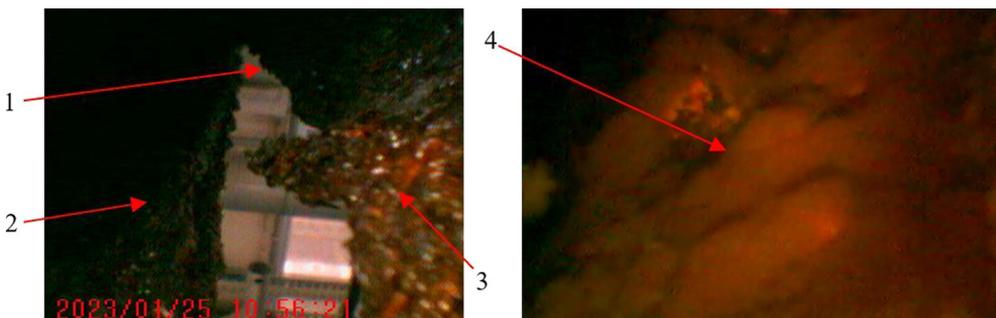
Using the damage in the form of the profile rupture, an inspection of the upper chord profile interior was conducted using a Mitcorp Prelude videoendoscope. The inspection confirmed the presence of water and algae in the profile. The water level was determined during the inspection to be reaching the lower end of the crack section. Corrosion products were found on the internal surfaces of the tubular element walls, and loose corrosion products were observed on the lower surface of the profile wall, indicating a significant degree of corrosion of all profile walls (Fig. 3).

Fig. 3. Interior image of the upper chord obtained via videoendoscope: 1 – crack, 2 – rust, 3 – loose corrosion products, 4 – algae in the water retention zone

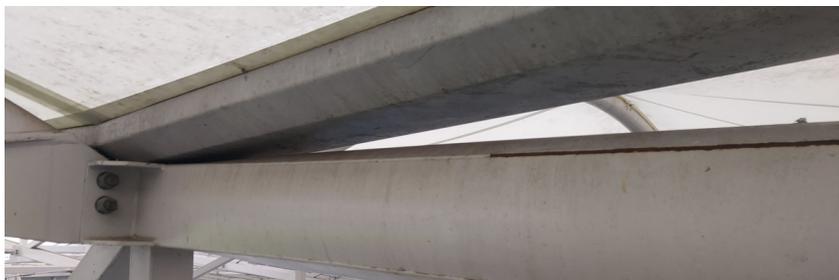
The second damaged girder also exhibited outward deformation of its walls (Fig. 4) over several spans. Similar to the first girder, these deformations were segmental, appearing over the length of the chord sections between successive nodes. Paint coat flaking was observed along the bending edge and weld seam of the tube, with corrosion visible at these points.

Fig. 4. Deformation of the tubular profile of the second damaged girder

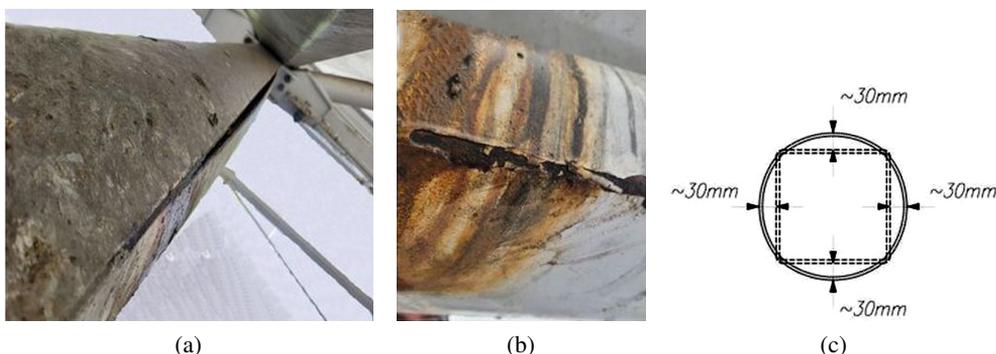
In the second damaged girder, similar to the first, a crack in the upper chord profile was found in the extreme span along the upper bend edge (Fig. 5a). Water was visible through the crack, flowing out and streaming along the side and bottom walls of the upper chord (Fig. 5b).

Fig. 5. Damage to the second girder caused by deformations: (a) crack along the upper bend edge, (b) paint coating flaking and corrosion on the lower bend edge, (c) inventory of wall deformations

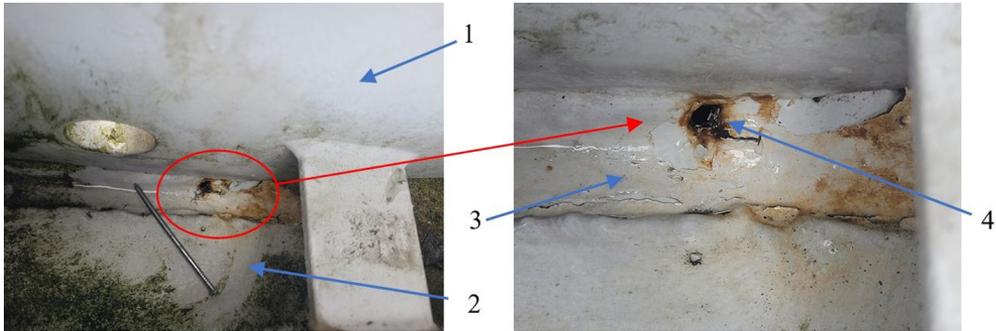
Seeking the water ingress point, a discontinuity was found in the butt weld connecting the node plate used for rod attachment to the upper chord surface (Fig. 6) at node E (Fig. 1). Water penetrated through this discontinuity into the upper chord, flowing down its slope to the extreme span, then filled the entire section and froze, causing the described damage. The described weld discontinuity is a welding non-conformity in the form of a crater at the end zone of the node plate. At this point, the plate used for rod attachment passes through the upper chord walls. The crater was likely due to improper weld termination during the welding process, possibly related to a sudden power cut-off and arc extinguishment.

Fig. 6. Discontinuity of the weld connecting the gusset plate to the upper chord of the girder:
1 – gusset plate, 2 – upper surface of the upper chord, 3 – fillet weld, 4 – crater

- Damage caused by freezing water expansion is a type of damage that cannot be predicted by designers,
- The presented example highlights the importance of weld quality control in steel structures.

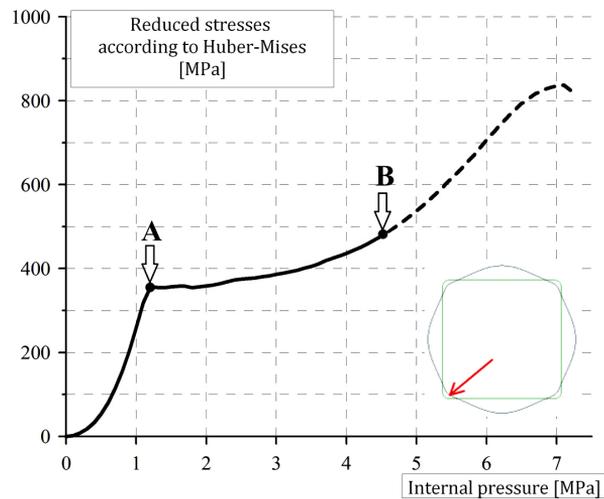
Figure 8 shows the calculated dependence of the tensile stresses in the tubular profile on its bent edge and the internal pressure. It shows that the tensile stresses in the corner exceed the yield strength at approximately 1.2 MPa and the tensile strength at approximately 4.6 MPa. This actually happened: upon reaching tensile strength, a crack occurred in the corner at the bend edge.

Fig. 8. Relationship between reduced stresses at the profile edge and internal pressure

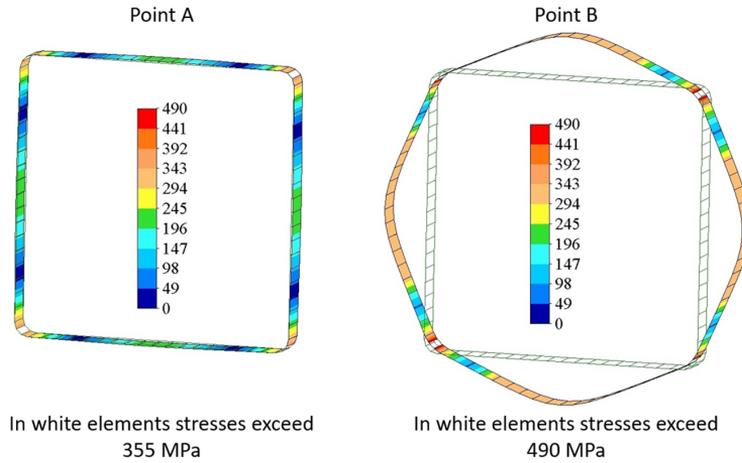
Figure 9 shows the stress state maps in the section under the load indicated by points A and B in Fig. 8. Uncoloured (white) elements are visible, where stresses exceed either the yield strength or the tensile strength. These areas correspond to the corners where the crack occurred.

Fig. 9. Stress maps in the tubular section under different loads

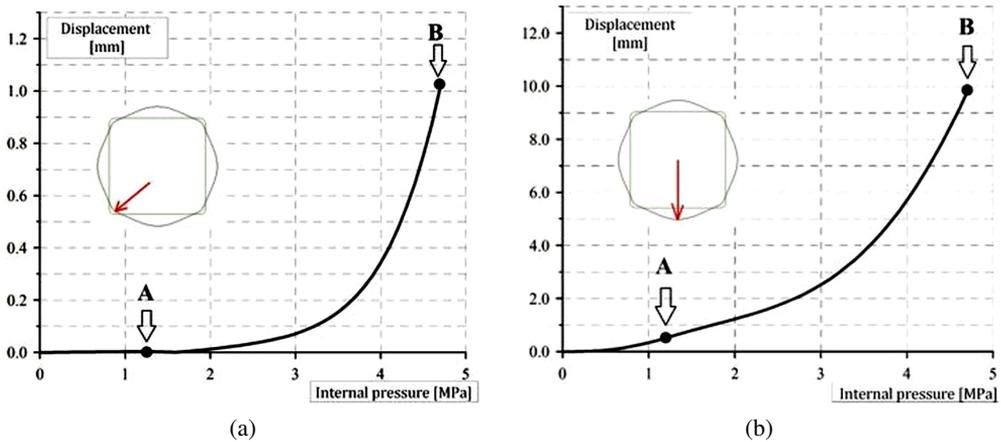
As a result of the calculations, a correlation between the wall displacement and the internal pressure obtained at the corner and at the midpoint of the wall was established, which is shown in Figure 10. It was found that stresses equal to the characteristic tensile strength of steel correlated with a wall displacement in the central part of about 10 mm. The deformation observed in situ was greater. This can be attributed to the fact that the actual corner strength could be higher (the bending effect and the characteristic strength are the 95% quantile of test results), and the mechanism could involve cyclic freezing and thawing of the water inside, changing the conditions of subsequent deformations. Freezing water after a profile rupture could lead to further deformation and crack widening.

Fig. 10. Correlation between wall displacement and internal pressure in a $200 \times 200 \times 6$ tubular profile: (a) at the corner, (b) at the midpoint of the wall
