Research paper

Expansive soils as the root cause of a historic underground potable water reservoir failure

Tomasz Godlewski¹, Radosław Mieszkowski²

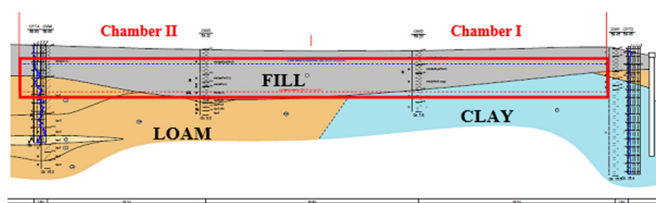
Fig. 3. Characteristic geotechnical cross-section of the reservoir, W-E direction [4]

The reservoir is located in a young glacial landform area within a moraine edge and documented glaciectonic uplifts. This determines the subsoil structure – a moraine hill of Pleistocene glacial deposits (loam and sand), within which folds, xenoliths and floats of Oligocene Septarian clays are present (results of glaciectonic displacements). The initially planned test numbers and locations (CPTU probing and drilling) were extended to cover additional drilling meant to precisely identify the course of glaciectonically displaced Septarian clays. They were completed with field tests using a flat dilatometer (DMT) and laboratory identification of the swelling pressure due to the need to determine the soil characteristics for its deformation range (potentially expansive soils). In order to determine the dampness of the made ground, shallow (1 m) drilling and trenching were made around the reservoir walls and on its ceiling. The geotechnical tests revealed that fine (cohesive) marginal soils represented by rigid-flexible Oligocene clays and postglacial soils in the form of rigid-flexible sandy loams and semi-cohesive clayey sands are the direct foundation of the analysed underground reservoir. Postglacial soils are deposited in the structure's western part. At the same time, Oligocene Septarian clays form the subsoil of the reservoir's eastern part (Fig. 3). Severely damped areas at the reservoir slope base were discovered within the fills.

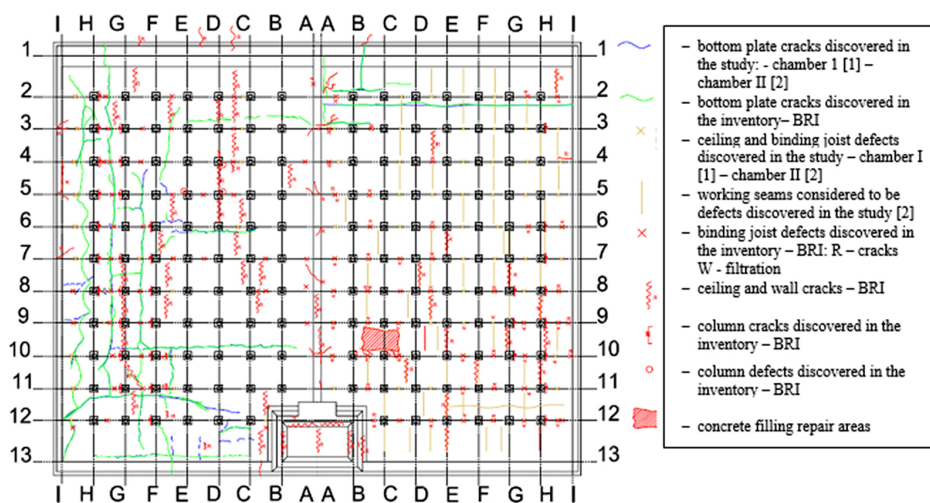
A detailed inventory of each chamber defects (made temporarily available after pumping out the water) was made before the geophysical measurements. Sketches were developed, openings measured and detailed photos taken [4]. Based on the above, the reservoir's technical condition was determined to be diversified. Referring the inventory results to the findings of 2004 (for chamber I, left) and 2016 (for chamber II, right), one can observe the progressing degradation of the reservoir's structure, though of various origins and intensity – Fig. 5. New fractures (not previously described) and cracks in the repair areas were discovered in chamber I. The cracks continue in the bottom plate along the reservoir's entire length in the eastern part (axes I, H, G to F) and crosswise on the axes 10–13 and between axes 2–3. The crack opening characteristic widths reach 1.5–2 mm (up to several mm locally) and are often filled with crushed material with numerous fine branches (Fig. 6a). Cracks on the binding joists, running towards the vault top, typically in the repair areas and often with intense lime efflorescence, up to 1.4 mm opening width, are characteristic of the chamber I (e.g. Fig. 6b).

Fig. 5. Inventory of the reservoir defects [4]

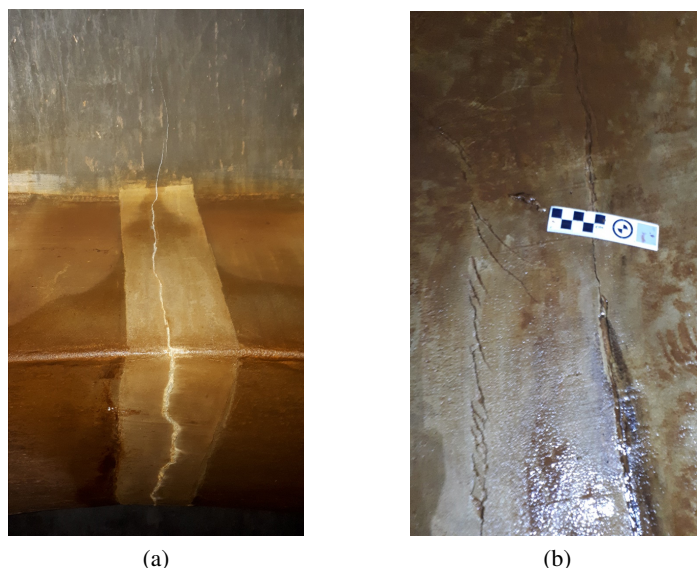
Fig. 6. (a) Bottom plate in chamber I, slanting cracks, locally with crushed material and branching, opening width ca. 0.9 mm; (b) binding joist in the H-G/8 axis in chamber I – a horizontal crack in the repair area, with efflorescence, opening < 0.3 mm, running vertically towards the vault (photo by T. Godlewski)

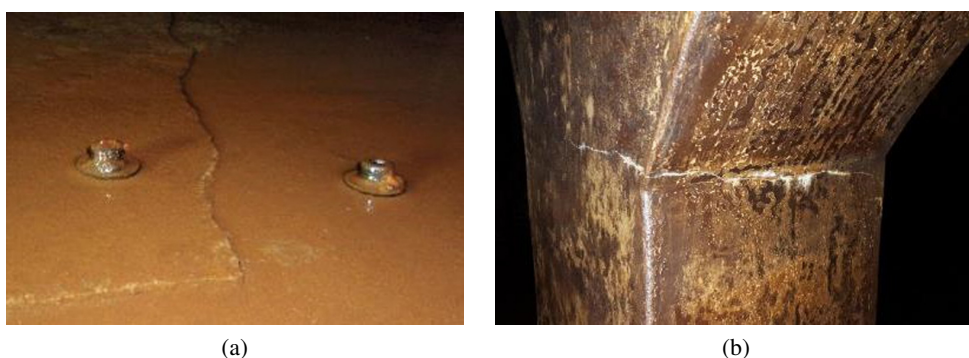
In some areas, mutual vertical displacement of the crack edges (offset) was visible – Fig. 7a. Characteristic tight cracks could be observed in the column areas at the column head widening; they reached no further than half the column width (Fig. 7b). The defects came in pairs on two adjacent columns in the direction of the numerical axes and applied to almost all columns in the H, G, and F axes (Fig. 5). Vault defects occurred all over column I, prevailing in the central part. In most cases, they are very fine cracks with lime efflorescence and in the repair areas.

Fig. 7. (a) Bottom plate in the G-F/9-10 axis in chamber I – monitored gap in the repair area, opening width > 2 mm, vertical displacement (offset) visible; (b) column in the H/2 axis (view from axis 3 side) in chamber I – a horizontal tight crack at the column widening area, reaching no further than half the column width (< 25 cm), crack opening ca. 4 mm wide with efflorescence (photo by T. Godlewski)

Cracks were also observed on the outer walls at the vault or pilaster edges. A significant number of cracks in the bottom plate, visible traces of shearing and vertical movements of the cracks, combined with the measurement results on the applied benchmarks and the nature of the column defects (compression?) suggest intense work of the structure in this part of the reservoir under stress with variable impact vectors.

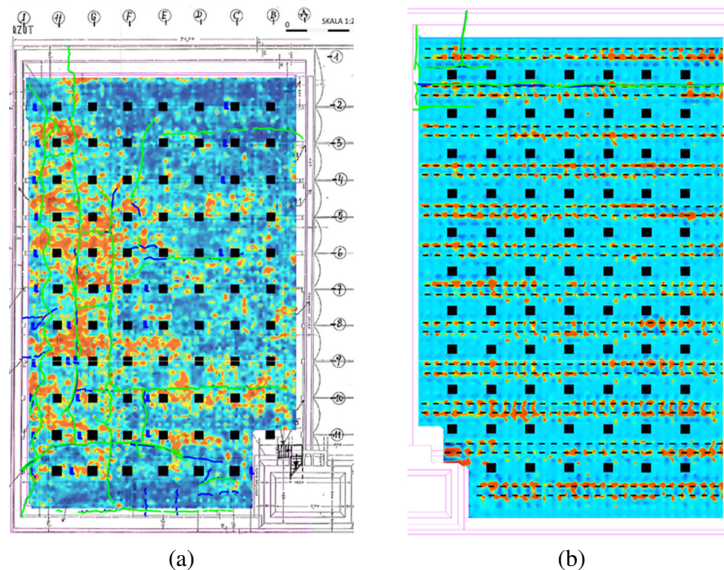
Numerous superficial areas of electromagnetic wave signal amplification were observed in the reservoir's bottom plate in chamber I, which is a testimony to the plate's non-homogeneity and cracking. It is confirmed by observations, whereby the GPR anomaly zone is much broader than the charted cracks – Fig. 9a.

This can suggest damping of the plate and material deterioration (concrete corrosion) much more advanced than expected based on observing visible cracks. The increased dampness zone in the bottom plate overlaps with the location of the prominent cracks identified in the reservoir structure. The GPR image shows linear, regular anomalies originating from the reinforcement. The echogram interpretation revealed that the reinforcing bars are not regularly spaced. The structure is reinforced but to a minimum extent. GPR measurements indicated the reinforcement

Fig. 9. View of the reservoir's bottom plate – map of GPR anomalies, 750 MHz antenna, against the cracks discovered on the surface: (a) image in chamber I, 0.25 m depth – visible irregular anomalies in the electromagnetic wave signal amplification (red), the effect of material cracking or non-homogeneity; (b) chamber II, 0.87 m depth – visible regular* anomalies in the electromagnetic wave signal amplification (red), the result of an under-plate drainage system [4]
