**Research paper****Problems in designing air domes: a lesson from
a construction disaster****Krzysztof Grzyb¹, Łukasz Drobiec², Jakub Zajac³, Olgierd Donajko⁴**

Keywords: air dome, air-supported structure, pneumatic structure, snow load, construction disaster, temporary construction

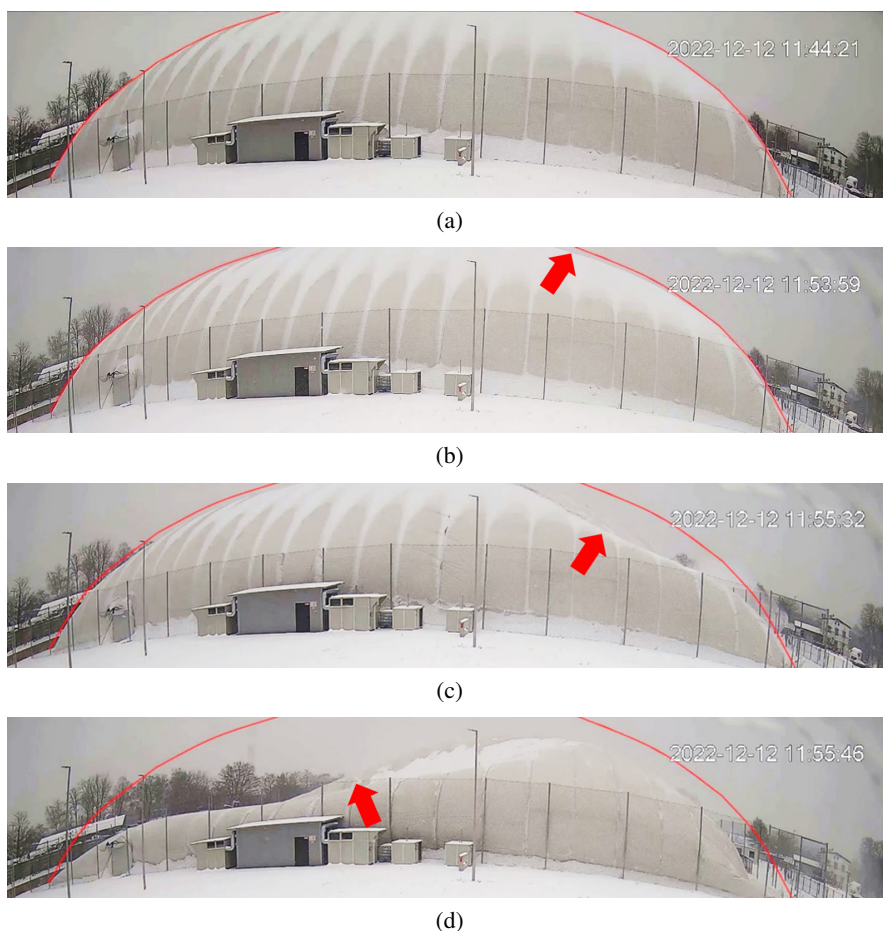
A construction disaster occurred on December 12, 2022, less than a month after the facility's opening (the hall was put into operation on November 19, 2022). Based on the available monitoring materials, the time-lapse analysis shows that the disaster occurred during snowfall that remained on the hall surface (Fig. 4a). The first stage of the disaster consisted of gradual deformation of the covering (deflection of the membrane) relative to the original shape of the structure (Fig. 4b). The deformations continued to develop for over 10 minutes. Monitoring photos at a later stage show the moment of tearing off the membrane and a sudden escape of the air inside (Fig. 4c). Approximately 33 seconds elapsed from the moment of tearing the membrane to its complete falling, with the northern emergency exits being cut off after approximately 14 seconds (Fig. 4d). Previously, the structure was characterised by a slight, uniform deflection of the membrane, which was practically impossible to observe with the unaided eye or without measuring devices. The photographs (monitoring frames) show the disaster's subsequent stages with the shell's initial outline.

Fig. 4. Subsequent phases of the construction disaster: a) initial condition of the membrane, b) gradual deformation of the membrane, c) moment of rupture of the membrane, d) cutting off the northern emergency exits

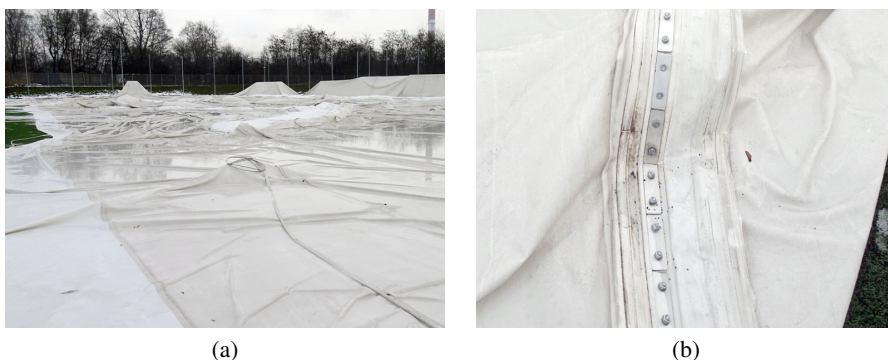
During the inspection eleven days after the disaster, large amounts of snow were still observed around the collapsed hall. The condition of the membrane on the pitch is shown in Fig. 5a. The structure destruction planes were located halfway along the facility's length. However, the tearing of the plating occurred outside the joint (Fig. 5b). Moreover, the presence of a layer of bubble foil, provided for in the design documentation, was not noticed. As a result of the collapse of the structure, the entrance revolving door fell over (Fig. 6a). In the southern part, after the coating fell, it was torn due to contact with the steel elements of the sports goal (Fig. 6b).

Fig. 5. Condition of the membrane after the disaster – December 23, 2022: (a) coating lying on the turf, (b) tearing of the plating outside the connection

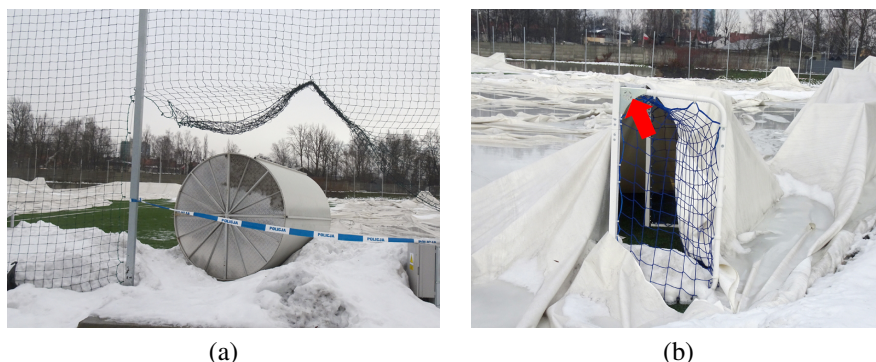
Fig. 6. View of the facility after the disaster: (a) overturned entrance revolving door, (b) tearing of the covering on the edge of the sports goal

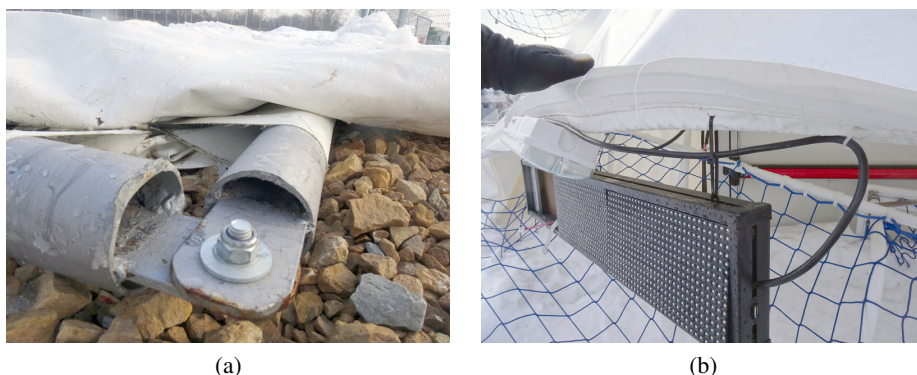
On the cladding fastening elements (peripheral pipes), there were locally visible traces of corrosion and the lack of sheets closing the pipes – in open sections – which could accumulate locally and intensify corrosion processes (Fig. 7a). Moreover, some elements of the hall's equipment were attached directly to the membrane using elements made of plastic, which locally weakened the covering material (Fig. 7b).

Fig. 7. Elements of fastening and equipment of the pneumatic hall after the disaster: (a) corner connection of the peripheral steel pipe with visible traces of corrosion, (b) elements of equipment attached to the membrane with plastic clamps

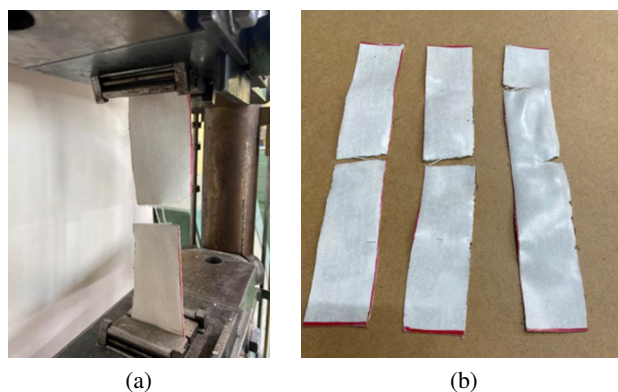
Fig. 8. Material tests of the plating: a) view of the selected sample in the machine strength ZD10/90, b) view of selected samples after rupture

Material tests of the membrane were performed to determine the causes of the construction disaster. For this purpose, samples of both layers of the roof membrane were taken in the area of its tear. The collected samples were weighed, and their weight was compared with the data provided in the documentation. On this basis, it was determined that the weight of the materials used was consistent with the design. Then, tensile tests of the membrane were carried out in two different testing machines, ZD10/90 (Fig. 8) and ZD100 (Fig. 9).

fibres was 1.83 kN/50 mm (in the project it was 3.0 kN/50 mm). The obtained strengths were, therefore, significantly lower than those assumed in the design. In tests of the internal membrane, the tensile strength along the fibres was 1.52 kN/50 mm (in the project, it was 2.4 kN/50 mm). The tensile strength across the fibres was 1.4 kN/50 mm (the design assumed 2.3 kN/50 mm). On this basis, it was found that the strength parameters of the membranes did not meet the declarations of the technical documentation.

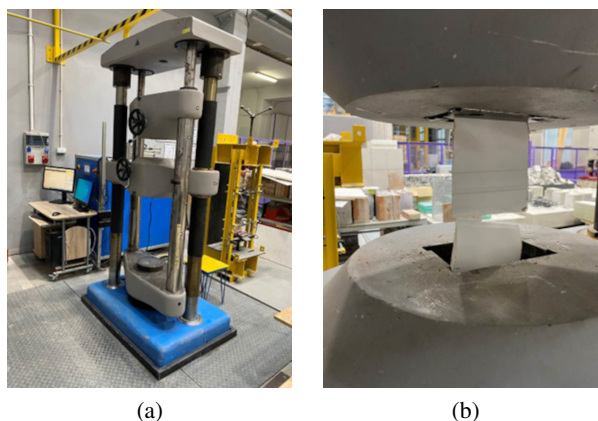
Samples with and without a seam were tested perpendicular and parallel to the seam, taken from the lower and upper membranes. Additionally, tests were performed on samples with an artificially made defect in the form of a cut on the edge and in the centre of the samples. In the case of the external membrane, the tensile strength along the fibres was 1.8 kN/50 mm (in the design, it was 3.2 kN/50 mm), while the tensile strength across the

Fig. 9. Material tests of the plating: (a) testing machine ZD100, (b) view of the selected sample after breaking

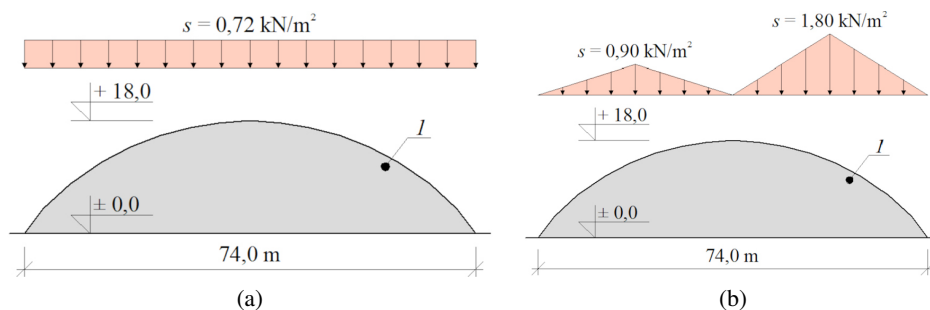
In the case of the analysed facility, there is no provision for snow removal from the roof. From a technical point of view, the mechanical removal of snow from the roof of the air dome is unrealistic due to the geometry of the structure and the lack of access to the crown of the roof. Therefore, the postulates of both standards [5] and [6] are unmet. Recalculated snow load values according to Eurocode procedures for two cases – snow load for cylindrical roofs (variant 1 – Fig. 10) and snow load with the calculated thermal coefficient and return period for temporary structures (variant 2 – Fig. 11) indicate the load greater than assumed in the project – Table 1.

Fig. 10. Snow load on the analysed air dome – variant 1: (a) evenly distributed load, (b) unevenly distributed load, I – the geometry of the facility

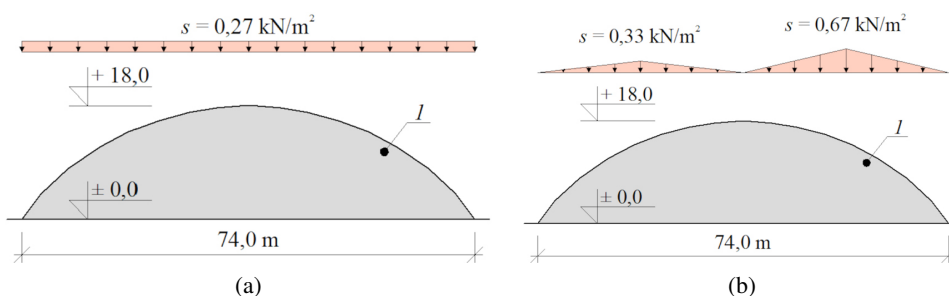
Fig. 11. Snow load on the analysed air dome – variant 2: (a) evenly distributed load, (b) unevenly distributed load, I – the geometry of the facility

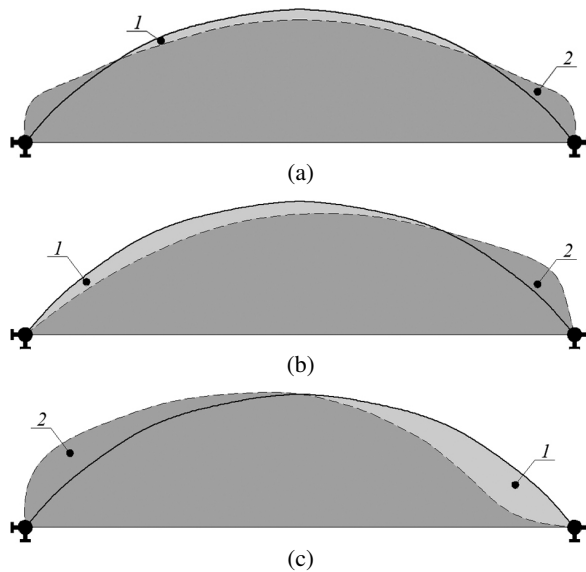
As part of the analyses, verification static calculations were also performed. It has been shown that there are three possible cases of loss of hall stability – Fig. 12. The first form is characterised by a flattening of the membrane due to the impact of snow at the top and the external walls of the coating being pushed outwards. The second and third forms are characterised by a loss of membrane stability in the support zone. The presented forms of stability loss coincide with the structure deformations visible during the analysed construction disaster.

Fig. 12. Possible global forms of stability loss: 1 – the original shape of the structures, 2 – the deformed shape of the structure

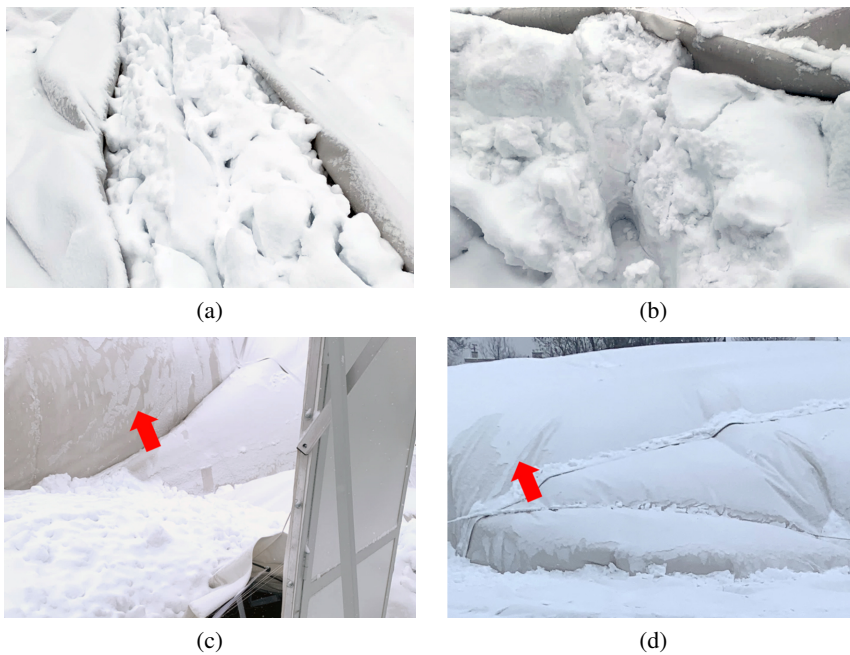
Based on the above considerations, it can be undoubtedly stated that the direct cause of the construction disaster was snow lying on the membrane of the air dome. Although the standards [5] and [6] allow for the adoption of reduced snow load values while ensuring snow removal from the roof, such an approach is controversial in Polish conditions. Assuming a higher snow load would make it impossible to design an air hall for which the internal pressure is 0.30 kN/m^2 . Even if the conditions that the investor should meet when using the tent are specified to prevent snow accumulation (e.g. the need to control the thickness of the snow cover or the temperature of the covering), in the event of heavy rainfall, clearing snow from this type of roof surface would be unrealistic. The assumptions based on the fact that hot air forced between the layers causes snow to melt are false. A sudden snowfall causes local membrane deformation. Only the tiny layer directly in contact with the coating melts. Then, water stagnation occurs, locally placing an additional load on the membrane.

Valuable evidence confirming this mechanism of destruction are photographs taken on the day of the disaster by the construction manager (Fig. 13). The photos show not only significant amounts of snow lying on the membrane but also areas where the snow has frozen to the coating (these places are marked with red arrows). The identified errors made at the design or construction stage and using a weaker membrane material could have contributed to the disaster – but they were not its direct cause. Moreover, operational errors were also found while determining the causes of the disaster. The facility manager did not remove snow along the edges of the arena, which he should have done by the facility's instructions for use.

Fig. 13. Photos of snow lying on the structure taken by the construction manager on the day of the disaster: (a) and (b) snow lying on the membrane, (c) and (d) snow stuck to the membrane
