Concrete degradation in an over 100-year-old drinking water treatment plant, a case of lime leaching from the water retaining tanks

Józef Zygmunt Jasiczak¹

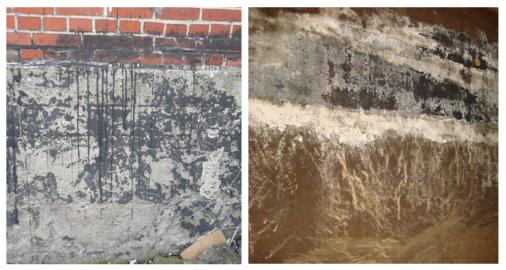
Until 2009 the building was used for water filters and storage of drinking water for the city citizens. In 2020 the technical condition of the chamber was checked. The examination discovered many cracks of the concrete peripheral walls, internal reinforced concrete posts and monolithic reinforced concrete ceiling over the water tank. All the cracks were filled with white substance, and in some places on the ceiling there were also white stalactites. The current technical condition of the described structure is shown in Fig. 4 and Fig. 5.

Fig. 4. Reinforced concrete wall of tank from outside and inside with leaks of white efflorescence

of the construction, which results in cracking of its elements. Migration of the white chemical compounds from outside to inside of the water tank (thus from the low relative humidity environment to the space over the water surface with very high relative humidity – over 95%) demands a wider explanation, since those processes have definitely weakened the structure of the concrete.

If a decision is made to revitalize the facility for other new purposes, the walls will need to be repaired and reinforced concrete structures strengthening. Repairs of the historic walls are carried out by specialized companies under the supervision of a conservator. It is best to strengthen reinforced concrete structures by using shotcrete on a steel mesh, as was done during the construction of the museum of the history of Polish Jews in Warsaw [18].

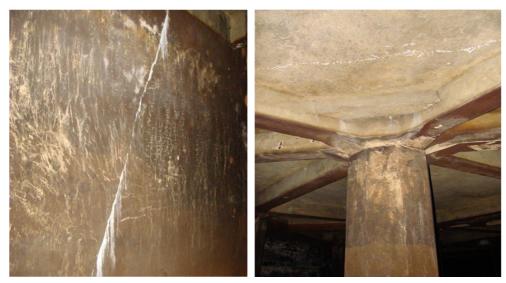
Fig. 5. Wall and pillar supporting rib-and-slab floor. Visible cracks filled with white compounds

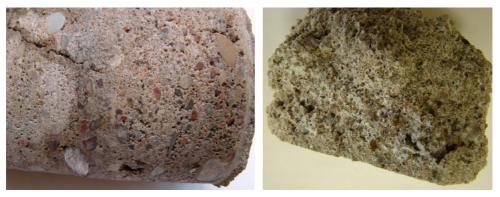
Tests of compressive strength of concrete on core specimens taken from the structures revealed a very low strength of the concrete at the moment – only 12.0–14.0 MPa, with the density of 2200 kg/m³ and water absorption by weight of 5.1%. The concrete in the core specimen taken from the ceiling is very inhomogeneous, porous, with signs of leaching of the cement stone and clearly visible white internal deposits, as well as internal delamination (Fig. 6–9).

Fig. 6. Porous bottom part of core specimen ϕ 100 mm Fig. 7. White drop-stones in the structure of bottom part of core specimen

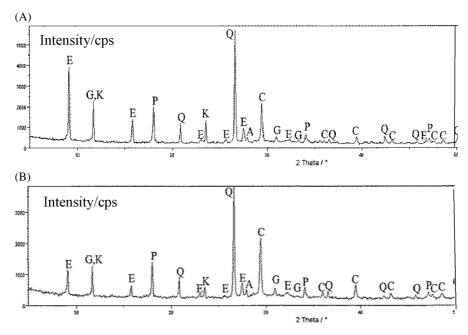
Fig. 11. Phases formations during long time hydration of portland cement concrete. Symbols of concrete phases: A – albite, Q – quarc, C- calcite, E – ettrigite, G- gipsum, K – carboaluminate, P – portlandite

Phase analysis of both concrete samples does not show significant differences. The analysed samples can be divided with regard to occurrence of two types of crystalline phases. Crystalline phases coming from the aggregate in the concrete, such as quartz and albite, as well as phases from cement and coming from its hydration, such as: ettringite, portlandite, carboaluminate, calcite and gypsum.

Taking into consideration the working conditions and the same way of sample preparation the half-quantitative occurrence of particular crystalline phases can be approximately defined. The counting sort analysis and the analysis of crystalline phase peak intensity show a definitely unambiguous tendency. In the (A) sample, in comparison with sample "B", there are much more crystalline phases coming from ettringite and quartz. Much more plaster phase and carboaluminate is visible, but since it is the most intense reflex of both phases in the same angle range 2Θ , it is hard to define clearly which phase prevails. The amount of portlandite and albite phase in both tested samples is similar. The only difference in the analysis is ettringite and calcite. We find more etytringite in sample A, but in sample (B) more calcite.

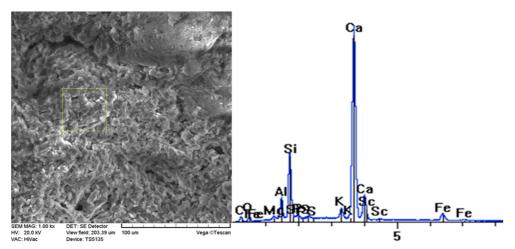
Fig. 12. Analysis of the typical part of outdoor wall (sample A). X-ray photography, the analysis of elements occurence

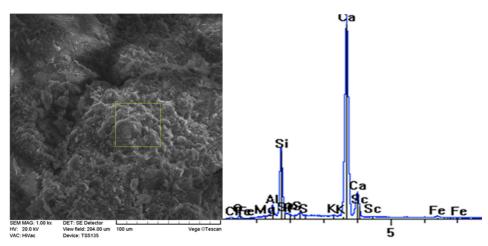
Fig. 13. Analysis of typical part of floor (sample B) – upper part of floor. X-ray photography, the analysis of elements occurence

effect. In the abruptions the long fibre ettringite can be found, which caused the bridging of the microstructure. It is clearly visible in the microphotograph in Fig. 13 and in EDS analysis (Area 2) which present the upper, carbonised part of B sample. Ettringite is not susceptible to leaching and migration caused by the difference in relative air humidity over and under the ceiling, which is confirmed in the analysis of the lower part of the ceiling presented in Figs. 14–16. The calcium cations are leached, whereas the ettringite "frame" is stable. Carbon dioxide reacting with calcium deposits in the linear or spot form, creates calcium carbonate, which is confirmed in Fig. 17. The described process can be compared to the formation of stalactites in caves found in calcareous deposits of rocks.

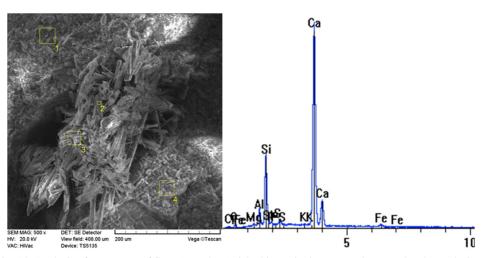
Fig. 14. Analysis of upper part of floor (sample B) riched in ettringite. X-ray photography, the analysis of elements occurence

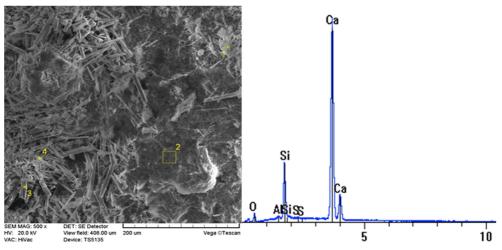
Fig. 15. Analysis of bottom part of floor (sample B) riched in ettringite. X-ray photography, the analysis of elements occurence

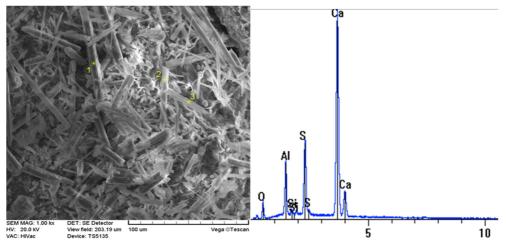
Fig. 16. Analysis of bottom part of floor (sample B) – enlarged left-hand, upper part of photography in Fig. 15 riched in ettringite. X-ray photography, the analysis of elements occurence.

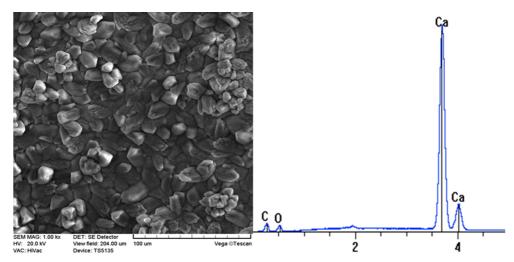
Analysis of wall and bottom part of floor – places with the white dripstones and stalactites presented before in Fig. 4, Fig. 5 are shown as SEM in Fig. 17.

Fig. 17. Analysis of wall and bottom part of floor – places with the white dripstones and stalactites. X-ray photography, the analysis of elements
