Research paper

Reconstruction of the road bridge on Monte Cassino Avenue in Koszalin

Abstract: This article presents the process of rebuilding the bridge on Monte Cassino Avenue in Koszalin, Poland. The deterioration of the pre-cast concrete beams resulted in a decrease in the load-bearing capacity. On this basis, the decision was made to demolish and build a new structure, taking into account existing foundations and strengthening them with additional pre-cast concrete piles. However, during demolition works, the northern structure of the bridge collapsed uncontrollably. After a reanalysis of the technology and taking into account additional safety requirements, the demolition works were renewed. Due to collapse and its possible negative impact on existing piles, design changes related to the location of the pier axes were introduced. The load tests conducted on the rebuilt bridge allowed the finite element (FE) model to be verified by determining and comparing the response of the structure to static and dynamic load. The verified model, as an element of a digital twin, can be used in facility management throughout the life cycle of the structure, minimising the risk of failures

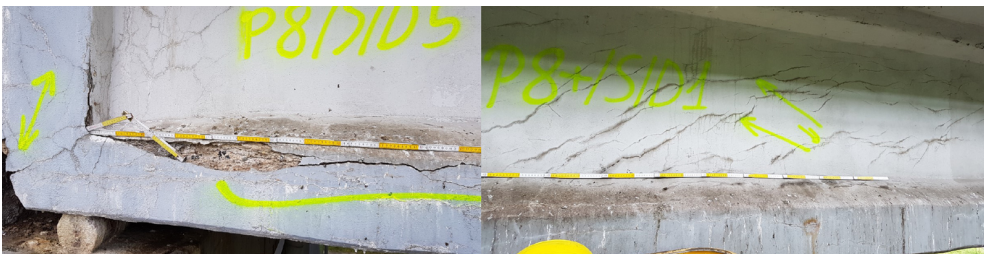
In 2020, an expert opinion was prepared to assess the current state of the structure, which confirmed its poor condition. On-site inspection combined with material tests, as well as static and strength analyses, showed a high risk of failure or collapse. The deterioration of pre-cast beams with a large number of inclined cracks near the anchor zones of the tendons (Fig. 2) exposed a reduced load-bearing shear capacity and indicated a prefailure condition. The damage found was a direct result of the yield strength exceedances in the stirrups and excluded the possibility of repair. Taking into account the above, the decision was made to close traffic and rebuild the bridge structure.

Fig. 2. Web cracks and damage to the pier zones of the WBS beams

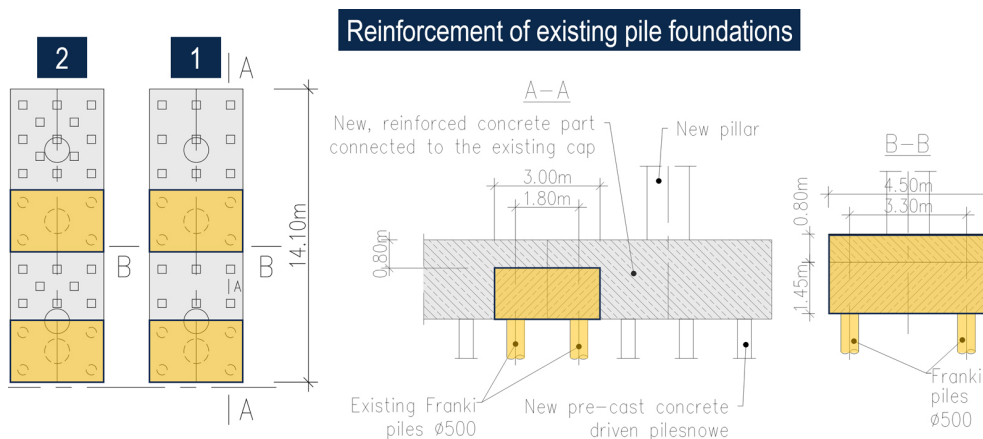
The load-bearing capacity of the existing piles was insufficient in each of the analysed piers. It was necessary to strengthen the foundations as proposed in Fig. 6. The original pile caps were joined and extended. The load-bearing capacity was improved by adding new pre-cast concrete driven piles.

Fig. 6. Reinforcement of existing pile foundations with pre-cast concrete driven piles

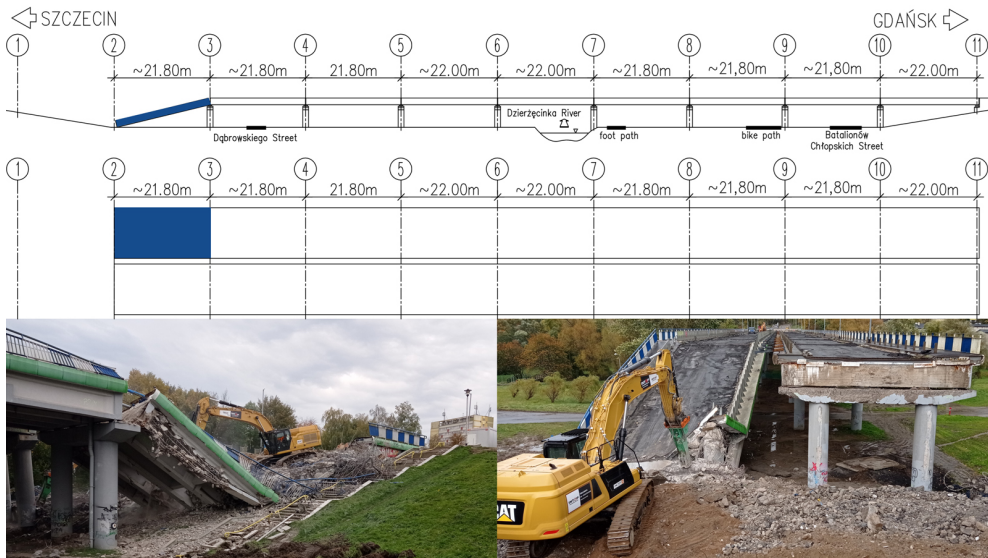
demolition of the abutments and end spans on the northern and southern routes. Taking into account the static scheme of the bridge, the demolition technology required removal of the span preceded by removal of one of its supports that led the span to be tilted. In this state, one of the edges had to be lowered to the ground level and the other had to remain on the bearings. Following this assumption, the pier no. 2 of the northern structure was removed, and the second span leaned against the pier no. 3 (Fig. 7).

Fig. 7. Demolition works and the state right before the uncontrolled collapse

The mentioned state caused the top of the pier no. 3 to tilt out of the vertical direction by 30–50 cm. As a result, the continuation of demolition works caused an uncontrolled collapse of the support and successive parts of the northern structure (Fig. 8). On 21 October 2021, immediately after the collapse, demolition technology and security measures were reviewed. Road traffic under the bridge was closed to prevent third party access to the site. The investor indicated the need to immediately reassess the demolition technology and resume the works due to inclination of the pier no. 3 on the southern bridge and the risk of similar collapse.

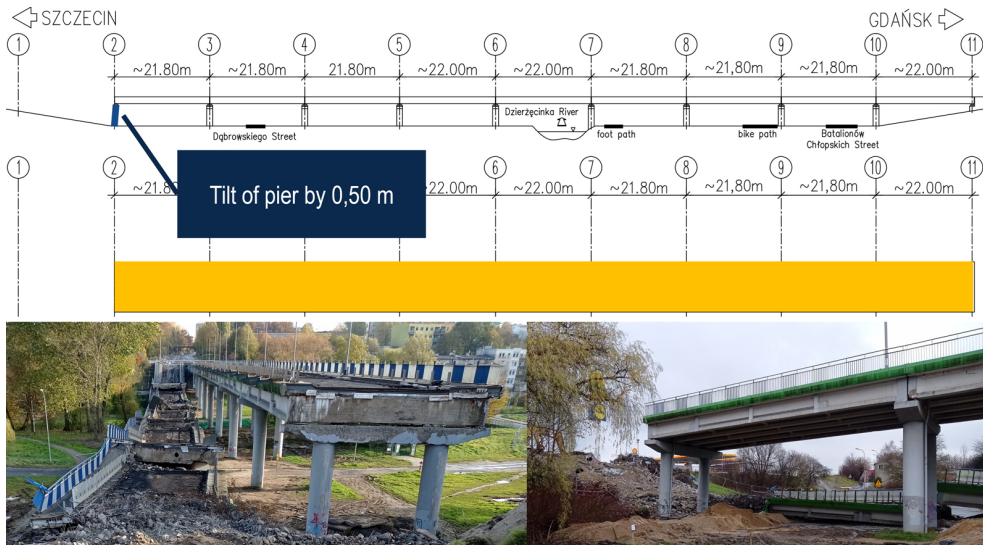
Fig. 8. The state after the uncontrolled collapse

The demolition works were continued taking into account all the requirements. The proposed technology was the only rational one that protected the people performing the works and the surrounding area, minimising the risks associated with the identified threats. In fact, there was no uncontrolled collapse of the southern bridge. This indicates the incidental nature of the construction failure caused by a structural defect of the pier no. 3 of the northern structure that could not be predicted. The reason for the failure of the pier was identified as an excessive thickness of the cover concrete and the absence of the required reinforcement in the columns.

On 27 October 2021, the technological design of the demolition works was revised. It was supplemented with additional security measures and protections under the southern bridge. However, the demolition technology itself did not change. The works were to proceed along the bridge starting from the outer side of the pier no. 2, using hydraulic breakers and concrete crushing shears, as before. Taking into account the works carried out so far, there was a high probability that the spans would collapse uncontrolled again as a result of the instability of the pier no. 3. However, changing the technology to an alternative method, e.g., implosion, would not increase the safety of the works. Considering the partial instability of the structure, it would pose a threat to people preparing the structures for demolition.

- Setting a safe distance from the edges of the bridge for workers and machinery.
- Resignation from longitudinal cutting along the girders.
- Permanent closure of road traffic under the bridge, protection against unauthorised access by third parties and pedestrians.
- Protection of pavement, footpaths, and road infrastructure under the bridge with sand beds and mats that provide a physical barrier against falling debris and the dynamic impact in the event of uncontrolled collapse.
- Securing and monitoring of the gas network exposed to damage during demolition works.
- Monitoring of selected facilities and buildings in the closest vicinity.

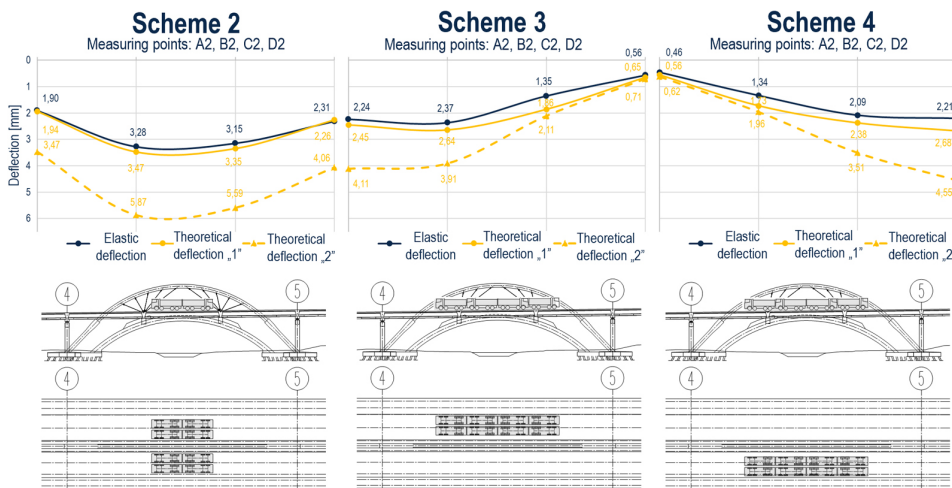
The analysis of the structural response from the basic arch span schemes (Fig. 11) confirmed that the code requirements were met and that the developed Finite Element (FE) model is correct. The elastic deflections of the girders were similar to those calculated theoretically in the uncracked phase and amounted on average for the S2, S3, and S4 span schemes in the relevant cross-sections to 97%, 85% and 83% of their values, respectively. Such results indicate that the stiffness of the girders is similar to the values assumed in the model analysed in the

uncracked phase. The model adopted for dimensioning provides results on the safe side and thus the load-bearing capacity that was theoretically assumed is correct. Permanent deflections are within the range of 0% to 8% of total deflections and therefore meet the code condition of not exceeding the level of 20%. Additionally, the displacements of the arches were measured during the selected load schemes. The maximum value was 1.39 mm and was slightly lower than the calculated values after updating the model (1.43 mm). The tests confirmed that the stiffness of the arches was close to that assumed theoretically.

Fig. 11. Selected static load schemes and deflections, including theoretical and measured values
