# Reconstruction of the road bridge on Monte Cassino Avenue in Koszalin

**Abstract:** This article presents the process of rebuilding the bridge on Monte Cassino Avenue in Koszalin, Poland. The deterioration of the pre-cast concrete beams resulted in a decrease in the load-bearing capacity. On this basis, the decision was made to demolish and build a new structure, taking into account existing foundations and strengthening them with additional pre-cast concrete piles. However, during demolition works, the northern structure of the bridge collapsed uncontrollably. After a reanalysis of the technology and taking into account additional safety requirements, the demolition works were renewed. Due to collapse and its possible negative impact on existing piles, design changes related to the location of the pier axes were introduced. The load tests conducted on the rebuilt bridge allowed the finite element (FE) model to be verified by determining and comparing the response of the structure to static and dynamic load. The verified model, as an element of a digital twin, can be used in facility management throughout the life cycle of the structure, minimising the risk of failures of strate

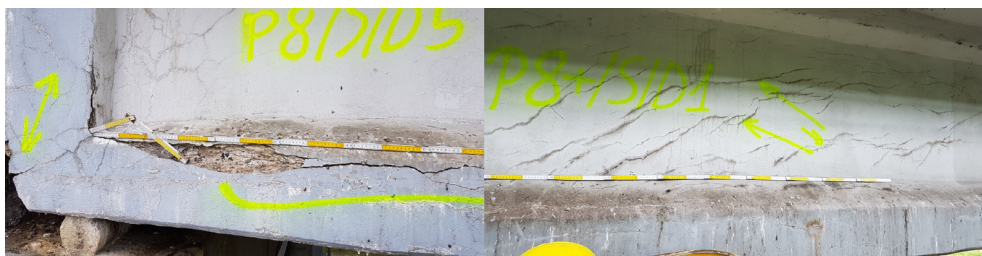
In 2020, an expert opinion was prepared to assess the current state of the structure, which confirmed its poor condition. On-site inspection combined with material tests, as well as static and strength analyses, showed a high risk of failure or collapse. The deterioration of pre-cast beams with a large number of inclined cracks near the anchor zones of the tendons (Fig. 2) exposed a reduced load-bearing shear capacity and indicated a prefailure condition. The damage found was a direct result of the yield strength exceedances in the stirrups and excluded the possibility of repair. Taking into account the above, the decision was made to close traffic and rebuild the bridge structure.

Fig. 2. Web cracks and damage to the pier zones of the WBS beams

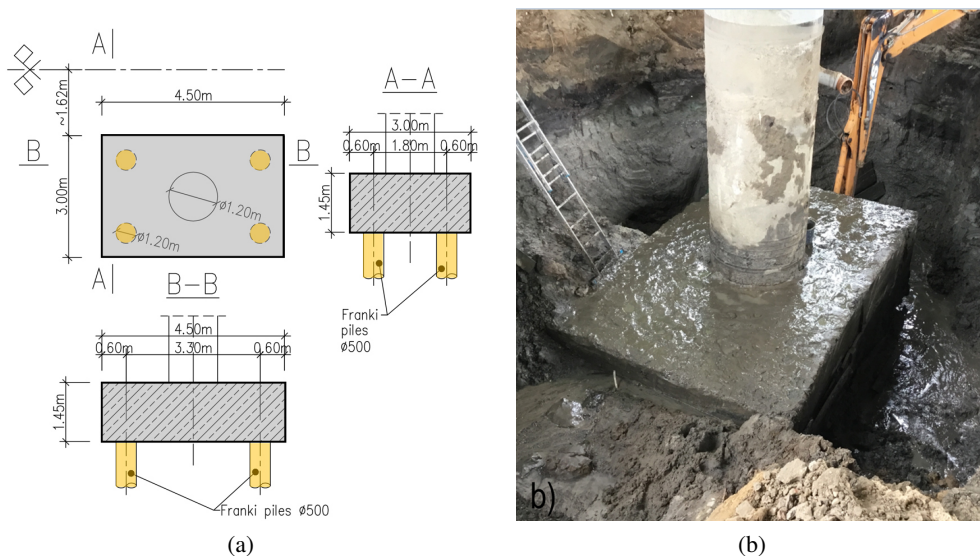
In 2021, the ability of the deep foundation to be reused for the new bridge was checked. The study consisted of a geological survey, static load tests on bridge spans to measure the settlement of the piers, and exposure of the pile caps for visual inspection and condition assessment. According to the archived documentation, the structure was based on Franki piles. Each of the existing pile foundations consisted of a cap with dimensions of  $3.0\text{ m} \times 4.5\text{ m} \times 1.45\text{ m}$  and four piles of  $0.50\text{ m}$  diameter (Fig. 3a), reinforced with  $\varnothing 14$  plain-surface bars every  $10\text{ cm}$  and  $\varnothing 6$  spiral reinforcement of  $10\text{ cm}$  pitch. The foundation level of the existing piles was confirmed by sounding surveys conducted and exposing the pile caps (Fig. 3b).

Fig. 3. Geometry of existing foundations (a) and the exposure of a pile cap (b)

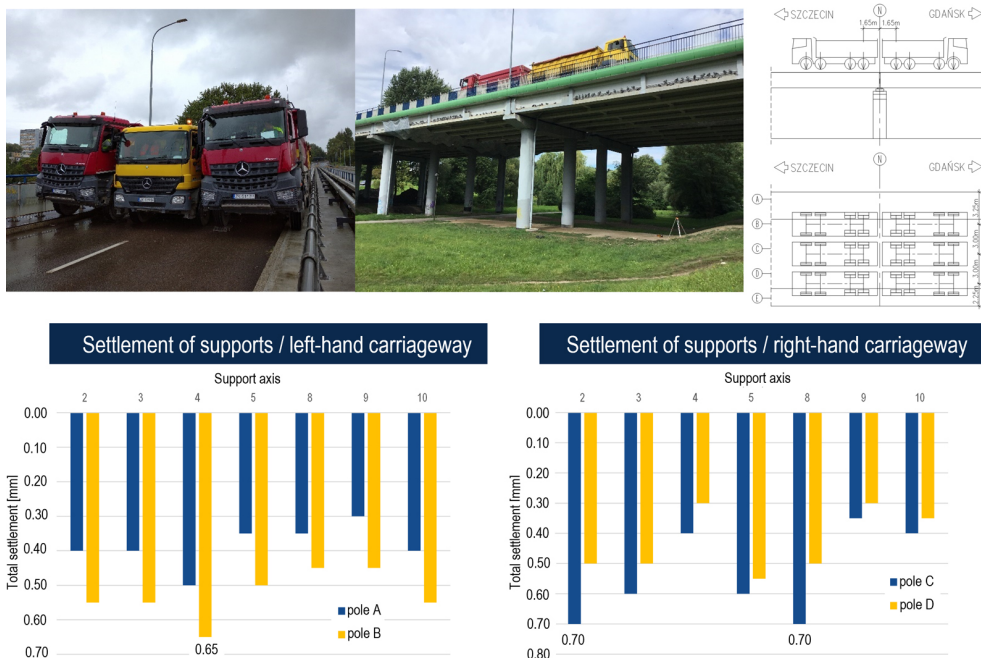
Before the work on the site, on August 20, 2021, static load tests were carried out on the bridge (Fig. 4). The aim of the tests was to confirm the elastic behaviour of the existing foundation, hence maintaining its safety margin in load-bearing capacity. Fourteen load schemes were used, designed to obtain maximum reactions on the piers. The maximum settlement measured during the load test did not exceed  $0.70\text{ mm}$ , so they were much lower than the allowed value of  $5\text{ mm}$ . The permanent settlement, remaining after unloading, is neglectable and reached up to  $0.15\text{ mm}$ . The differential settlement, measured in relation to the adjacent piers, did not exceed  $0.70\text{ mm}$  and was much lower than the maximum value allowed of  $10\text{ mm}$ . Taking into account the results of the load tests, it was confirmed that the existing foundation could be reused in the new structure.

Fig. 4. Settlement of the piers during a static load test on the old bridge

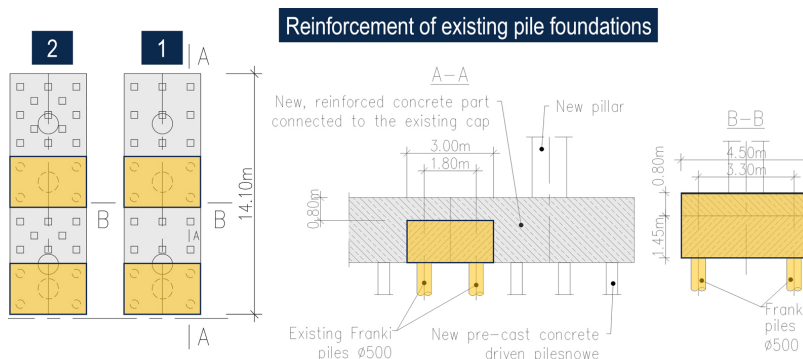
The load-bearing capacity of the existing piles was insufficient in each of the analysed piers. It was necessary to strengthen the foundations as proposed in Fig. 6. The original pile caps were joined and extended. The load-bearing capacity was improved by adding new pre-cast concrete driven piles.

Fig. 6. Reinforcement of existing pile foundations with pre-cast concrete driven piles

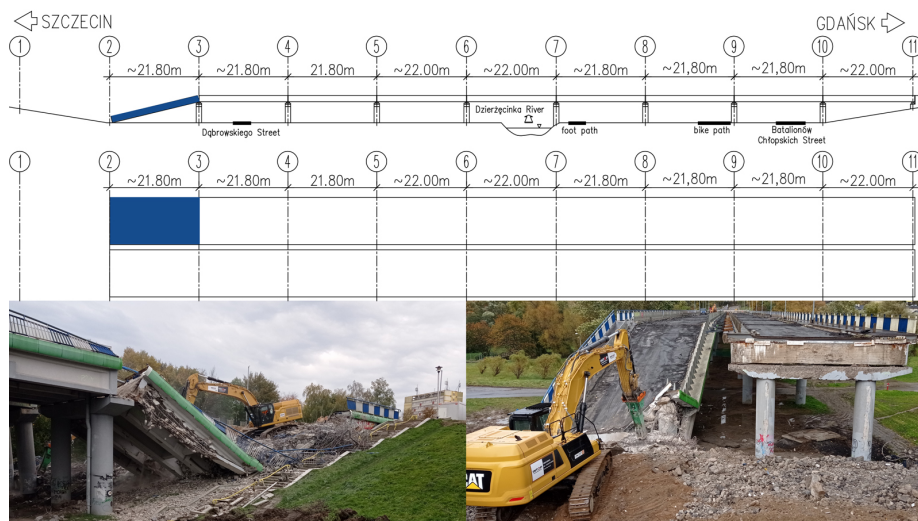
Several demolition technologies were considered taking into account the total length and type of the structure, including blasting and implosive methods, mechanical cutting along the joints of prefabricated beams, and crushing span by span using hydraulic machinery. One of the requirements was to maintain the continuity of road traffic under the bridge. On this basis, the demolition of successive spans was designed that provided excavators equipped with hydraulic breakers and concrete crushing shears. The operation started on pier no. 1 by demolition of the abutments and end spans on the northern and southern routes. Taking into account the static scheme of the bridge, the demolition technology required removal of the span preceded by removal of one of its supports that led the span to be tilted. In this state, one of the edges had to be lowered to the ground level and the other had to remain on the bearings. Following this assumption, the pier no. 2 of the northern structure was removed, and the second span leaned against the pier no. 3 (Fig. 7).

Fig. 7. Demolition works and the state right before the uncontrolled collapse

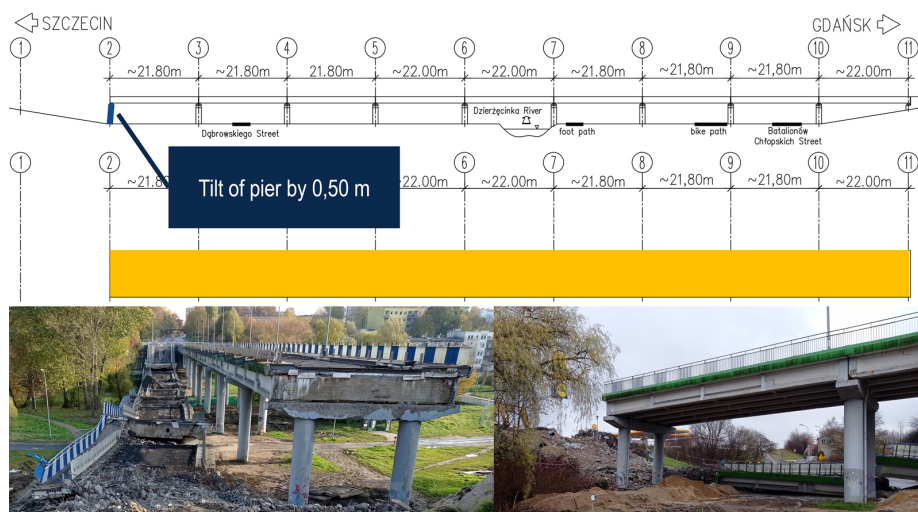
The mentioned state caused the top of the pier no. 3 to tilt out of the vertical direction by 30–50 cm. As a result, the continuation of demolition works caused an uncontrolled collapse of the support and successive parts of the northern structure (Fig. 8). On 21 October 2021, immediately after the collapse, demolition technology and security measures were reviewed. Road traffic under the bridge was closed to prevent third party access to the site. The investor indicated the need to immediately reassess the demolition technology and resume the works due to inclination of the pier no. 3 on the southern bridge and the risk of similar collapse.

Fig. 8. The state after the uncontrolled collapse

The demolition works were continued taking into account all the requirements. The proposed technology was the only rational one that protected the people performing the works and the surrounding area, minimising the risks associated with the identified threats. In fact, there was no uncontrolled collapse of the southern bridge. This indicates the incidental nature of the construction failure caused by a structural defect of the pier no. 3 of the northern structure that could not be predicted. The reason for the failure of the pier was identified as an excessive thickness of the cover concrete and the absence of the required reinforcement in the columns.

On 27 October 2021, the technological design of the demolition works was revised. It was supplemented with additional security measures and protections under the southern bridge. However, the demolition technology itself did not change. The works were to proceed along the bridge starting from the outer side of the pier no. 2, using hydraulic breakers and concrete crushing shears, as before. Taking into account the works carried out so far, there was a high probability that the spans would collapse uncontrolled again as a result of the instability of the pier no. 3. However, changing the technology to an alternative method, e.g., implosion, would not increase the safety of the works. Considering the partial instability of the structure, it would pose a threat to people preparing the structures for demolition.

- Setting a safe distance from the edges of the bridge for workers and machinery.
- Resignation from longitudinal cutting along the girders.
- Permanent closure of road traffic under the bridge, protection against unauthorised access by third parties and pedestrians.
- Protection of pavement, footpaths, and road infrastructure under the bridge with sand beds and mats that provide a physical barrier against falling debris and the dynamic impact in the event of uncontrolled collapse.
- Securing and monitoring of the gas network exposed to damage during demolition works.
- Monitoring of selected facilities and buildings in the closest vicinity.

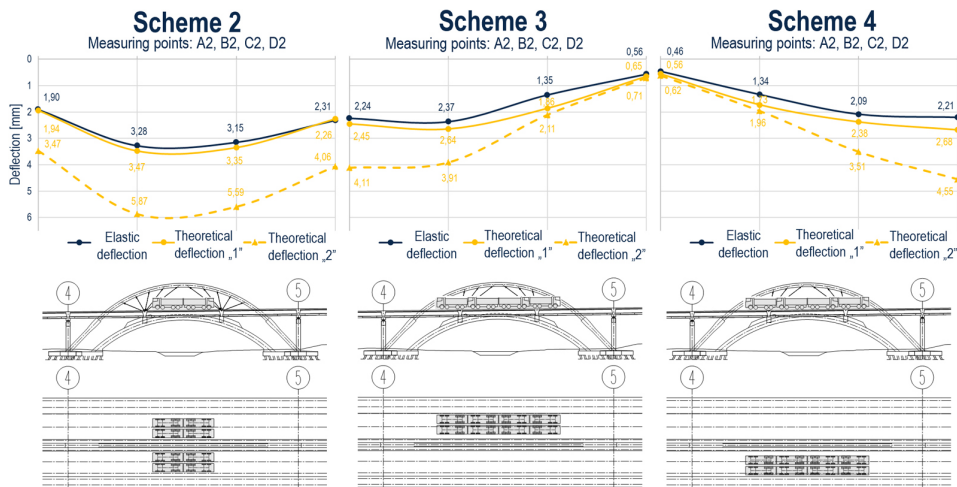
not exceeding the level of 20%. Additionally, the displacements of the arches were measured during the selected load schemes. The maximum value was 1.39 mm and was slightly lower than the calculated values after updating the model (1.43 mm). The tests confirmed that the stiffness of the arches was close to that assumed theoretically.

Fig. 11. Selected static load schemes and deflections, including theoretical and measured values
