# Reconstruction of the road bridge on Monte Cassino Avenue in Koszalin

**Abstract:** This article presents the process of rebuilding the bridge on Monte Cassino Avenue in Koszalin, Poland. The deterioration of the pre-cast concrete beams resulted in a decrease in the load-bearing capacity. On this basis, the decision was made to demolish and build a new structure, taking into account existing foundations and strengthening them with additional pre-cast concrete piles. However, during demolition works, the northern structure of the bridge collapsed uncontrollably. After a reanalysis of the technology and taking into account additional safety requirements, the demolition works were renewed. Due to collapse and its possible negative impact on existing piles, design changes related to the location of the pier axes were introduced. The load tests conducted on the rebuilt bridge allowed the finite element (FE) model to be verified by determining and comparing the response of the structure to static and dynamic load. The verified model, as an element of a digital twin, can be used in facility management throughout the life cycle of the structure, minimising the risk of failures of strate

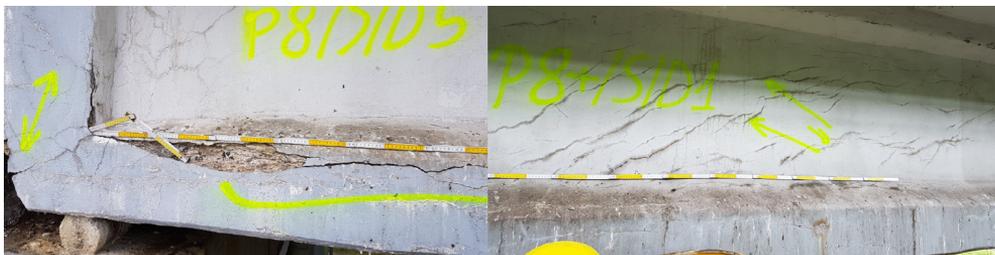
In 2020, an expert opinion was prepared to assess the current state of the structure, which confirmed its poor condition. On-site inspection combined with material tests, as well as static and strength analyses, showed a high risk of failure or collapse. The deterioration of pre-cast beams with a large number of inclined cracks near the anchor zones of the tendons (Fig. 2) exposed a reduced load-bearing shear capacity and indicated a prefailure condition. The damage found was a direct result of the yield strength exceedances in the stirrups and excluded the possibility of repair. Taking into account the above, the decision was made to close traffic and rebuild the bridge structure.

Fig. 2. Web cracks and damage to the pier zones of the WBS beams

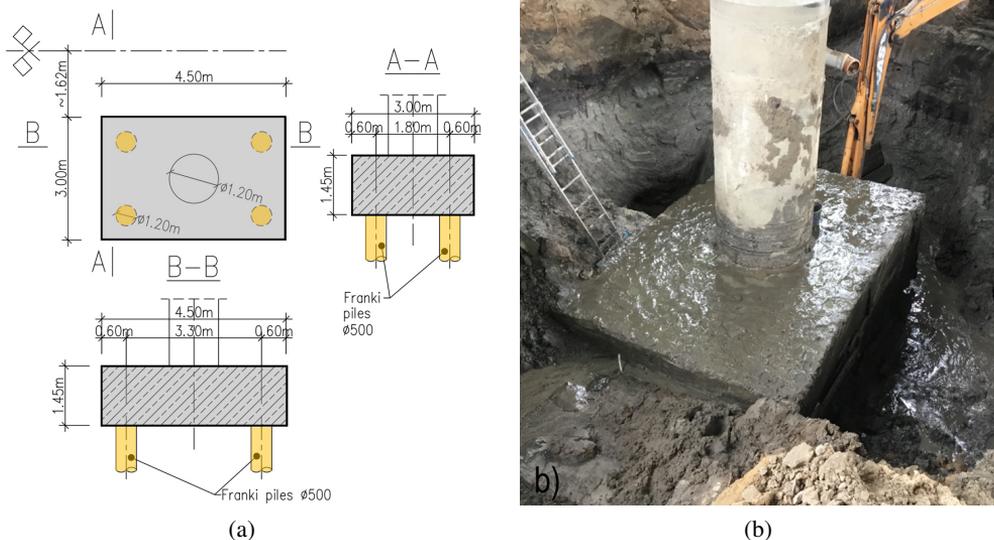
In 2021, the ability of the deep foundation to be reused for the new bridge was checked. The study consisted of a geological survey, static load tests on bridge spans to measure the settlement of the piers, and exposure of the pile caps for visual inspection and condition assessment. According to the archived documentation, the structure was based on Franki piles. Each of the existing pile foundations consisted of a cap with dimensions of  $3.0\text{ m} \times 4.5\text{ m} \times 1.45\text{ m}$  and four piles of  $0.50\text{ m}$  diameter (Fig. 3a), reinforced with  $\text{Ø}14$  plain-surface bars every  $10\text{ cm}$  and  $\text{Ø}6$  spiral reinforcement of  $10\text{ cm}$  pitch. The foundation level of the existing piles was confirmed by sounding surveys conducted and exposing the pile caps (Fig. 3b).

Fig. 3. Geometry of existing foundations (a) and the exposure of a pile cap (b)

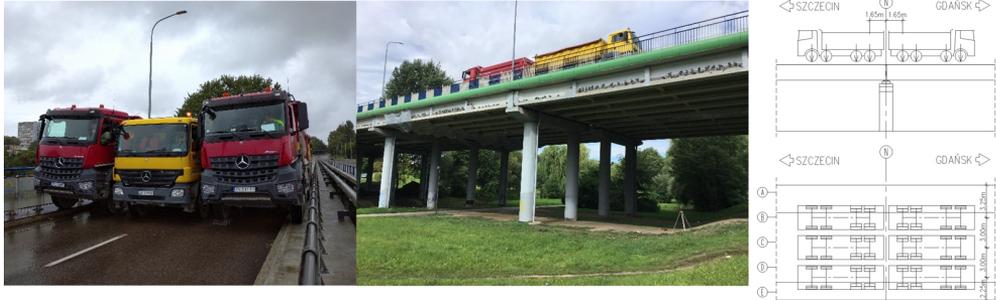
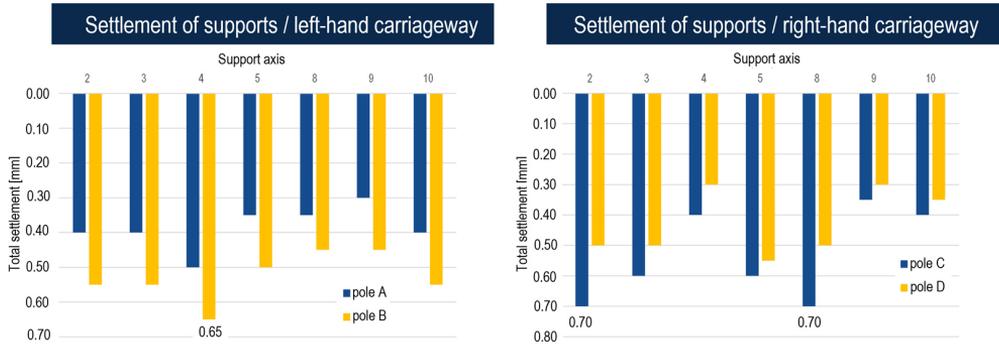
Before the work on the site, on August 20, 2021, static load tests were carried out on the bridge (Fig. 4). The aim of the tests was to confirm the elastic behaviour of the existing foundation, hence maintaining its safety margin in load-bearing capacity. Fourteen load schemes were used, designed to obtain maximum reactions on the piers. The maximum settlement measured during the load test did not exceed  $0.70\text{ mm}$ , so they were much lower than the allowed value of  $5\text{ mm}$ . The permanent settlement, remaining after unloading, is neglectable and reached up to  $0.15\text{ mm}$ . The differential settlement, measured in relation to the adjacent piers, did not exceed  $0.70\text{ mm}$  and was much lower than the maximum value allowed of  $10\text{ mm}$ . Taking into account the results of the load tests, it was confirmed that the existing foundation could be reused in the new structure.

Fig. 4. Settlement of the piers during a static load test on the old bridge

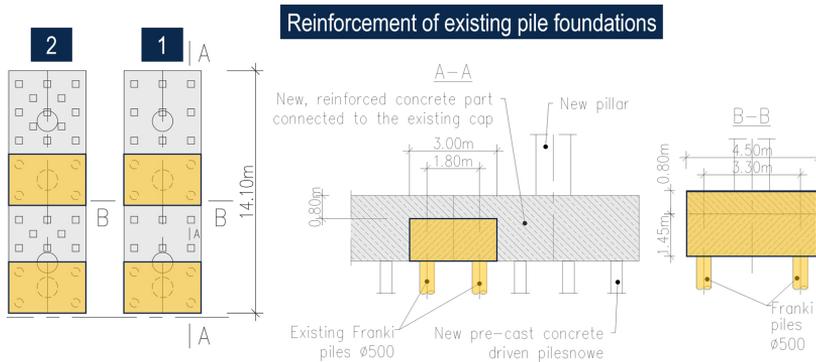
The load-bearing capacity of the existing piles was insufficient in each of the analysed piers. It was necessary to strengthen the foundations as proposed in Fig. 6. The original pile caps were joined and extended. The load-bearing capacity was improved by adding new pre-cast concrete driven piles.

Fig. 6. Reinforcement of existing pile foundations with pre-cast concrete driven piles

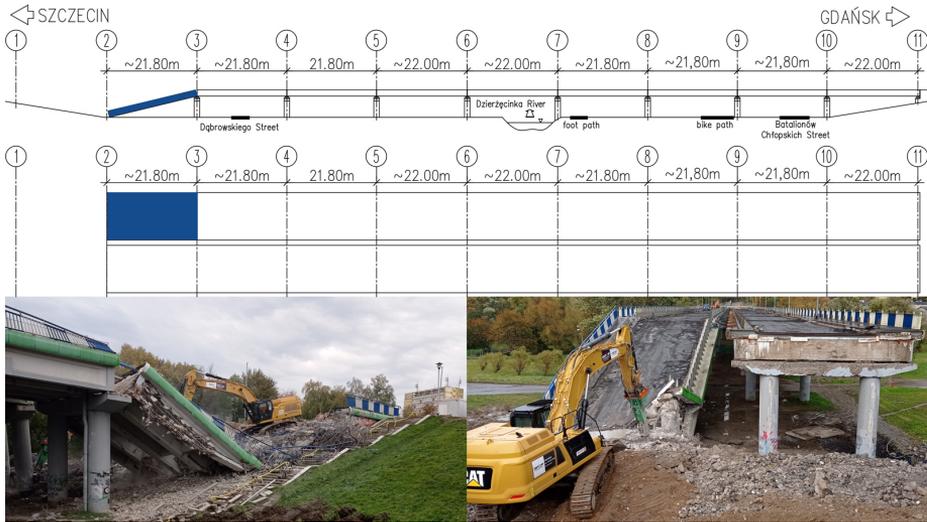
Several demolition technologies were considered taking into account the total length and type of the structure, including blasting and implosive methods, mechanical cutting along the joints of prefabricated beams, and crushing span by span using hydraulic machinery. One of the requirements was to maintain the continuity of road traffic under the bridge. On this basis, the demolition of successive spans was designed that provided excavators equipped with hydraulic breakers and concrete crushing shears. The operation started on pier no. 1 by demolition of the abutments and end spans on the northern and southern routes. Taking into account the static scheme of the bridge, the demolition technology required removal of the span preceded by removal of one of its supports that led the span to be tilted. In this state, one of the edges had to be lowered to the ground level and the other had to remain on the bearings. Following this assumption, the pier no. 2 of the northern structure was removed, and the second span leaned against the pier no. 3 (Fig. 7).

Fig. 7. Demolition works and the state right before the uncontrolled collapse

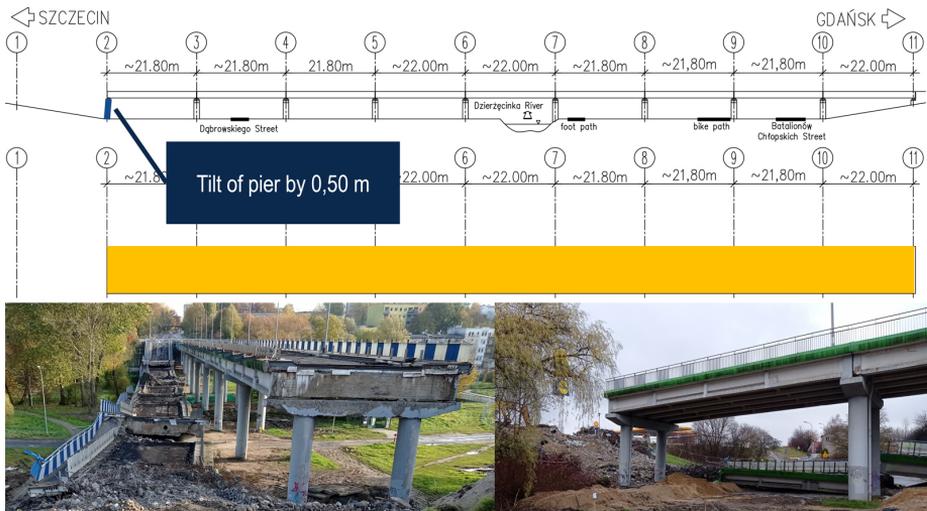
The mentioned state caused the top of the pier no. 3 to tilt out of the vertical direction by 30–50 cm. As a result, the continuation of demolition works caused an uncontrolled collapse of the support and successive parts of the northern structure (Fig. 8). On 21 October 2021, immediately after the collapse, demolition technology and security measures were reviewed. Road traffic under the bridge was closed to prevent third party access to the site. The investor indicated the need to immediately reassess the demolition technology and resume the works due to inclination of the pier no. 3 on the southern bridge and the risk of similar collapse.

Fig. 8. The state after the uncontrolled collapse

On 27 October 2021, the technological design of the demolition works was revised. It was supplemented with additional security measures and protections under the southern bridge. However, the demolition technology itself did not change. The works were to proceed along the bridge starting from the outer side of the pier no. 2, using hydraulic breakers and concrete crushing shears, as before. Taking into account the works carried out so far, there was a high probability that the spans would collapse uncontrolled again as a result of the instability of the pier no. 3. However, changing the technology to an alternative method, e.g., implosion, would not increase the safety of the works. Considering the partial instability of the structure, it would pose a threat to people preparing the structures for demolition.

- Setting a safe distance from the edges of the bridge for workers and machinery.
- Resignation from longitudinal cutting along the girders.
- Permanent closure of road traffic under the bridge, protection against unauthorised access by third parties and pedestrians.
- Protection of pavement, footpaths, and road infrastructure under the bridge with sand beds and mats that provide a physical barrier against falling debris and the dynamic impact in the event of uncontrolled collapse.
- Securing and monitoring of the gas network exposed to damage during demolition works.
- Monitoring of selected facilities and buildings in the closest vicinity.

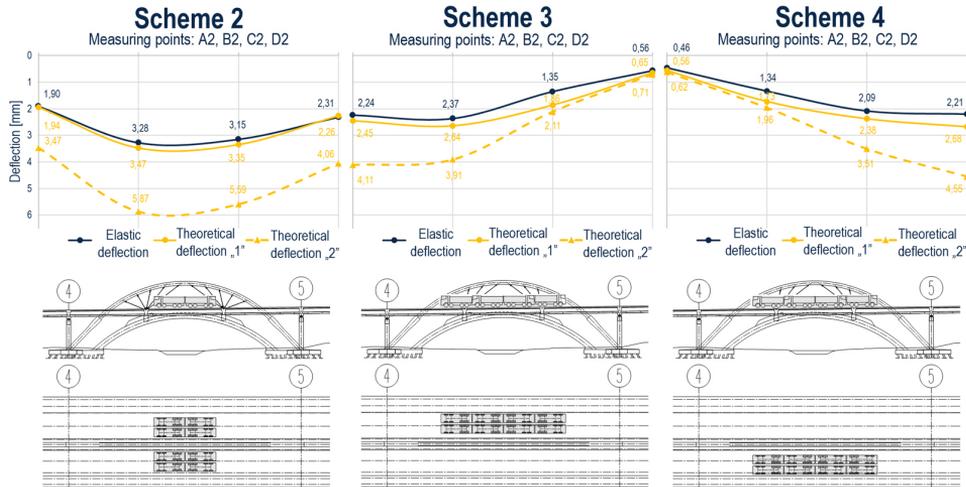
The analysis of the structural response from the basic arch span schemes (Fig. 11) confirmed that the code requirements were met and that the developed Finite Element (FE) model is correct. The elastic deflections of the girders were similar to those calculated theoretically in the uncracked phase and amounted on average for the S2, S3, and S4 span schemes in the relevant cross-sections to 97%, 85% and 83% of their values, respectively. Such results indicate that the stiffness of the girders is similar to the values assumed in the model analysed in the uncracked phase. The model adopted for dimensioning provides results on the safe side and thus the load-bearing capacity that was theoretically assumed is correct. Permanent deflections are within the range of 0% to 8% of total deflections and therefore meet the code condition of

not exceeding the level of 20%. Additionally, the displacements of the arches were measured during the selected load schemes. The maximum value was 1.39 mm and was slightly lower than the calculated values after updating the model (1.43 mm). The tests confirmed that the stiffness of the arches was close to that assumed theoretically.

Fig. 11. Selected static load schemes and deflections, including theoretical and measured values
