Research paper

Floods – a permanent threat to building structures on the example of the Odra River basin

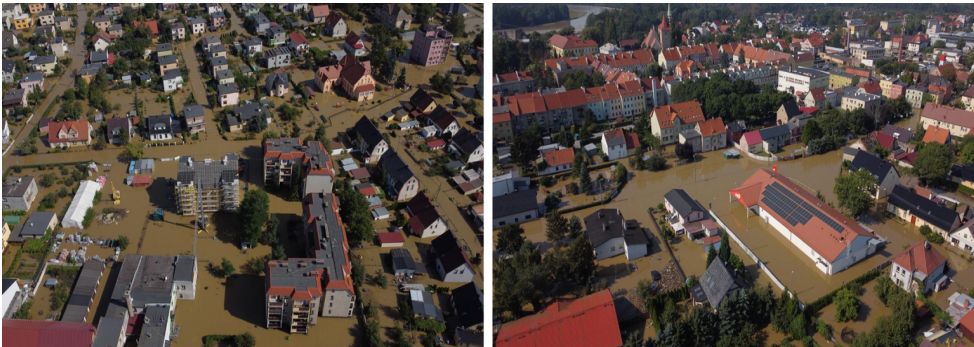
Fig. 1. Lewin Brzeski in September 2024 – photo by S. Szpineta, J. Kieronki, M. Karas, A. Czepichal

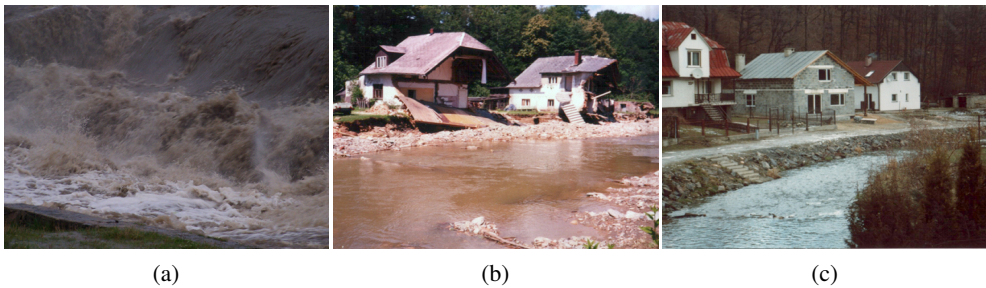
Fig. 2. Residential buildings in the village of Jarnoltówek (near Glucholazy): a) flood wave, b) damaged residential buildings (August 1997), c) newly constructed buildings on the site of the damaged ones (October 1998) – photo by D. Bajno

- damage to the structure of foundations (Fig. 2, 4c), walls, and floors (Fig. 4a,b), due to partial or complete loss of subbases and protective layers [1, 9–11],

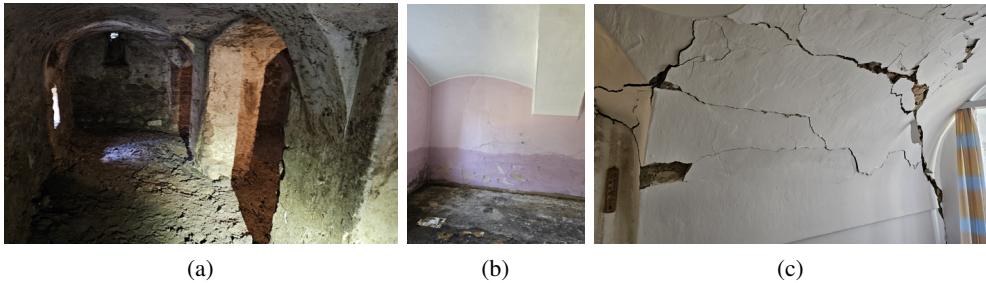
Fig. 4. Nowy Swietow, 22 September 2024: a), b) wet and contaminated floors and walls of basements and ground floors; c) damaged structure of a building dating from the mid-19th century – photo by D. Bajno

This problem was frequently compounded by insufficient or entirely nonfunctional ventilation which had often already been ineffective even before the flooding. Partition walls in the basements of newer multi-family buildings typically constructed from hollow bricks were prone to damage due to the disturbance of the floor's base layers which lacked proper foundations and depth. Numerous previously unnoticeable, web like cracks in the plaster appeared as the result of leaching of lime binders and shrinkage during the drying process. Floor finishing layers such as parquet and wooden boards became warped and detached from the subfloor, rendering them unusable even after disinfection (Fig. 4b).

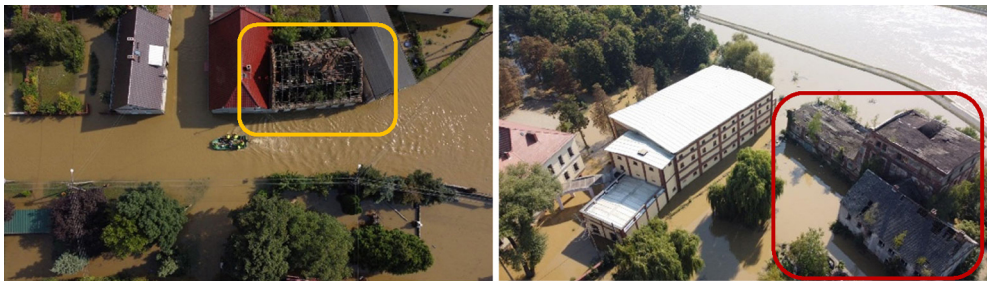
Fig. 5. Buildings already in very poor technical condition prior to the flood (Lewin Brzeski) – photo by S. Szpineta, J. Kieronski, M. Karas, A. Czepichal

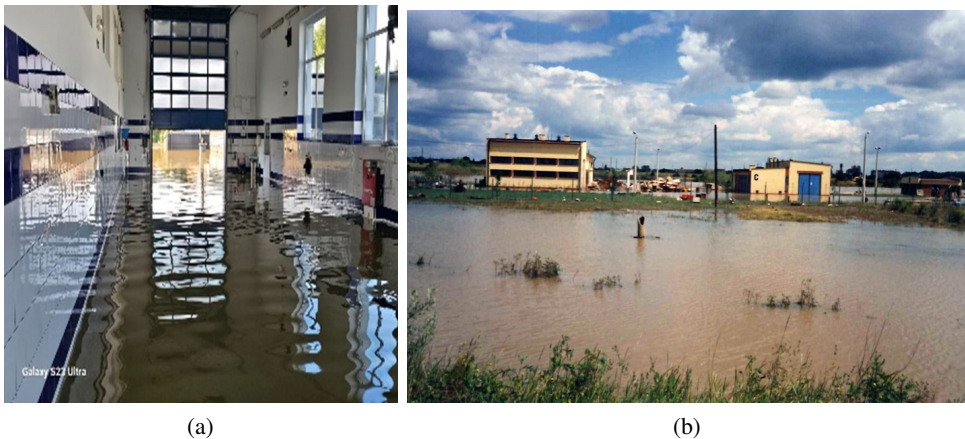
Fig. 6. Causes of bacteriological contamination: a) flooded workshop surfaces (September 2024) – photo by M. Karas; b) a water-filled municipal waste storage basin (July 1997) – archive of the Municipal Services Department in Opole

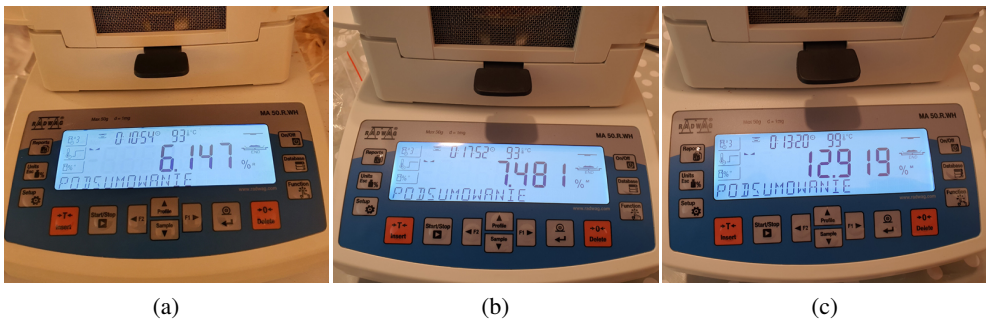
Fig. 7. Laboratory test results of brick moisture levels: a) sample no. 1, b) sample no. 2, c) sample no. 3

- sample no. 1 – 6.15% (*at a moderate level of moisture*),
- sample no. 2 – 7.48% (*at a moderate level of moisture*),
- sample no. 3 – 12.92% (*wet*).

In reality, some of the examined walls exhibited a very high-water content (classified as wet according to Table 2) which was primarily due to the lack of proper protection of these partitions against external moisture, as well as disorganized water management around the buildings. Nevertheless, these conditions were not the result of the recent flood events.

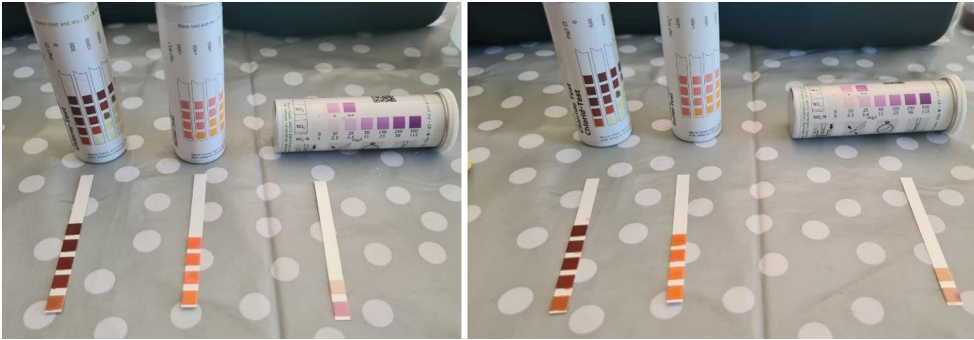
The results of the analysis showed that the salt content was low for nitrates, chlorides, and sulfates (Table 3 and Fig. 8).

Fig. 8. Results of salt content analysis in plasters and bricks

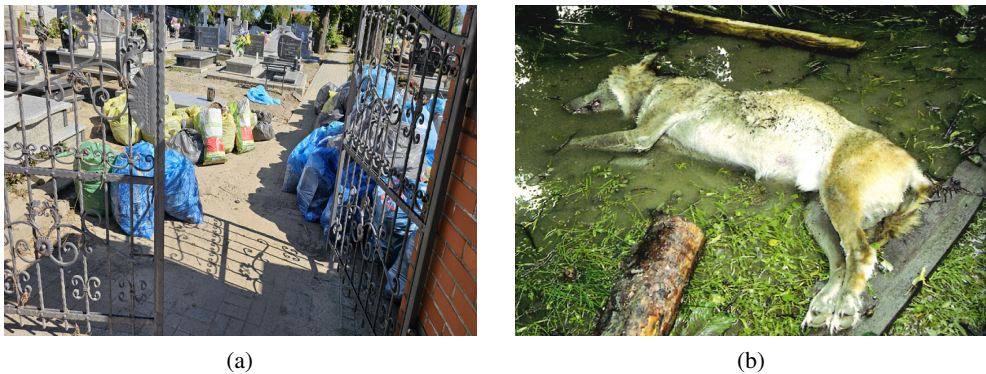
- objects carried by the water, such as rescue equipment, vehicles, small architectural elements,
- carcasses of animals (Fig. 9b),
- flooded cemeteries (Fig. 9a), workshops (Fig. 6a), manufacturing facilities, wastewater treatment plants, and waste disposal sites (Fig. 6b).

Fig. 9. Sources of microbiological contamination in floodwater: a) cemetery adjacent to residential buildings (Nowy Swietow, September 2024) – photo by D. Bajno; b) dead animals (July 1997) – photo by M. Przygoda, after [4]

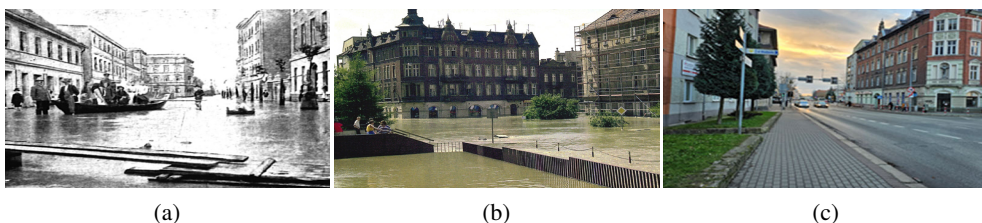
Figures 10 and 11 present the same locations and buildings affected by flooding over the past 120 years (specifically in 1903, 1997, and 2025). Current surveys of these structures, conducted in 2025, did not reveal any structural damage, either in the underground or above-ground parts. No traces of flood-related moisture effects from past events are currently visible. Moreover, the interior surfaces of the basement walls and ceilings show no signs of cracking, fissuring, or fungal growth.

Fig. 10. Spychalskiego Street in Opole: a) in July 1903 (according to [4]), b) in July 1997 (photo by M. Przygoda, from [4]), c) current view (January 2025) – photo by D. Bajno

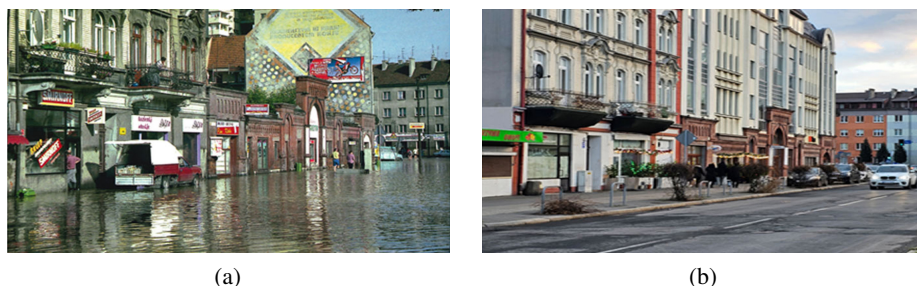
Fig. 11. Wroclawska Street in Opole: a) in July 1997 (photo by M. Przygoda, from [4]), b) current view (January 2025) – photo by D. Bajno
