Research paper

Safe Lighting Point as a new component of road safety elements

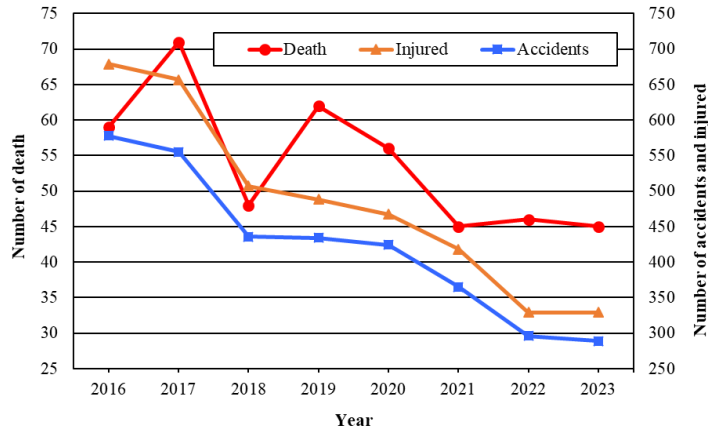
Fig. 2. Accidents involving collision with a column/sign in 2016-2023 (source: [7–14])

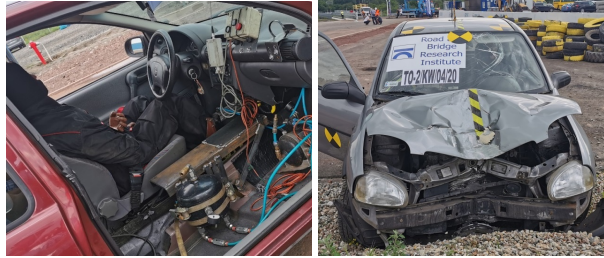
Fig. 6. View of the measuring apparatus installed inside the test vehicle and the condition of the sample vehicle after the crash test (source: own elaboration)

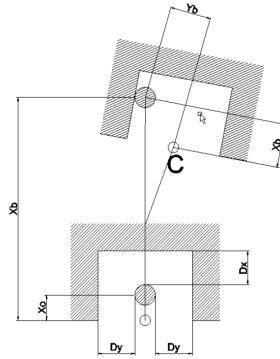
Fig. 8. Illustration describing the theoretical head impact on the left side of the vehicle cabin interior

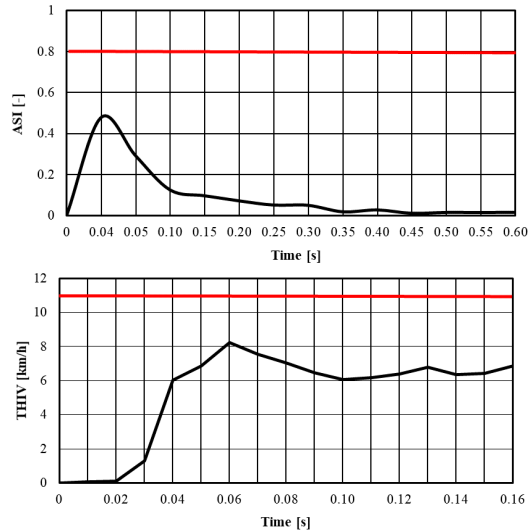
Fig. 9. ASI and THIV diagrams for the 100NE-B-S-SE-SD-0 test

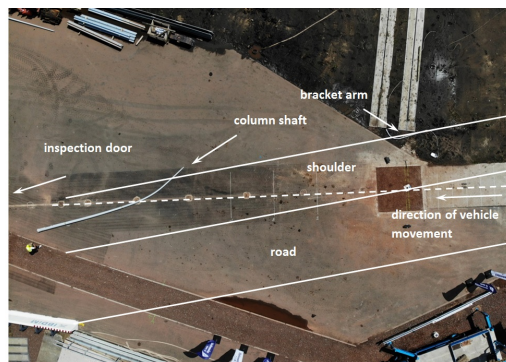
Fig. 10. Scale view of the scatter of the lighting set components following a vehicle collision with a lighting column shaft at a test speed of 100 km/h (source: [33])

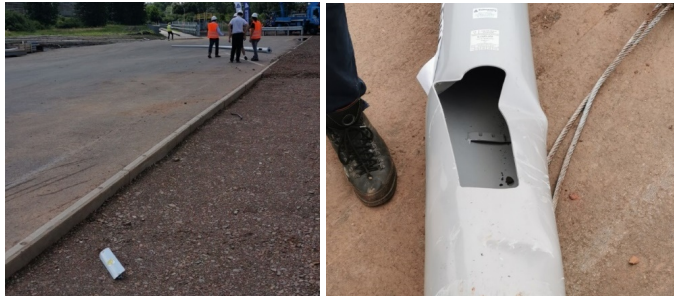
Fig. 11. View of the site of the fallen inspection door and the damage to the column shaft caused when it was pulled out of the ground (source: [33])

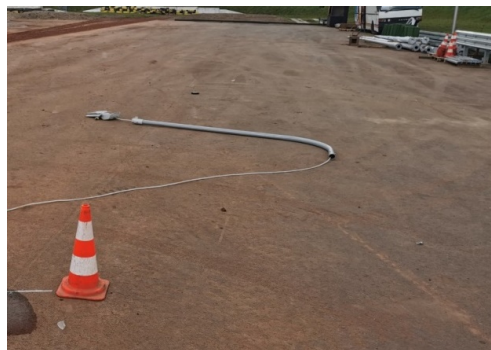
Fig. 12. View of the site of the fallen bracket detached from the column shaft (source: [33])

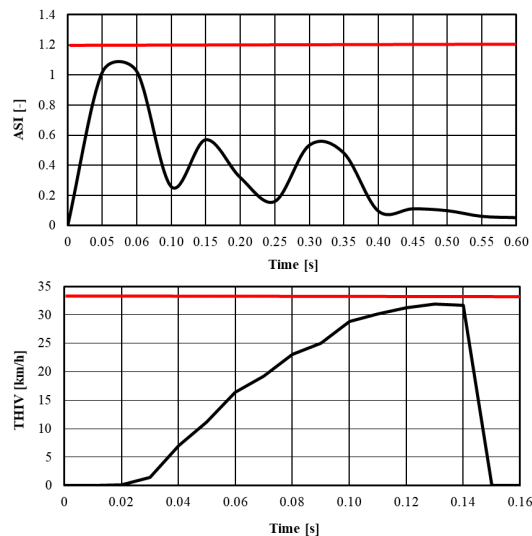
Fig. 14. Diagrams of ASI and THIV values for the impact test at a speed of 70 km/h

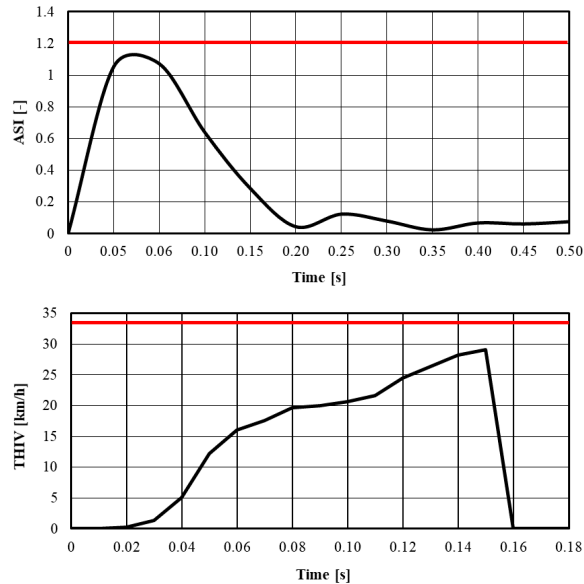
Fig. 15. Diagrams of ASI and THIV values for the impact test at a test speed of 100 km/h
