# Assessment of long-term performance of foam glass as an insulating sub-base in varying humidity and temperature conditions

This article presents the experimental research on foam glass working under varying moisture and temperature conditions. The long-term performance, key to its application as tank base insulation.

The material under analysis was foam glass used as a base insulation of a steel tank designed to store products at 200°C. The brand new material, applied in this case, had a closed cell structure and following parameters declared by the producer: bulk density

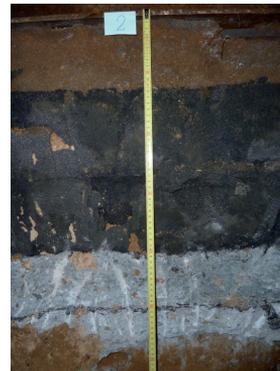
Fig. 1. Diagram of the tank and sub-base construction: (a) tank, (b) tank sub-base

The picture in Fig. 1b represents the interstitial space of the tank, i.e. the zone beyond the effect of the heat emitted by the stored product. Although damp, the foam glass was

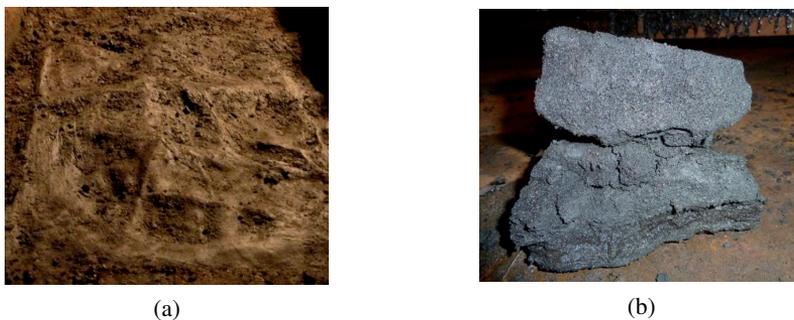
Where two separate layers of deteriorated foam glass could be identified in the tank pad (Fig. 2a and 2b), surface undulations of the lower layer were very pronounced (Fig. 3a). On the other hand, where the division into the two layers was hardly distinguishable (Fig. 2c), the deterioration was very severe and the foam glass turned into a wet, compressed lump (Fig. 3b).

Fig. 3. Surface undulations of the lower foam glass layer (a) and foam glass deterioration (b)

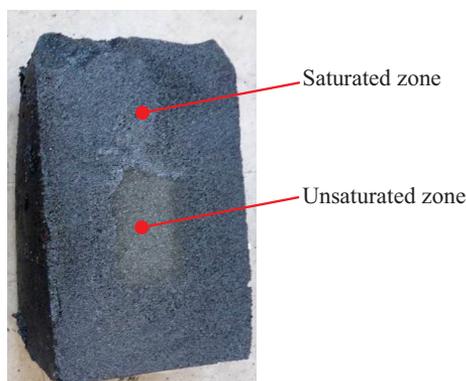
A significant degree of saturation of the foam glass results in a deterioration of its thermal insulating capacity. Taking into account the thermal conductivity coefficients of foam glass and water at a temperature of  $200^\circ\text{C}$  amounting to  $0.076 \text{ W/(m}\cdot\text{K)}$  and about  $0.66 \text{ W/(m}\cdot\text{K)}$  respectively, without detailed research and analysis, it can be concluded that such a high saturation of foam glass will result in a several-fold decrease in its thermal insulating capacity. This property was further deteriorated by a 2–3 times reduction of the layer thickness. Investigations into the degree of saturation of the foam glass also indicate that the closed cell structure of the material has been significantly damaged. The

Fig. 4. Cross-section through an saturated foam glass specimen

simultaneous interaction of water and high temperature, and consequently water vapour, led to damage of the pore walls and a change in the structure to an open porous one, susceptible to saturation. The tested material was already saturated, so the pore structure was damaged, and therefore it was not possible to study the structure degradation process. Evaluation of this phenomenon will be carried out on a new undamaged foam glass.

The saturation levels, defined by the percent of liquid contained in the respective specimens are given in Table 1 and an example of the test specimen is shown in Fig. 4. The greatest liquid content was determined on the specimens sampled from the lower layer of foam glass obtained from the test pits under the interstitial space (specimens No. 1/2a,

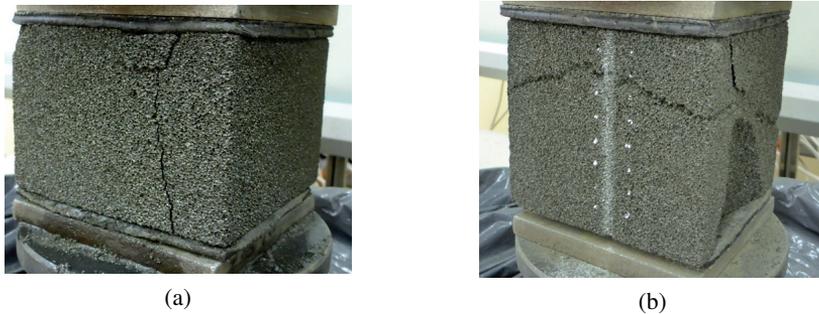
In series No. 2, where the pressure elements were fitted with bituminous spacers, the specimens reached a strength of 0.7 MPa (Table 2) and two failure modes were identified: vertical fracture (Fig. 7 and Fig. 8a) and horizontal fracture (Fig. 8b).

Fig. 8. Example of samples during the tests: (a) vertical fracture, (b) horizontal fracture

The series No. 2 specimens achieved the declared compressive strength of 0.7 MPa. Bituminous spacers eliminated the prevalent failure mode, namely crushing of the foam glass at the interface with hard surfaces, in this way increasing the obtained compressive strength.

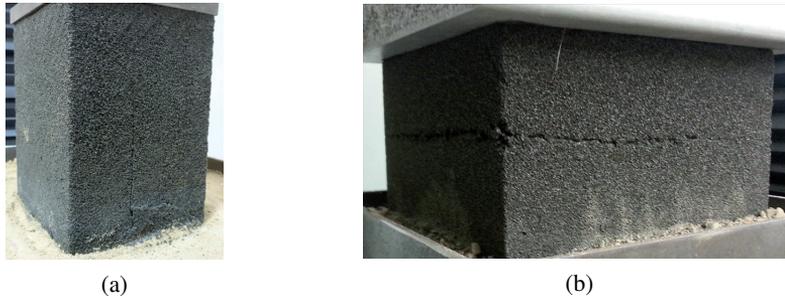
- fracture in an oblique and/or vertical plane, initiated at the bottom of the specimen, where the specimen rested on the hot sand base (Fig. 9a and Fig. 10a), which was sudden in the case of damper specimens,
- sudden horizontal fracture at half the height of the specimen (Fig. 9b and Fig. 10b). This failure mode was noted only for  $200 \times 200$  mm specimens.

Fig. 10. Example of samples during the tests: (a) vertical fracture, (b) horizontal fracture

None of the series No. 3 specimens reached the declared compressive strength of 0.7 MPa yet all had sufficient capacity to withstand the maximum stress under the tank bottom, i.e. 0.25 MPa. The maximum achieved loads did not induce stresses that would initiate crushing of the specimen material in the pressure zone, how it occurred in series

No. 1, even though the load was applied directly by hard plates. Thus the specimens failed by fracture initiated at the bottom due to limited stability of the sand base or fractured at other locations, especially in the case of larger samples for which the stability of base was of lesser importance. In the latter case, the fracture was not initiated near the sand base.

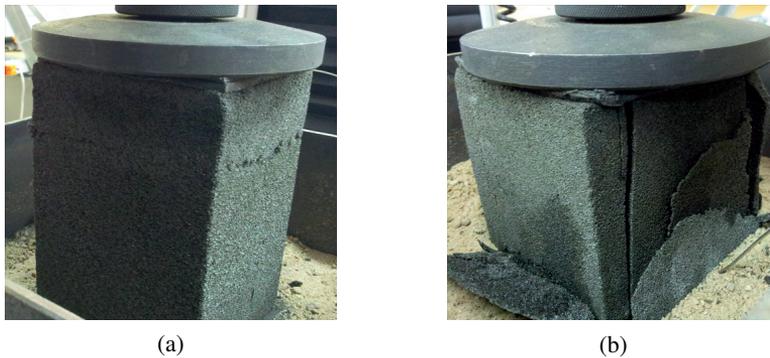
- sudden fracture in a horizontal, vertical or oblique plane, not initiated in the lower part of the specimen (Fig. 11 and Fig. 12a),
- fracture in the oblique and vertical planes initiated in the bottom part of the specimen (Fig. 12b). During the failure of wetter specimens, pieces of foam glass fell off at the interface with hot sand base, producing a loud sound.

Fig. 12. Specimens during the tests: (a) horizontal fracture, (b) oblique and vertical fracture

None of the series No. 4 specimens reached the declared compressive strength of 0.7 MPa, yet a majority of them had sufficient capacity to withstand the maximum stress under the tank bottom, i.e. 0.25 MPa. As in tests without the bituminous separators, the prevalent failure mode was the fracture initiated at the bottom of the specimen, at the

interface with the sand base. Also noted were horizontal and oblique fractures not initiated near the interface with the sand base. The breaking loads were at the same level as in the testing of series No. 3, which means that the bituminous separator did not increase the measured compressive strength of the specimens.

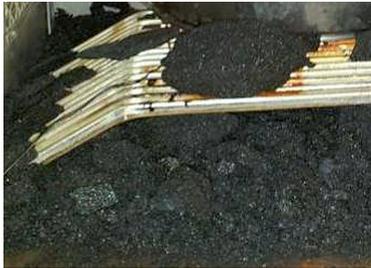
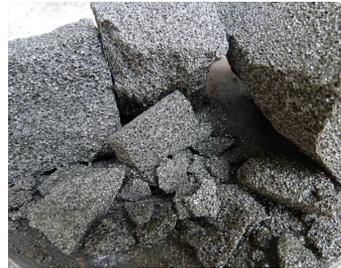
The phenomena observed in the material subjected to simultaneous heating and loading called for a subsequent test to assess the behaviour of foam glass exposed to the specified temperature of 200°C without any mechanical loading. During heating in the laboratory oven already at ca. 130–140°C, the foam glass started to crack, producing crackling sounds to get completely destroyed when the temperature reached 200°C (Fig. 14a). Heating of samples from one side only up to the specified temperature of 200°C also caused their failure (Fig. 14b).

Fig. 14. Heating of samples at 200°C: (a) completely destroyed samples after all-around heating in the laboratory oven, (b) cracked foam glass specimens after one-sided heating on a hot plate

Absorption of water considerably affects reducing the foam glass performance. Investigations show that the foam glass generally does not reach the declared compressive strength. Moreover, it becomes more prone to progressive deterioration at an interface with a hard surface, especially if non-uniform and rough, such as a layer of sand. If this surface is additionally heated to high temperature, the foam glass undergoes destruction by chipping or crushing just at stresses several times lower than the limits for this material, and even with no applied load. Prolonged exposure of wet foam glass to high temperatures results in a virtually complete destruction of the material.
