# Behavior of damaged TBM tunnel under MJS and Micro-disturbance grouting treatment: a case study

**Abstract:** The operating subway tunnel is often damaged due to excessive deformation in China. In order to ensure the safe for operation, remediation and protection measures must be taken, especially in soft soil areas. This paper presents a case study on remedial scheme of damaged TBM (Tunnel Boring Machine) tunnel adjacent to excavation combining with MJS (Metro Jet System) and micro-disturbance grouting technology in Hangzhou, China. The track bed settlement, horizontal displacement and convergence of the TBM tunnel caused by MJS and micro-disturbance grouting construction were analyzed and discussed. The results showed the characteristics of soil layer under the tunnel have significant influence on the treatment effect. Even if multiple grouting was adopted, the treatment failure may occur under the combination action of external loads such as traffic load or surcharge load, which should be considered when civil engineers design remediation scheme. The results can provide practical experience and guidance for similar treatment scheme of damaged TBM tunnel.

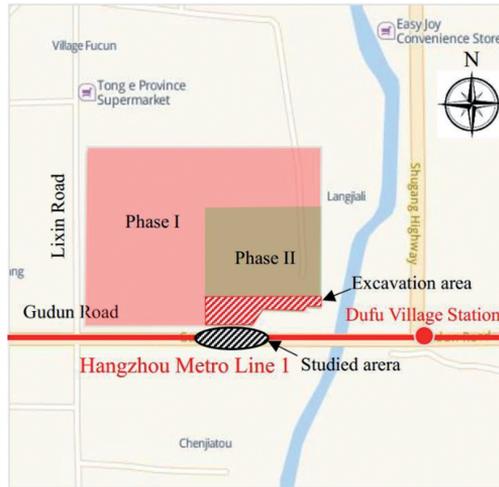
Fig. 1. Plan layout of the site

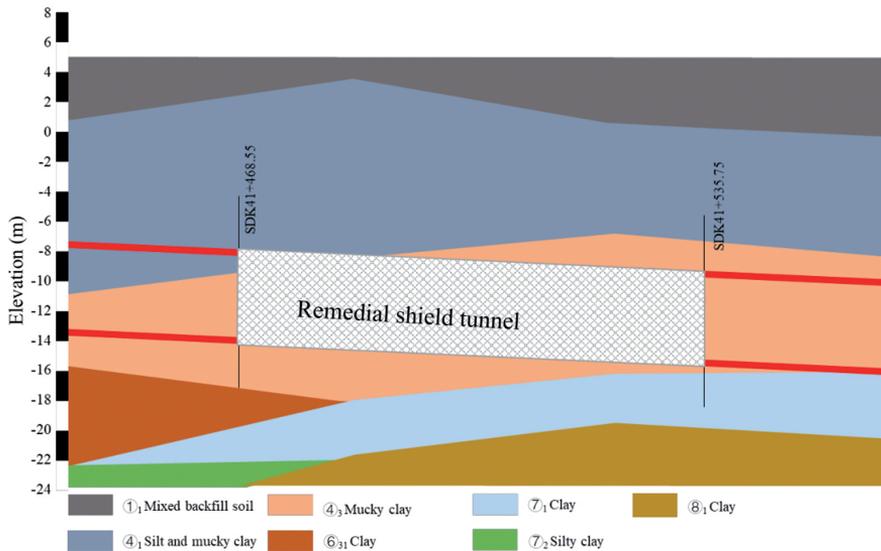
Fig. 2. (Color) Partial longitudinal geological profile of the up-track tunnel

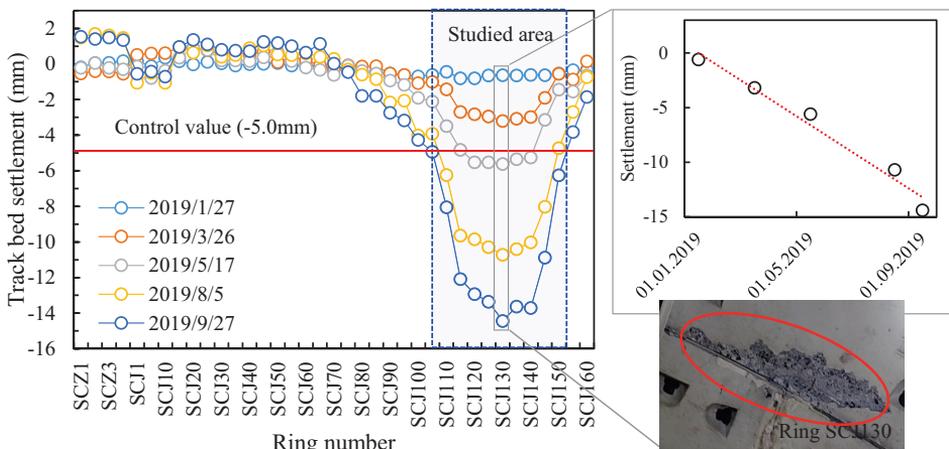
According to the settlement monitoring results, the cumulative track bed settlement of up-track tunnel is presented in Fig. 3. From Fig. 3, the local settlement of the up-track TBM tunnel was obvious, and the settlement area is mainly between ring SCJ105~SCJ155. The maximum settlement was -14.4 mm at ring SCJ130 during excavation construction on September 27, 2019, which was about three times the control value. Based on the variation of track bed settlement at ring SCJ130, the track bed settlement did not tend to be stable,

Fig. 3. Track bed settlement of the affected up-track TBM tunnel

but still increased gradually. After the basement structure completion on August 5, 2019, the settlement continued to develop.

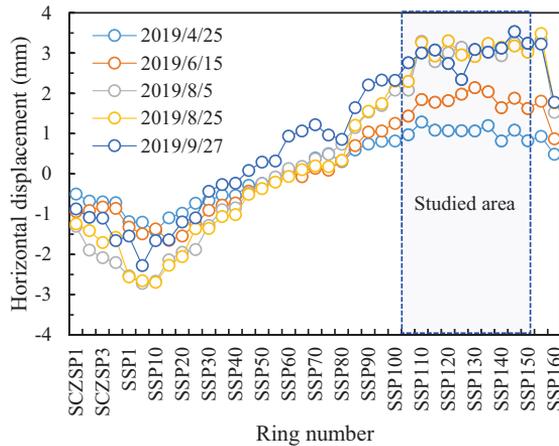
Fig. 4 plots the horizontal displacement of the affected up-track TBM tunnel, from which there was an obvious horizontal movement towards the foundation pit from ring 105 to 150. The maximum horizontal displacement was 3.5 mm. After the basement structure was completed, the horizontal displacement tended to be stable gradually.

Fig. 4. Horizontal displacement of the affected up-track TBM tunnel

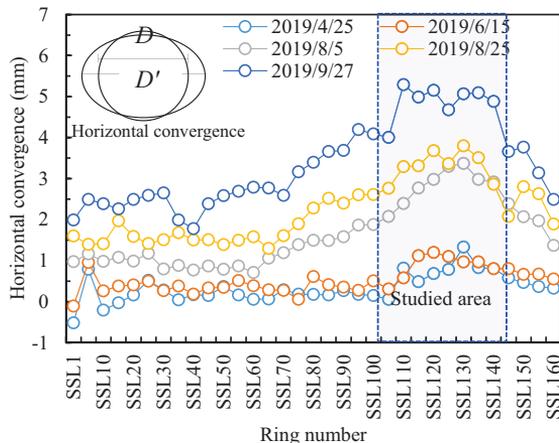
The horizontal convergence ( $\Delta D$ ) of the affected up-track TBM tunnel is presented in Fig. 5. From Fig. 5, the up-track TBM tunnel had evident compression deformation between ring 80 and ring 150 during excavation. The maximum horizontal convergence of the affected up-track TBM tunnel was 5.3 mm at ring 90. The horizontal convergence continued to increase after the basement structure was completed.

Fig. 5. Horizontal convergence ( $\Delta D$ ) of the affected up-track TBM tunnels

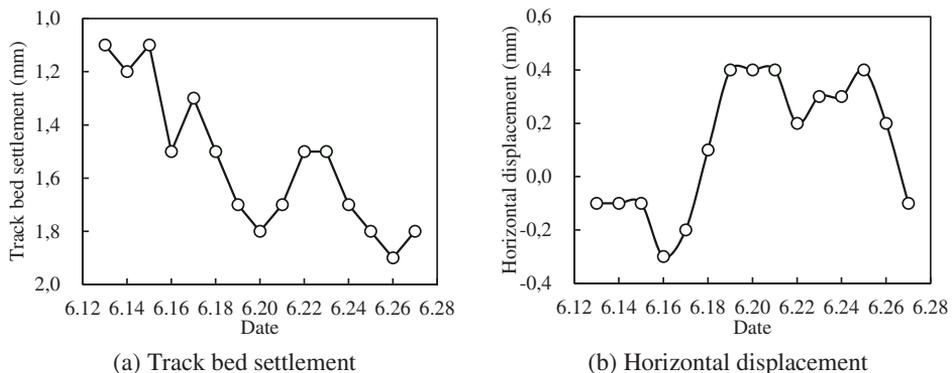
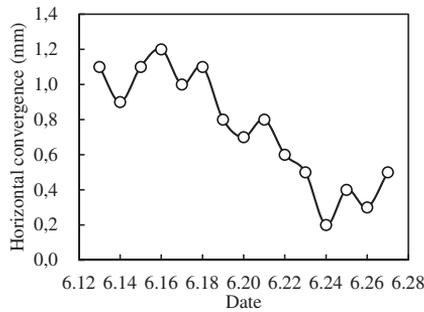
Fig. 7 (a), (b)

From Fig. 7, the MJS test pile construction has little impact on the damaged tunnel. The track bed settlement gradually increases during the whole test pile construction, and the maximum value is 1.9 mm on June 26. The horizontal displacement and convergence are very small and have almost no effect on damaged TBM tunnel.

(c) Horizontal convergence

Fig. 7. Variation of behavior of damaged tunnel adjacent to test piles (ring number 153 to 155)

The positions with small deformation (ring number 153 to 155) are selected as the test section for pile test. Both diameters of the four test piles are 2400 mm, with a length of 8.6 m. The pile centers on both sides are 4.6 m from the center line of the damaged TBM tunnel. In order to ensure the safety of the tunnel, test piles on the south side are carried out first. The construction is planned in the sequence of North M39, South M38, North M38, South M39. The interval time of jet grouting with adjacent pile positions in a row shall not be less than 24 hours. The test pile construction starts from June 13, 2020 to June 27, 2020. During MJS test pile construction, the variation of behavior of damaged tunnel adjacent to test piles (ring number 153 to 155) is shown in Fig. 7.

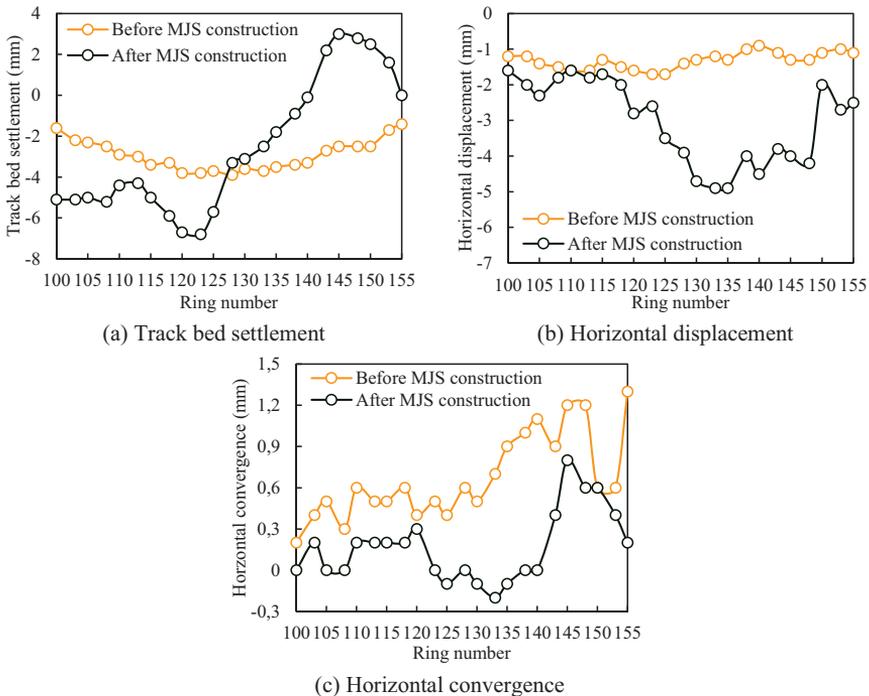
Fig. 8. Comparison results of damaged TBM tunnel deformation

from which MJS construction has the greatest influence on horizontal displacement of the damaged TBM tunnel. The maximum horizontal displacement is  $-4.9$  mm at ring 133 and 135. From Fig. 8a, the track bed uplift was caused by MJS construction between ring 128 and 155, and the maximum uplift was 3 mm at ring 145. The horizontal convergence of all rings was small. To summarize, the effect of MJS construction on damaged TBM tunnel is not significant.

According to the experiences and parameters obtained from test pile construction, the remaining 74 MJS piles are constructed in the test section. The construction method is the same as the test pile construction. During MJS construction of test section, the grouting volume and grouting pressure did not exceed the design value. In addition, the monitoring data of the damaged TBM tunnel were stable and within the control value. Comparison results of damaged TBM tunnel deformation (ring number 100 to 155) are shown in Fig. 8,

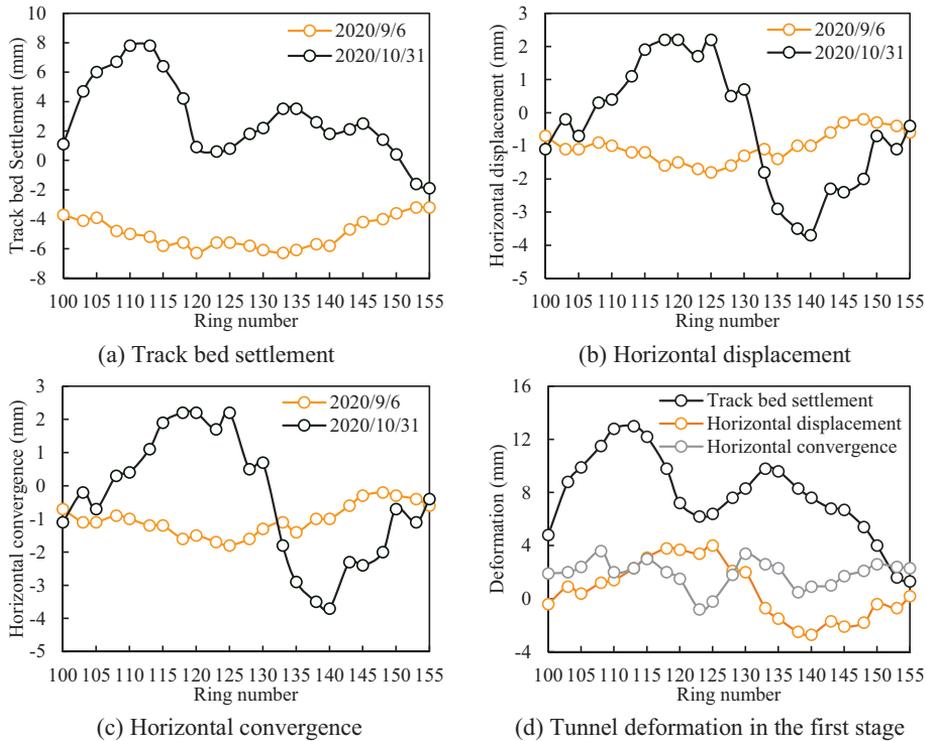
The first stage starts from September 6, 2020 to October 31, 2020, and a total of 110 grouting holes in 55 rings have been completed. The construction parameters were adopted based on the design scheme, and each grouting lift is close to the control value of 2 mm. Comparison results of damaged TBM tunnel deformation caused by micro-disturbance grouting in the first stage are shown in Fig. 9a–9c, and the tunnel deformation in the first stage (Fig. 9c) are determined by the difference at the beginning and end of the first stage construction. The micro-disturbance grouting construction in the first stage has obvious effect on the damaged TBM tunnel treatment from Fig. 9. The maximum track bed uplift is 13 mm at ring 113 in the first micro-disturbance stage, and the minimum uplift is 1.3 mm at ring 155. The average of the track bed uplift is 7.8 mm. The changes of horizontal

displacement and convergence are relatively small, and no more than 4 mm in the first stage.

Fig. 9. Comparison results of damaged TBM tunnel deformation

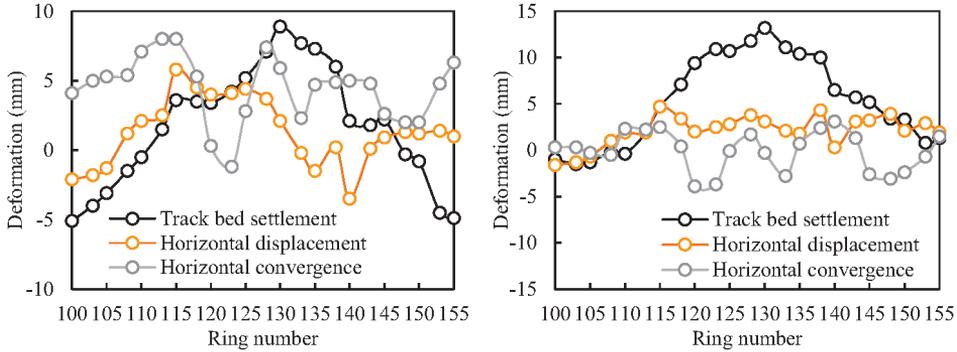
Based on long-term monitoring data of Hangzhou metro line 2, the maximum settlement area is located at ring 125 to ring 135. As of September 6, 2020, the maximum settlement of the line 2 is located at ring 130, and the value is  $-74.7$  mm. After the grouting in the first stage, the maximum settlement of the TBM tunnel is  $-66.1$  mm by October 29, 2020. The micro-disturbance grouting scheme of the second stage is the same as the first stage. The grouting construction of the second stage started from November 27, 2020 and ended on January 2, 2021. A total of 44 micro-disturbance grouting was carried out with the same grouting scheme in the first stage. The tunnel deformation at the end of the second stage grouting is shown in Fig. 10a, from which the track bed settlement shows obvious uplift deformation. On January 4, 2021, the maximum uplift is 8.9 mm at ring 130. The changes of horizontal displacement and convergence is small, which is similar to the first stage. Fig. 10b presents the deformation caused by the second stage grouting, which is the difference at the beginning and end of the second stage construction. The average of the

track bed uplift caused by the second stage grouting is 5.35 mm, and the maximum uplift is 13.2 mm at ring 130. Both the horizontal displacement and convergence are less than 5 mm, which are relatively small.

(a) Deformation on January 4, 2021 (b) Tunnel deformation in the second stage

Fig. 10. Variation of the tunnel deformation caused by the second stage grouting

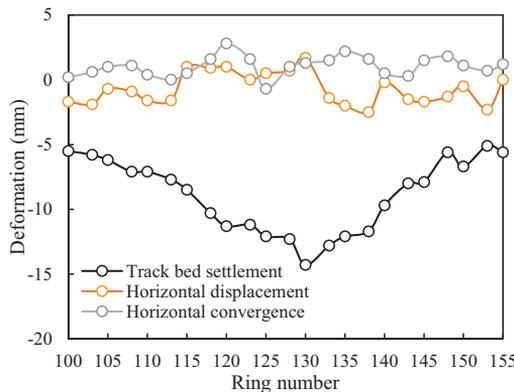
Variation of the tunnel deformation after micro-disturbance grouting is presented in Fig. 11, which is the measure difference between January 4, 2021 and March 16, 2021. After the second stage of grouting, the large settlement of the TBM tunnel was still observed based on the monitoring data. Once again, the average of track bed settlement is  $-8.9$  mm from Fig. 11. The maximum track bed settlement is  $-14.3$  mm located at ring 130. The variation of horizontal displacement and convergence is relatively small. Therefore, the third stage grouting was proposed to meet the requirement that the settlement rate is less than  $\pm 0.02$  mm/d for 3 months.

Fig. 11. Variation of the tunnel deformation after the second micro-disturbance grouting

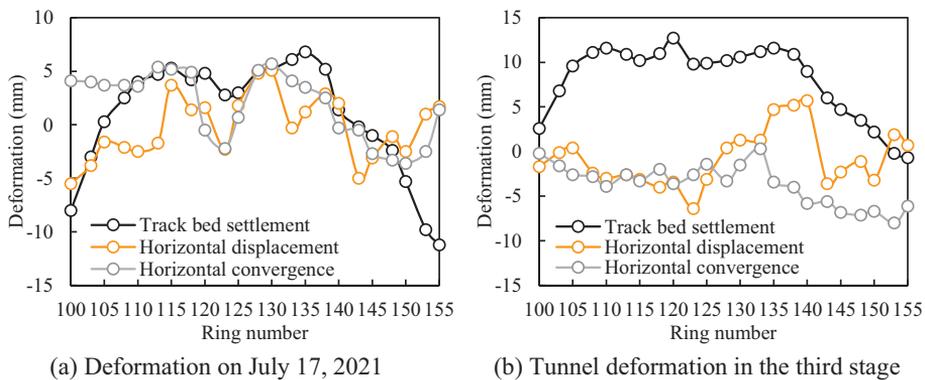
The third stage micro-disturbance grouting starts from March 16, 2021 to July 17, 2021, and the grouting holes and scheme is the same as the first stage. The difference is that grouting depth is 24 m due to the thick muddy soil layer under the tunnel, which is deeper than the first stage. The tunnel deformation at the end of the third stage grouting is shown in Fig. 12a, from which the track bed settlement shows obvious uplift deformation. On July 17, 2021, the maximum uplift is 6.8 mm at ring 135. The deformation caused by the third stage grouting is shown Fig. 12b, which is the difference at the beginning and end of the third stage construction. The average of the track bed uplift caused by the third stage grouting is 8.05 mm, and the maximum uplift is 12.7 mm at ring 120. The maximum horizontal convergence is  $-6.1$  mm at ring 155, and the horizontal displacement is relatively small.

Fig. 12. Variation of the tunnel deformation caused by the third stage grouting

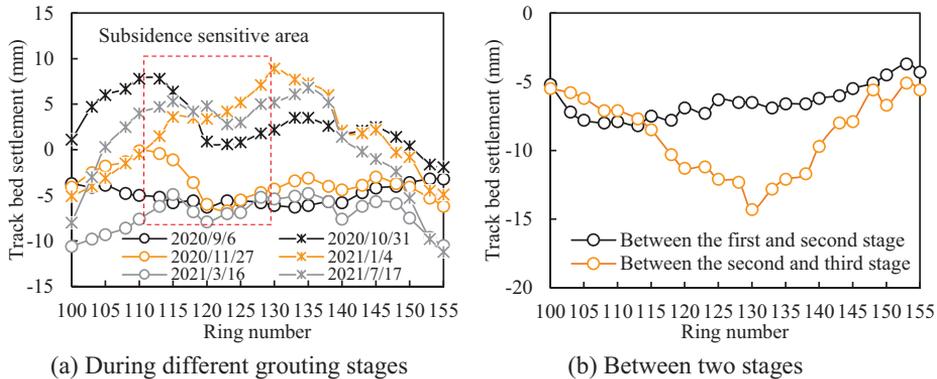
Figure 13 presents the track bed settlement under different grouting stages. From Fig. 13a, the maximum liftings of three grouting stages were 13 mm (ring 113), 13.2 mm (ring 130) and 12.7 mm (ring 120) respectively, from which the micro-disturbance grouting has significant effect on tunnel uplifting. However, the average track bed settlements at the start of the three stages were  $-5.0$  mm,  $-3.6$  mm and  $-7.2$  mm, respectively. It means that once the grouting was completed, the remedial TBM tunnel quickly sink again. According to the previous monitoring results, the up-track tunnel at ring 115÷130 showed large convergence deformation before tunnel operation, and the mechanical performance of tunnel structure was weakened, which was easy to sink again (subsidence sensitive area). From Fig. 13c, the average of track bed settlement between the first and second stage (26 days) was  $-6.5$  mm, and the maximum settlement was  $-8.2$  mm at ring 113. The average settlement between the second and third stage (71 days)  $-8.9$  mm, and the maximum settlement was up to  $-14.3$  m at ring 130. Therefore, it is difficult to completely stabilize the thick mucky clay under the TBM tunnel by micro-disturbance grouting method. Combining

with geological and site conditions, the phenomenon can be speculated for the reasons: (1) thick mucky clay layer under the TBM tunnel; (2) poor mechanical performance of tunnel structure; (3) heavy vehicle loads and surcharge above the tunnel.

Fig. 13. Track bed settlement under different grouting stages
