# THE HISTORY OF THE RAILWAY BRIDGES BY THE CITADEL IN WARSAW

T. BLADYNYEC<sup>1</sup>

*Keywords:* bridges, Citadel, destruction, history, reconstruction, steel, truss, Warsaw;

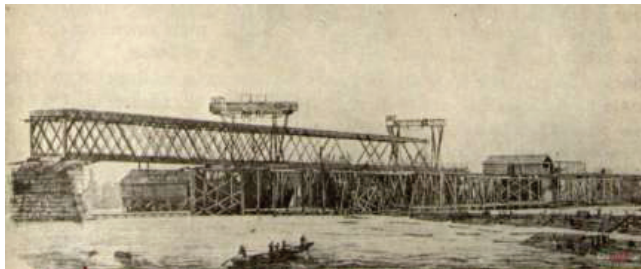
Fig. 2. Construction of the bridge in 1874. Visible two portal cranes built on the site were used for movement and installation of the steel structure.

Until autumn of the same year the construction of the five pillars was completed and works over the sixth one were coming to the end; there were carried out works involving installation of the four spans. Basic works in the construction of the bridge were finished until the beginning of February 1875, and in July the bridge was used by the trains transporting sand from Targowek for the construction of left-bank part of the Ring Railroad. On 19 November 1875 took place the formal acceptance of the bridge by the railway authorities. One year later, on 14 November, was put in use the whole Ring Railway. Upon termination of the works at the bridge the pontoon bridge was removed.

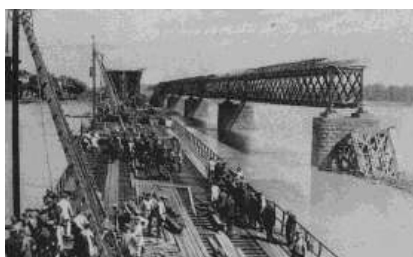
Fig. 3. Reconstruction of the newer bridge by the Germans during the World War I. Damaged older bridge visible on the right.

The company J. Gollnow und Sohn from Stettin received commission for permanent reconstruction of the both bridges by the Citadel. Works on the south track of the newer bridge lasted from 30 September 1915 to 22 January 1916, when the bridge was put into service. During that time the traffic railway was directed to the older bridge. While completing construction works on the newer bridge were, among others, complemented with concrete the blown up pillars. Permanent reconstruction of the North track was finished on 19 February 1916. In practice 350 workers were engaged in the project, mostly local Polish men.

Reconstruction of the older bridge started just after termination of works on the newer bridge and was finished in April 1916. Three damaged spans were cut for scrap and removed, and in their place was built the new construction composed of the same girders like in the newer bridge.

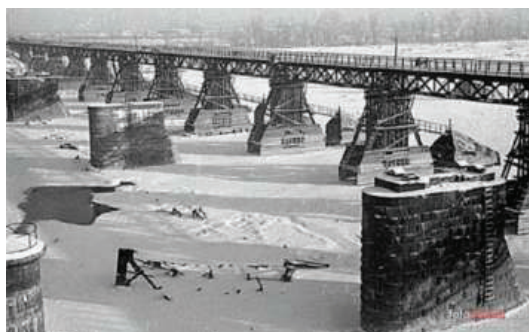
Fig. 5. Temporary bridge with visible supports of demolished railway bridges by the Citadel. Supports of the older bridge have been rebuilt just after the war, but the bridge itself was rebuilt only in 1959...

After taking over Warsaw by the Red Army started the construction of temporary bridges. In 18 January 1945 Red Army engineering troops started the construction of a temporary railway bridge about 25 m above the bridges by the Citadel. This crossing was composed of 18 truss constructions with upper carriageway of support's spread 23 m and 2 steel plate shore spans, of 10 m spread. The full length of the bridge was 515.70 m and its height – 14.50 m.

For this reconstruction the Soviet military prepared 3 700 m<sup>3</sup> of rounded wood, 500 wooden piles, bridge sleepers and 110 tons of metal elements for clamps, clamping rings etc. Similarly like in all Soviet war bridges, there were used intermediate wooden supports, in which, on the basis of previously driven in the bottom of the river piles, were installed wooden frames prepared ahead on the river bank. The span in the form of truss construction were transported to the site in whole, where they were put on the wooden posts with use of a bridge crane. The bridge was opened for traffic on 29 January 1945 at 17.30. It had an exceptional strategic importance, because the war was still going on and Soviets wanted to have quick transport to the West.
