Research paper

Assessment of the risk of road embankment instability due to water filtration using fully coupled numerical analysis

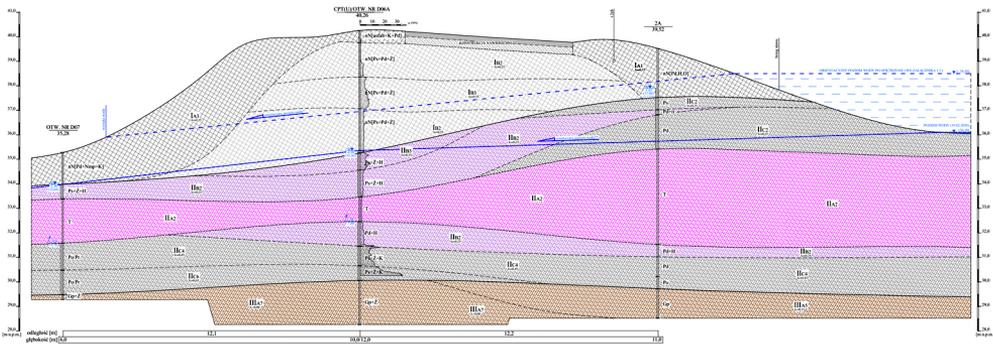
Fig. 2. Characteristic cross section through the embankment, indicating location of the cut-off wall; the blue dashed line symbolizes the approximate water level after damming; the solid blue line represents the water level after dewatering of the pond

The geotechnical cross-section analyzed in the model represents the sediments described in chapter 2.1 Geological structure. Within the cross-section (Fig. 2), following soil layers are identified:

- Loose anthropogenic soils belonging to package I, primarily composed of sands, organic sands, gravels with occasional admixtures of brick rubble and humus. CPTu probe results indicated that these soils exhibit average cone resistance (q_c) values ranging from 2.4 to 3.7 MPa and friction ratio (R_f) ranging from 0.4 to 2.2%.

- Organic and non-cohesive loose soils of package II comprise peats, aggravate muds, gyttjas, organic sands, and gravels. CPTu probe results indicate that these soils exhibit average cone resistance (q_c) values of 1.0 MPa and friction ratio (R_f) ranging from 3.0 to 9.0% for organic soils. Loose, humus sands are characterized by average cone resistance (q_c) values ranging from 2.5 to 3.2 MPa and friction ratio R_f of 0.3 to 1.8%.
- Package III includes hard plastic and semi-stiff cohesive soils. These soils consist of sandy clays and exhibit average cone resistance values q_c ranging from 2.6 to 5.2 MPa and friction ratio R_f falling within the range of 2.2 to 4.5%.

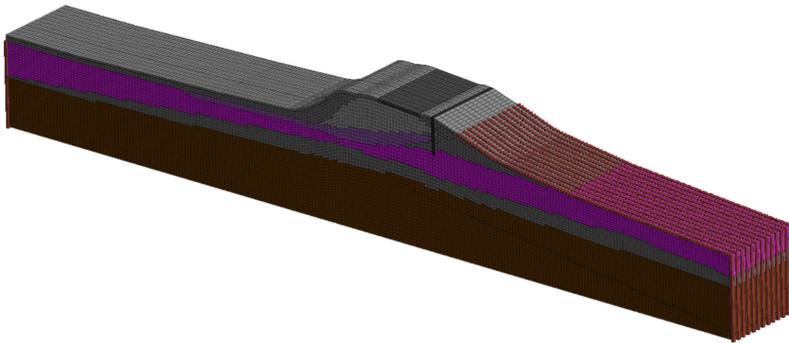
Fig. 3. Model view

The substrate was designed using data from geological documentation, resulting in the soil substrate and construction model (Fig. 3). For natural soils Hardening Soil constitutive model was used. It is an elasto-plastic model, with an additional cap yield surface that encloses the elastic domain in stress space ($p - q$) on the hydrostatic (p) axis. The cap allows for simulating the densification/compaction of the material. The model represents the behavior of the soil in elastic-plastic zone, with hardening related to the stress path. Based on data from the geological documentation, the following parameter values were derived:

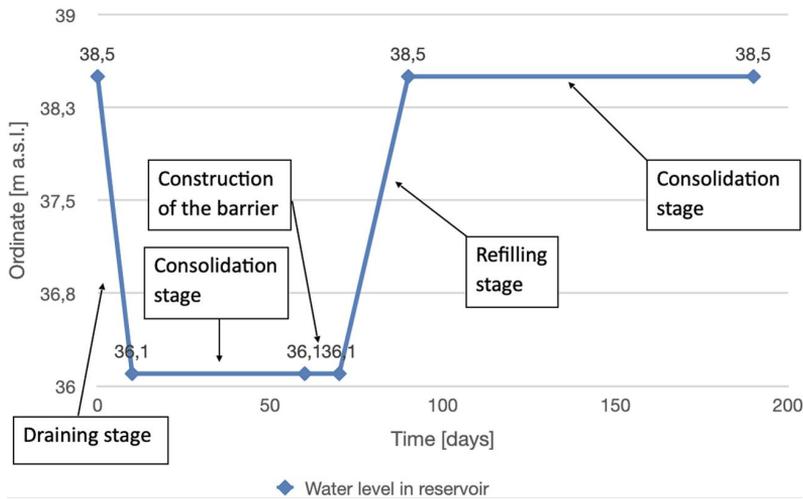
Fig. 4. Reservoir filling diagram with marked construction stages implemented in the software

In addition to kinematic boundary conditions, defined as the fixation of nodes at the edges of the model, the water flow in various construction stages was also simulated. The initial water level was modeled on 38.5 m above sea level, as steady flow. Then, for the construction purposes, the water was drained through the dike (modeled as transient flow) to the ordinate of 36.1 m above sea level. After the construction, the water was refilled into its initial level, and once again, the flow was modeled as transient. In the final stage of the analysis, during the consolidation, the embankment was infiltrated with water of a transient flow, which eventually converged to the steady state [1, 12]. The reservoir's water level changes over time are shown in Figure 4.

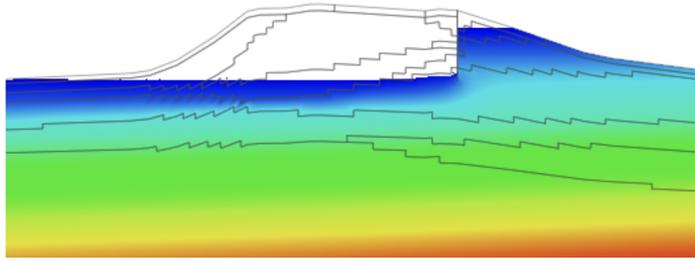
Fig. 6. Water level after final construction stage – consolidation lasting 100 days

Figure 6 shows the final water level, after the construction of the cut-off barrier and 100 days of consolidation processes.

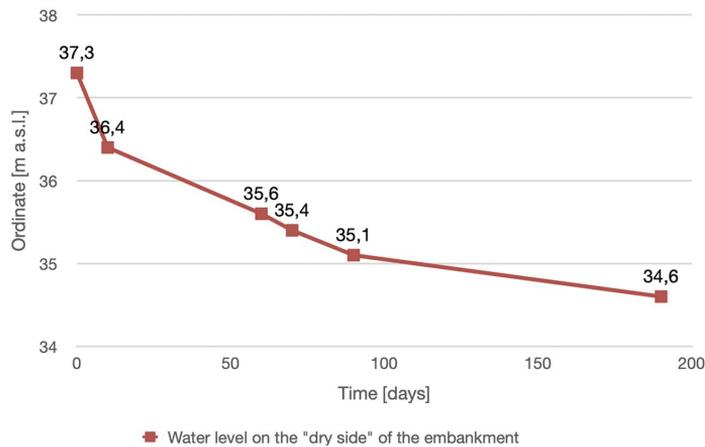
Fig. 7. Changes of the water level on the downstream slope of the embankment over time

The coupled analysis of stresses and filtration showed that the construction of the vinyl sheet pile wall, designed as a cut-off wall anchored in soils with low water permeability, effectively lowered the water level on the downstream slope of the embankment. Figure 7 displays the water level on the downstream slope of the embankment over time. After the construction and refilling of the reservoir, the water level on the analyzed side did not return to its original level. Figure 8 presents selected filtration paths after the final construction stage.

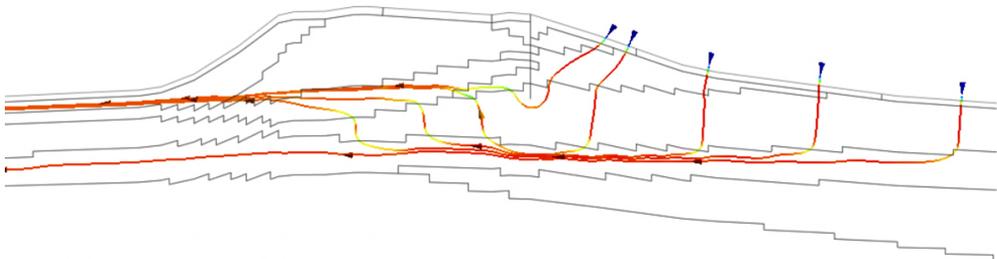
Fig. 8. Selected water flow paths – final stage

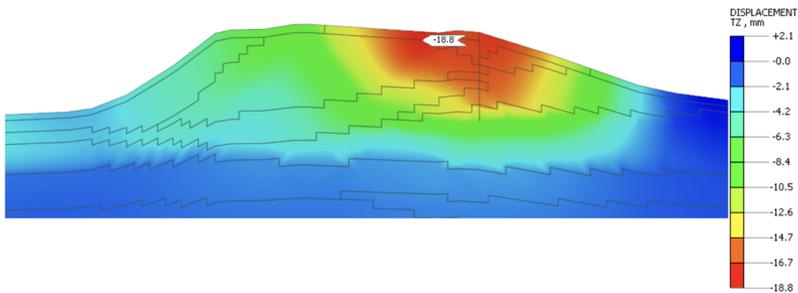
Fig. 9. Settlements – consolidation stage after dewatering, before the installation of the barrier

The change in the groundwater level induces stress variations within the soil medium, resulting in embankment settlement (when the reservoir water level is lowered) or uplift (when the reservoir is filled). The analysis conducted indicated that lowering the water in the reservoir from 38.5 to 36.1 m above sea level leads to an embankment settlement of 19 mm. The analyzed embankment has previously experienced water level fluctuations several

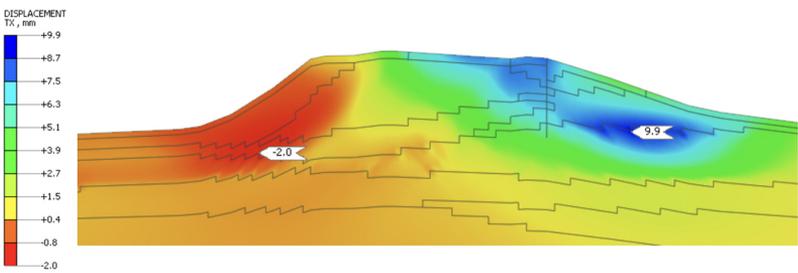
Fig. 10. Horizontal displacements – consolidation stage after dewatering, before the installation of the barrier

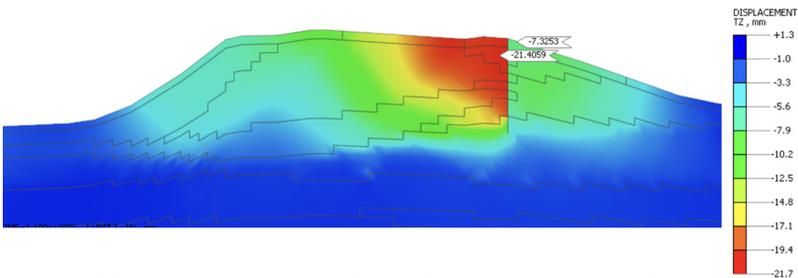
Fig. 11. Settlements – final stage

times; nevertheless, it is estimated that after the construction of the vinyl sheet pile wall, the embankment will permanently settle by approximately 22 mm. However, the upstream slope of the embankment will still undergo slight displacements depending on the water level in the reservoir. Furthermore, the permanent lowering of the water level in organic soils may cause secondary consolidation, which was not considered in the analysis due to its unpredictable nature, arising from the diversity of soil structures of organic soils. Figures 9– 12 illustrate displacements in various construction phases and Figure 13 shows the embankment displacements over time.

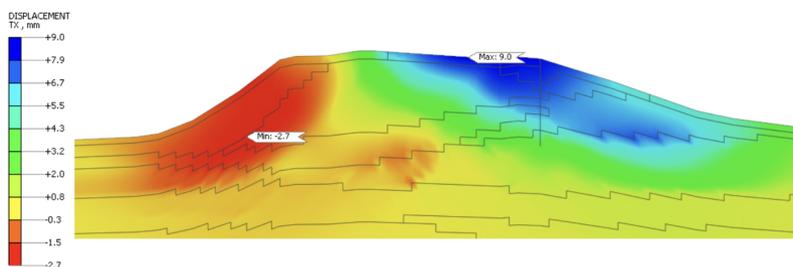
Fig. 12. Horizontal displacements – final stage

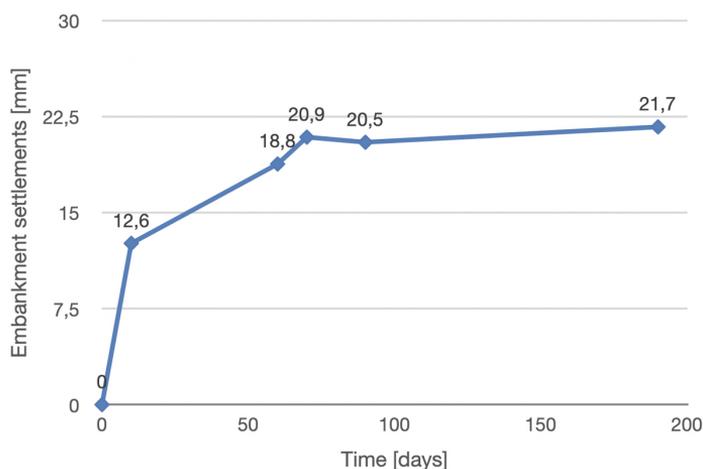
Fig. 13. Settlements of the embankment over time

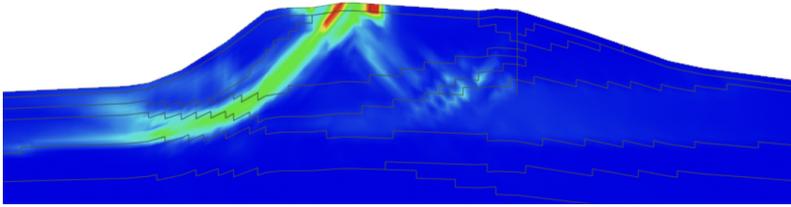
Fig. 14. Strains – stage “0”

- 1.06 in stage “0”,
- 1.03 after lowering the water level in reservoir to 36.1 meters above sea level,
- 1.10 after construction of the cut-off wall and filling the water in reservoir.

According to Wysokiński criterion [15], a factor of safety of at least 1.25 is required to consider the slope safe from landslides. The analysis indicates that the construction of the barrier will not worsen the slope stability. It should also be emphasized that in the current state, slope stability is already at risk. The slip surface after dewatering would be global, potentially leading to damage to the road structure. The strain results indicating potential slip surfaces were presented in Figures 14 and 15.

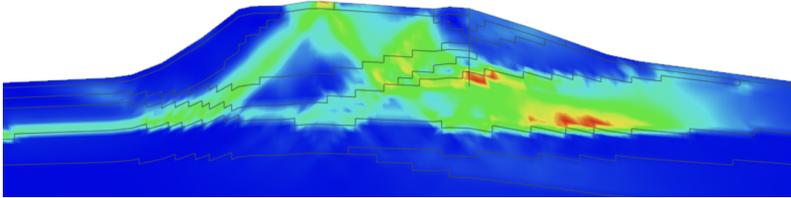
Fig. 15. dewatering stage before the construction of the cut-off wall
