## Research paper

# Research on static load test of segmental-assembled steel temporary beam buttress of railway line

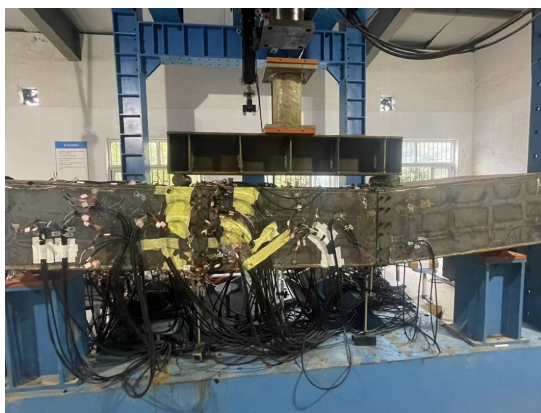
(b) The final failure mode of the specimen

Fig. 6. The vertical load-displacement curve and the final failure mode of the specimen

On the premise of ensuring safety, the load continued until 388 kN, and multiple noises occurred continuously. It was observed that the bottom flanges and webs near multiple bolt holes of were severely sheared and damaged. At the same time, multiple bolts were sheared and collapsed, causing a sharp decrease in the bearing capacity of the specimen and the loading was terminated. The final failure mode of the specimen is shown in Figure 6(b). It can be seen from the figure that the specimen did not experience local buckling or overall instability during the loading process.

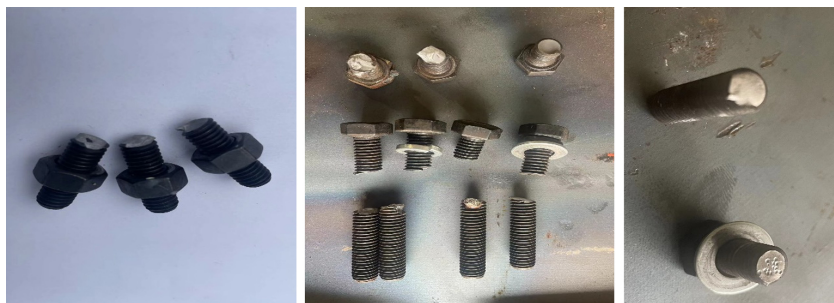
Figures 18 and 19 respectively give the photos of bolt failure and mother plates damage. The bolt of the right web was sheared and damaged when loaded to 380 kN, indicating that a significant shear stress occurred near the bottom plate on the right side. The failure cross section of bolt is neat, and the right web underwent significant punching deformation. When the test load reached 388 kN, the bottom flanges near the bolt holes were completely cut and damaged, forming the U-shaped failure gap. Below the axis of the left web, significant tensile stress was applied and significant punching deformation occurred, with bolt holes on the left web being damaged by punching.

Fig. 18. Photos of bolt failure

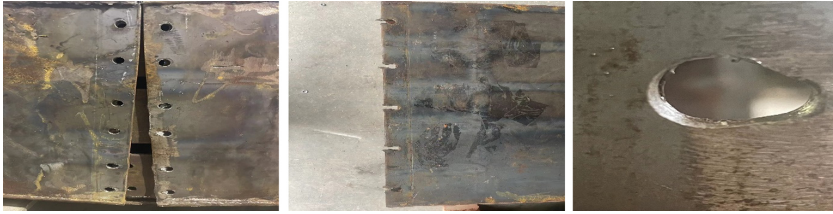
Fig. 19. Photos of mother plates failure
