# Concrete degradation in an over 100-year-old drinking water treatment plant, a case of lime leaching from the water retaining tanks

Józef Zygmunt Jasiczak<sup>1</sup>

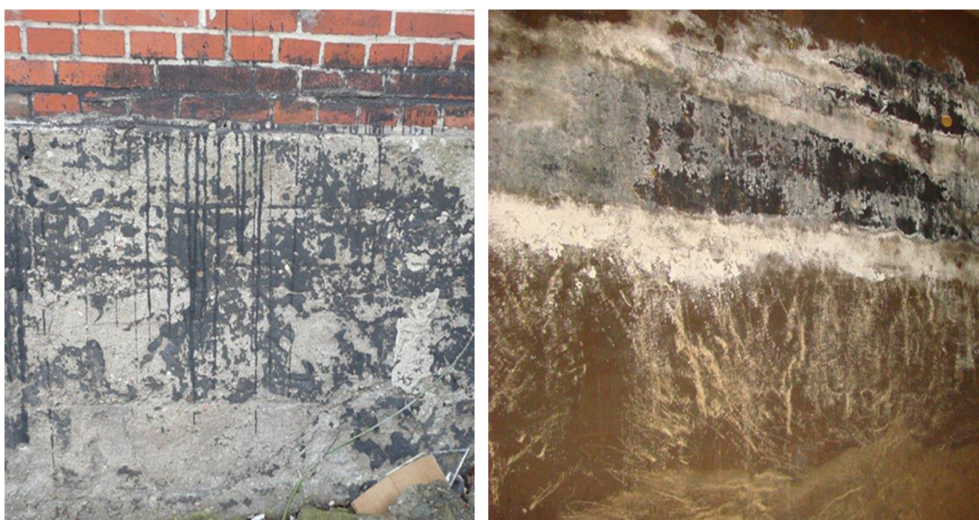
Fig. 4. Reinforced concrete wall of tank from outside and inside with leaks of white efflorescence

Until 2009 the building was used for water filters and storage of drinking water for the city citizens. In 2020 the technical condition of the chamber was checked. The examination discovered many cracks of the concrete peripheral walls, internal reinforced concrete posts and monolithic reinforced concrete ceiling over the water tank. All the cracks were filled with white substance, and in some places on the ceiling there were also white stalactites. The current technical condition of the described structure is shown in Fig. 4 and Fig. 5.

During observations of the technical condition of the drinking water tank (Figs. 4, 5) the way the concrete was put in the structure was restored: the concrete components were dosed volumetrically and mixed manually, and the mixture was put in layers about 0,5 m thick, the concrete with high plastic consistency was applied. In Fig. 4 and Fig. 5 the delamination in the area of layer contact are visible, since each layer was put after the previous had hardened. Thus, an abrasion occurred, as well as the difference in relative air humidity outside and inside the tank caused the migration of  $\text{Ca}^{2+}$  ions into the inside of the tank, which caused the formation of characteristic white deposits. Migration of calcium compounds caused the dealkalisation of the outer parts of the concrete and increased the vulnerability to corrosion of the reinforcement steel, as well as it increased the porosity of the cement matrix. Similar case of leaching of the cement matrix in buildings, that are over hundred years old and exploited in high relative air humidity, has not been described in any of the quoted bibliographical positions presented in 4.1.

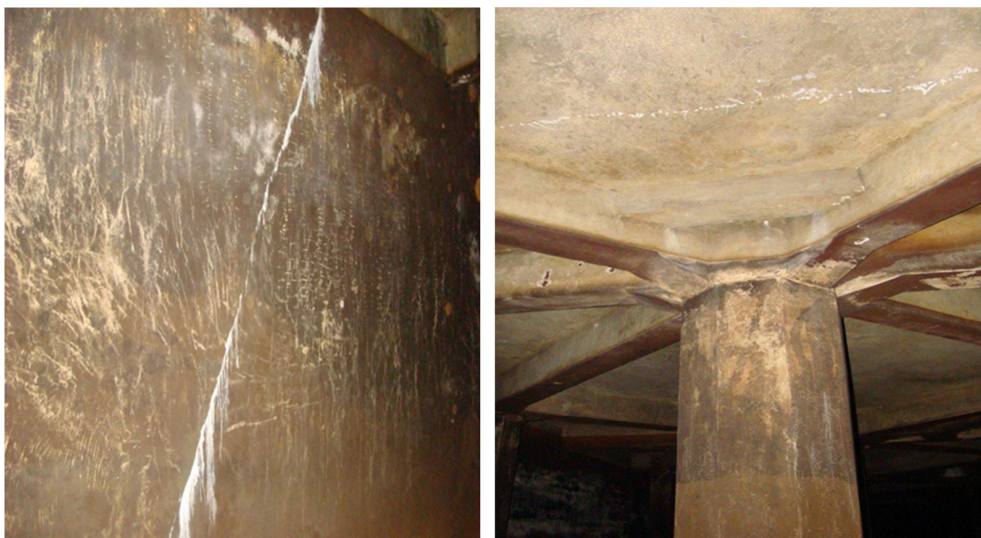
Fig. 5. Wall and pillar supporting rib-and-slab floor. Visible cracks filled with white compounds

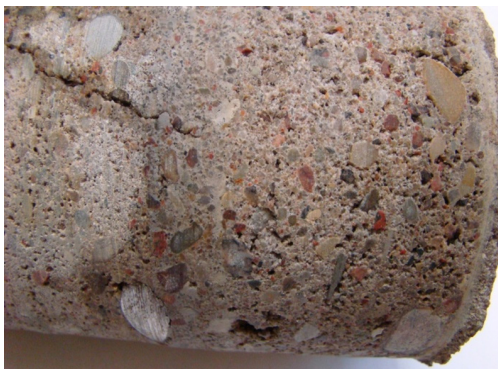
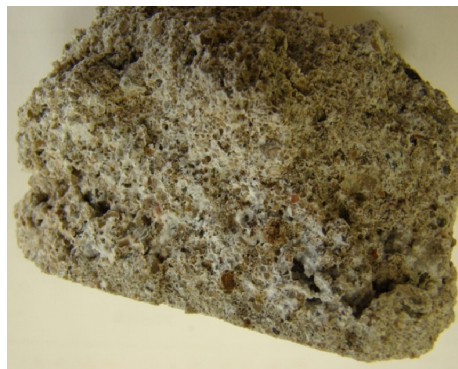
Tests of compressive strength of concrete on core specimens taken from the structures revealed a very low strength of the concrete at the moment – only 12.0–14.0 MPa, with the density of 2200 kg/m<sup>3</sup> and water absorption by weight of 5.1%. The concrete in the core specimen taken from the ceiling is very inhomogeneous, porous, with signs of leaching of the cement stone and clearly visible white internal deposits, as well as internal delamination (Fig. 6–9).

Fig. 6. Porous bottom part of core specimen  $\phi$  100 mm Fig. 7. White drop-stones in the structure of bottom part of core specimen

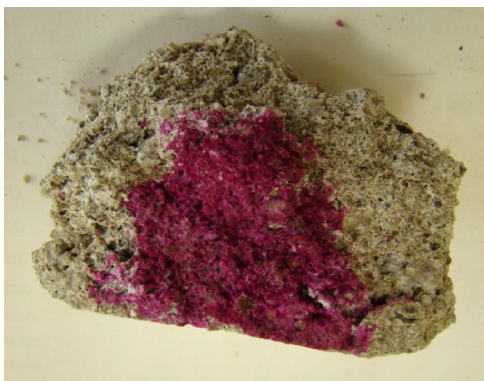
Fig. 8. Carbonation test in the bottom part of core specimen

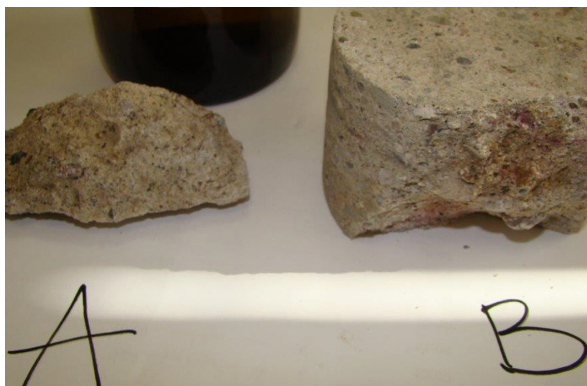
Concrete samples taken from two areas, presented in Fig. 10 as A and B, underwent grinding according to current research procedure and their phase composition was defined. Samples: A – taken from the wall (Fig. 4), B – taken from the upper part of core sample in the upper surface of floor (Fig. 6). In the carbonation test phenolphthalein does not change the color to pink. Sample A is a carbonated concrete, sample B – concrete free of leached basic compounds. In the both cases there are conditions to rapid corrosion of steel reinforcement.

Fig. 10. Samples: A – taken from the wall and B – taken from the upper part of core floor sample
