## Research paper

# Analysis of the impact of widening the bridge deck on the redistribution of the internal forces in the structure on the example of the bridge in Opole, Poland

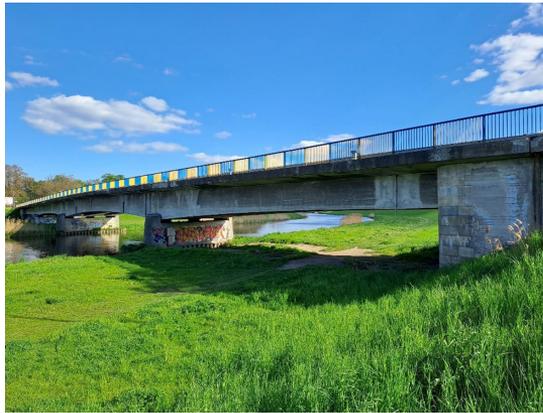
Fig. 1. View of the bridge [own archive]

The analysed bridge is located in Opole, in the course of Wrocławska Street (DW 414 at km 180+858) and runs over the so-called Relief Canal. It is a reinforced concrete bridge built in 1938 (Fig. 1). The superstructure is a four-span, three-beam, gerbered superstructure located at an oblique angle of 68 to the obstacle. The main beams have variable height and width of the webs; in the area of the pillars, they are reinforced with a lower plate passing towards the hinges into a flange of variable width [16, 17]. The beam spans in the bearing axis are shown in Fig. 2.

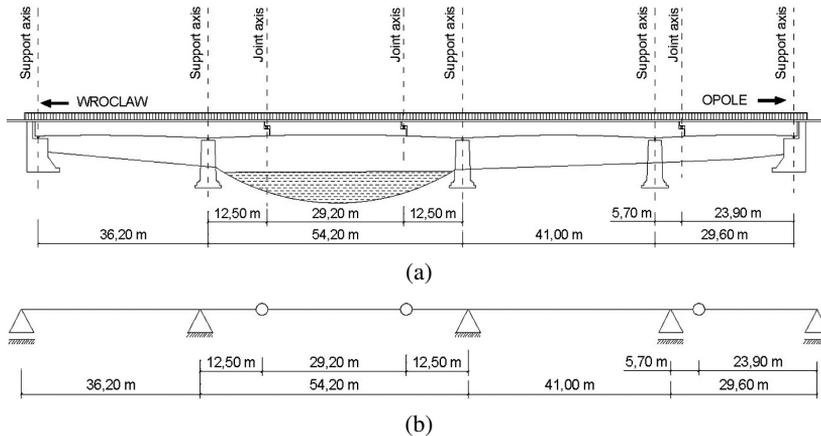
Fig. 2. Road bridge over Wrocławska Street in Opole: (a) view of the structure from the downstream side, (b) static scheme of the bridge [own elaboration]

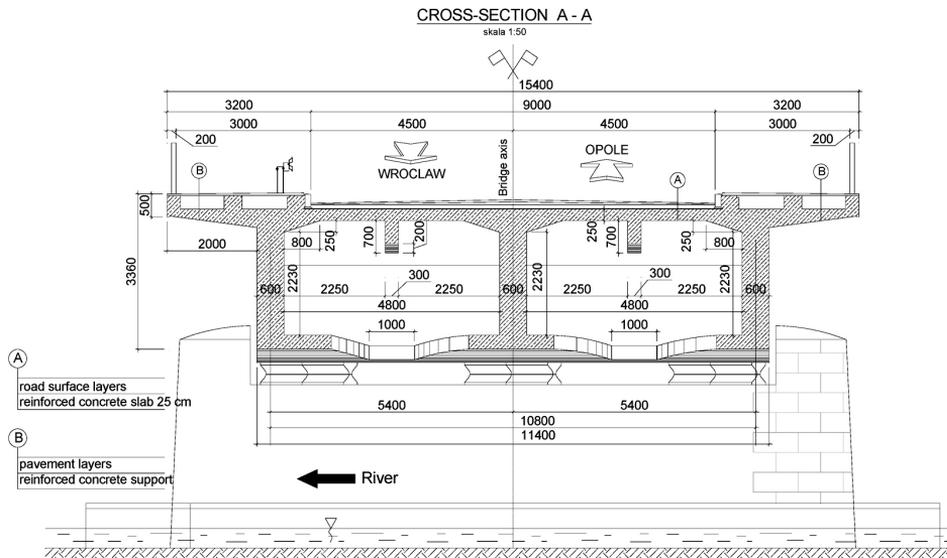
Fig. 3. Cross-section

The reinforced concrete slab of the carriageway is 25 cm thick and has pavement supports extending beyond the outer girders with a 2.00 m overhang (Fig. 3). Three ribs were made within the pavement to support the pavement surface elements, namely: a handrail rib, a rib where the kerb separating the cycle path from the pavement is fixed and a rib at the stone kerb of the carriageway (Fig. 3).

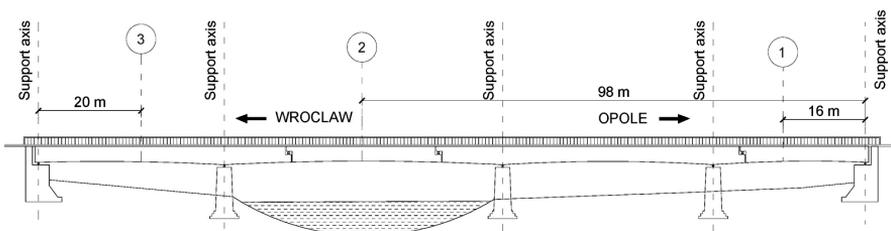
Fig. 4. Schematic side view with three core intake sites marked

Another concrete test was carried out while the bridge was undergoing an upgrade, which involved widening the carriageway by 0.5 metres at the expense of the pavement on the left side. Cylindrical samples were taken for testing from the elements that formed the footing for the pavement slabs in the pavement structure. The samples were taken at the three locations shown in Fig. 4. The surface of the samples was adjusted using the pen overlay method (according to PN-EN 12390-3:2011 appendix A – by applying a levelling layer [19]) and then tested using Method A (according to PN-EN 12390-13:2014 [20]). The results of the tests obtained are summarised in Tables 1 and 2. Taking into account the values obtained and the results of the concrete tests which were available in the technical documentation of the object, and the fact that the concrete in the studies of the author of the work came out showing a class in the range of C35/45÷C30/37 – concrete C35/45 was assumed for further numerical analyses.

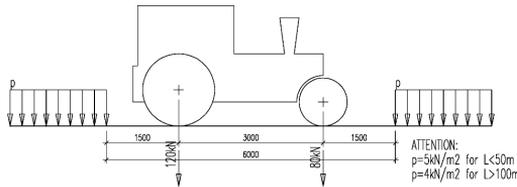
Movable load model according to the standard of 1.01.1920

ATTENTION:  
 $p=5kN/m^2$  for  $L \leq 50m$   
 $p=4kN/m^2$  for  $L > 100m$

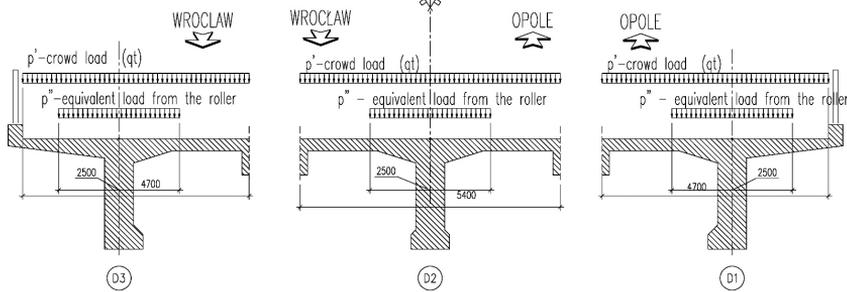
Fig. 6. Road roller loading scheme according to [23]

Each model was loaded with two load systems. Firstly, the load applicable at the time of construction of the structure was set according to [23]. The models take into account assumptions in which internal forces, displacements and reactions are calculated in such a way that each beam carries 100% of the imposed load according to [23] (Fig. 6) (the transverse co-operation of the spans was then not taken into account in the present understanding, so that in this case analysed at present almost the entire weight of the cylinder fell on one beam) [17]. In each variant, the loading according to [23] was distributed in the same way (Fig. 6). For the second loading arrangement according to PN-EN 1991-2 [15], a lateral distribution according to the rigid cross-beam method was adopted, which results in approximately 50% of the live load falling on the girder. The distribution of the loads on each girder in variant A is shown in Figs. 7–9. For the other variants, the second set of loads was distributed according to the principles of PN-EN 1991-2. For the remaining variants B and C (three traffic lanes) the second set of loads was distributed in accordance with the principles of PN-EN 1991-2. For comparison, the Fig. 10 shows the load distribution for the end girder D1.

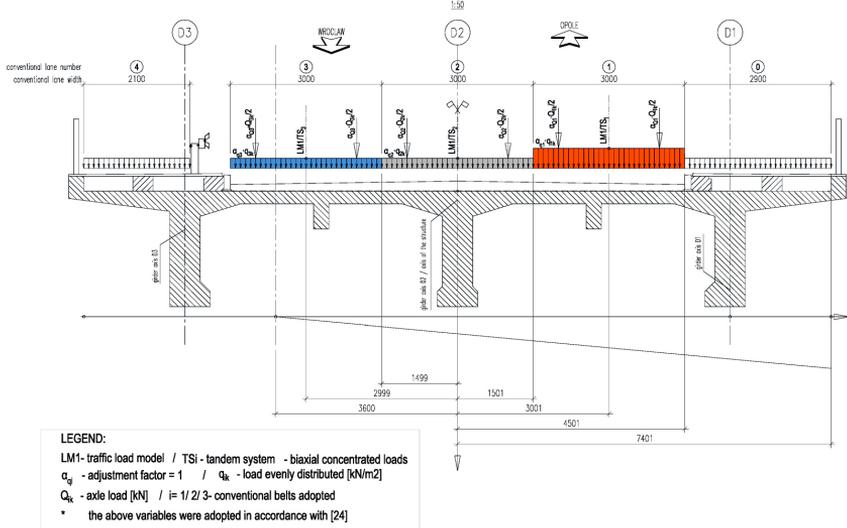
Fig. 7. Load distribution diagram according to PN-EN 1991-2 for edge girder No. 1 in variant A

In the first stage, a structural layout was modelled (Variant A) which represents the condition of the structure during construction and in use until 2015. The bridge has two lanes in opposite directions each 4.5 m wide, and two 3.0 m pavements on both sides. The load distribution on each girder is shown in Figures 7–9.

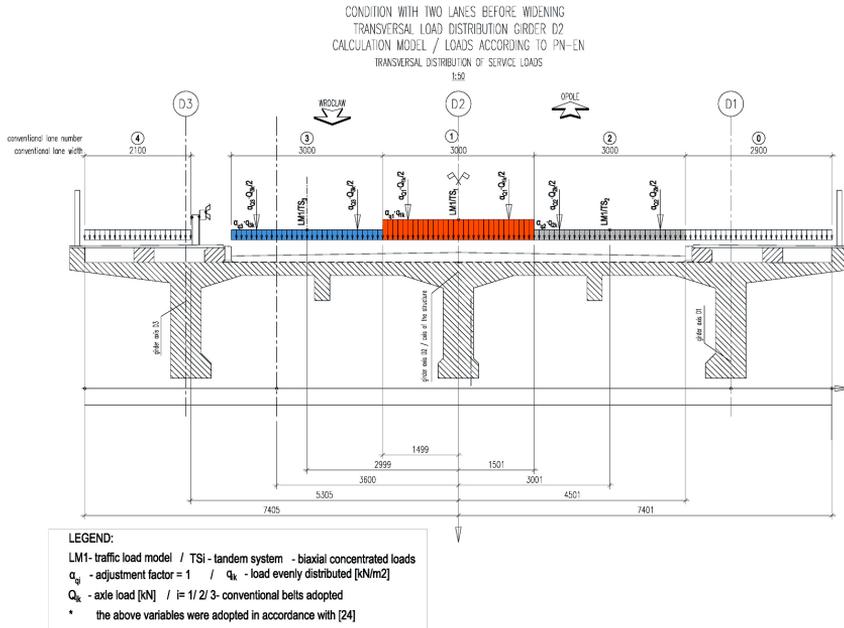
Fig. 8. Load distribution diagram according to PN-EN 1991-2 for edge girder No. 2 in variant A

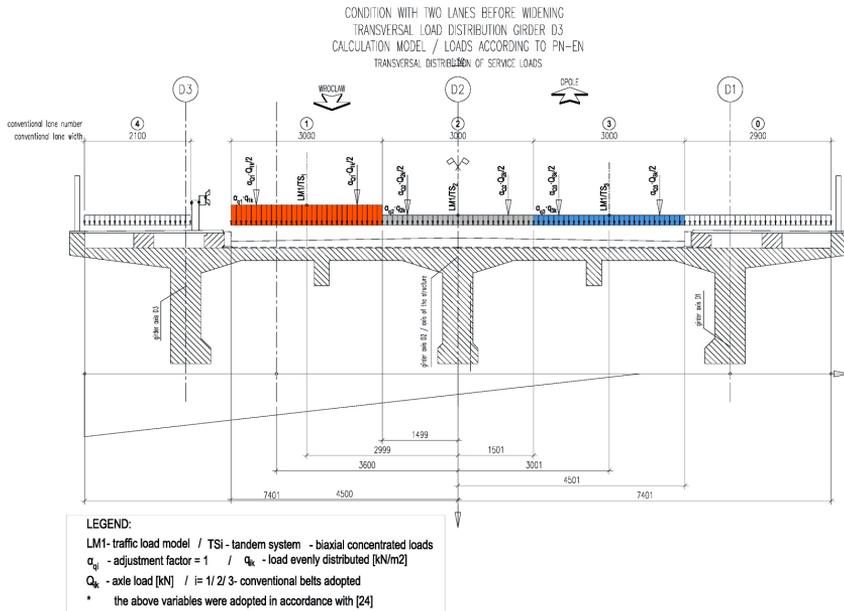
Fig. 9. Load distribution diagram according to PN-EN 1991-2 for edge girder No. 3 in variant A

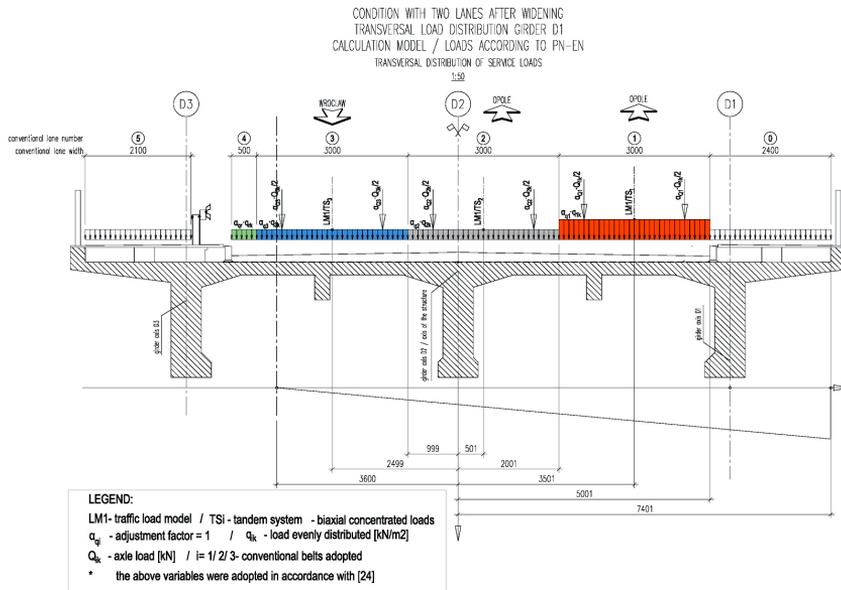
Fig. 10. Load distribution diagram according to PN-EN 1991-2 for edge beam no. 1 in variants B and C

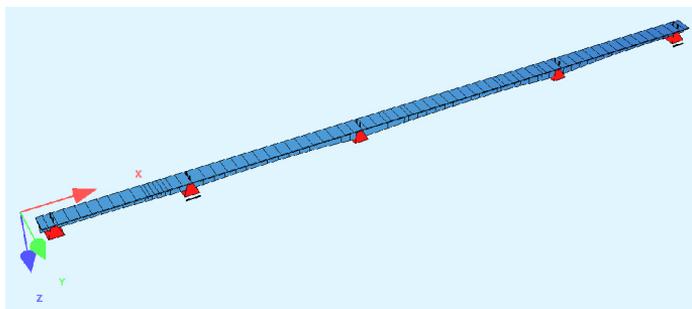
Fig. 11. Model of the extreme girder no. 1 in the SOFiStiK program after eliminating the joints

In the third stage of work, the model was modified to make the structure tighter by removing the Gerber joints (variant C). The loads remain the same, only the static scheme of the structure changes (Fig. 10). The changes were made in the TEDDY text editor, using the SOFiMSHA tab and KINE commands (Fig. 11).

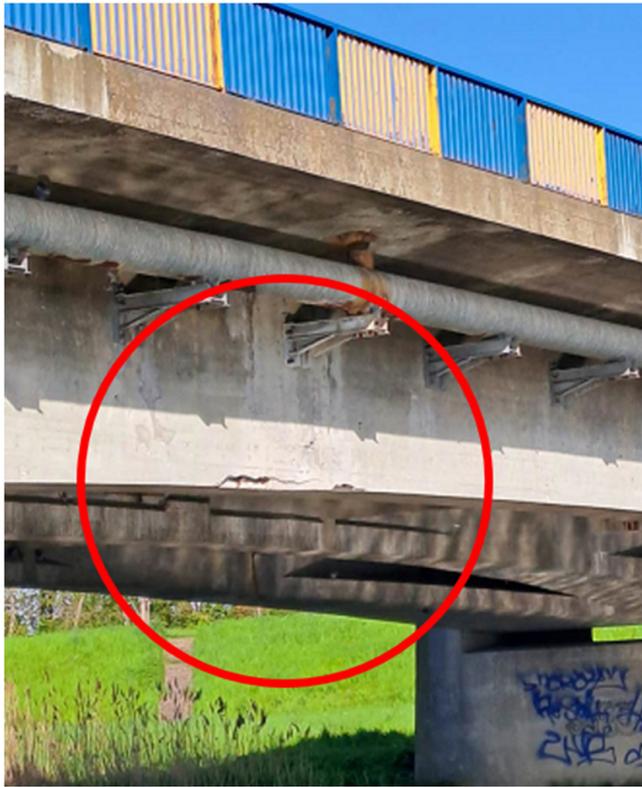
Fig. 12. View of girder 1 in the strand bay. Concrete defects and numerous cracks in the bottom zone of the girder

carried out to determine the impact of this change. In the technical documentation, only expert reports of the facility dated 2012 (i.e. before the widening) were available, as well as proposals for widening the carriageway width to 4 lanes with additional external structural reinforcement. It is therefore necessary to consider whether it would be possible to widen the facility to 4 lanes in the future and whether the design of external structural reinforcement would allow the transfer of more vehicle traffic. The structure has been in operation for eight years after the upgrade and while its condition is satisfactory, it is uncertain for how long. Already, additional scratches and efflorescence can be seen on the facility, which has appeared over the last few years. The concrete defects in the lower zone visible in Fig. 12 relate to girder

No. 1, which takes the heaviest loads (the carriageway has been widened to 0.5 m above it). Continuous real-time monitoring of the structure should be considered, and further numerical studies of the structure should be carried out at the same time for comparison purposes.
