# **Analysis of the impact of widening the bridge deck on the redistribution of the internal forces in the structure on the example of the bridge in Opole, Poland**

**Karolina Jurasz-Drozdowska<sup>1</sup>, Wojciech Radomski<sup>2</sup>**

**Abstract:** Redistribution of internal forces in existing bridge structures occurs very often in practice, especially when they are functionally modernized (e.g. by widening the deck), as well as as a result of changing the static system of the structure. The most telling and relatively common example of the latter situation is the elimination of hinges (e.g. hinges in Gerber systems or hinges in the middle of the span of concrete bridges erected using the cantilever concreting method) and thus creating a continuous hingeless system. As a result of this change, internal forces are redistributed, and insufficiently thorough consideration of it can lead to serious, negative consequences. The article analyzes a real bridge structure located in Opole. The structure accepted for testing has a complicated structural system and has Gerber hinges. The lower flanges of the girders have a variable width along the entire length of the spans – therefore a

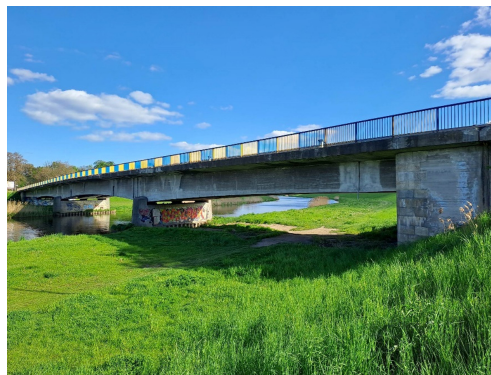
Fig. 1. View of the bridge [own archive]

The analysed bridge is located in Opole, in the course of Wrocławska Street (DW 414 at km 180+858) and runs over the so-called Relief Canal. It is a reinforced concrete bridge built in 1938 (Fig. 1). The superstructure is a four-span, three-beam, gerbered superstructure located at an oblique angle of 68 to the obstacle. The main beams have variable height and width of the webs; in the area of the pillars, they are reinforced with a lower plate passing towards the hinges into a flange of variable width [16, 17]. The beam spans in the bearing axis are shown in Fig. 2.

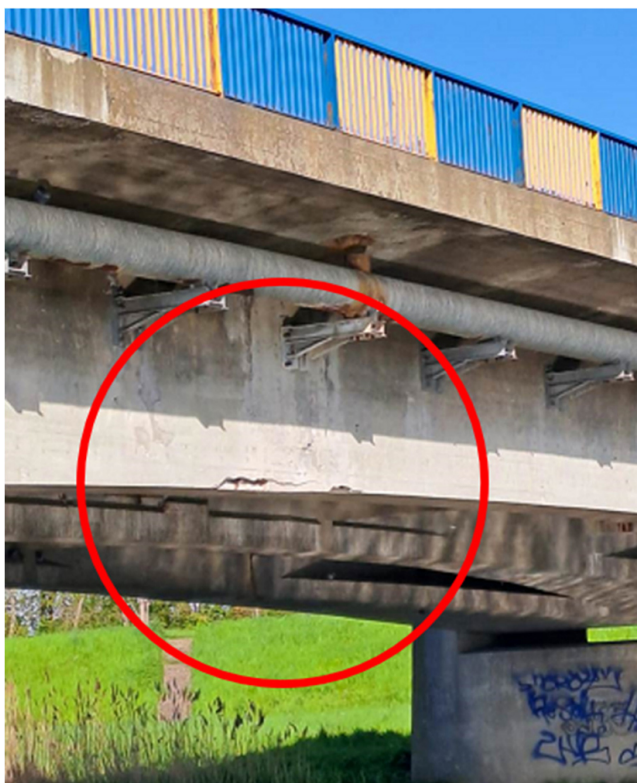
Fig. 12. View of girder 1 in the strand bay. Concrete defects and numerous cracks in the bottom zone of the girder

Several years after the renovation and the addition of an extra lane, the structure still bears traces of overloading, new cracks and defects are visible. This is understandable, as the structure, which was not load-bearing at the time of the earlier analyses and expert reports (there was even talk of reducing its load-bearing capacity), was additionally overloaded by the new lane and thus a higher volume of vehicles. This immediately raises the question of the distribution of internal forces in the bridge structure, which have certainly changed and, in the new configuration, affect the operation of the individual girders, which were designed for a different load distribution. This and other relationships will be addressed and described further on.
