Research paper

Historical and aesthetic compatibility of earth-based mortars on the example of ancient stone structures in the Black Sea Basin

Ewa Sobczyńska¹, Wojciech Terlikowski²

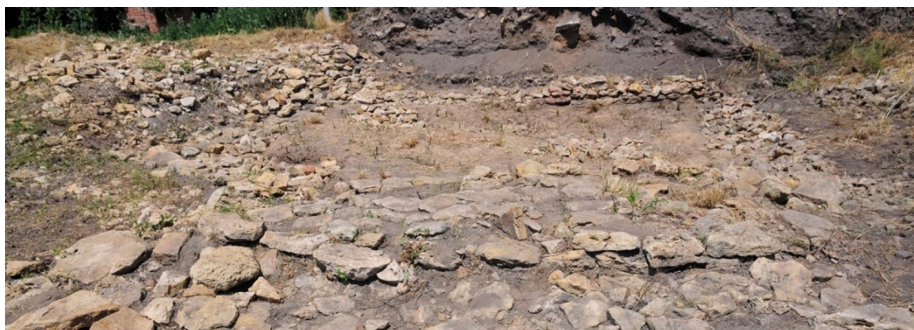
Fig. 2. View of a masonry wall on earth-based mortar, Tanis (Department of Fundamentals of Building WUT archives)

Archaeological activities in the Black Sea Basin were carried out by the Faculty of Civil Engineering at Warsaw University of Technology in cooperation with the National Museum in Warsaw (Conservation Mission in Tyritake in Crimea [8]) and the Institute of Archaeology at Warsaw University and the Centre for Research on Antiquity in Southern and Eastern Europe (Conservation Mission in Tanais near Rostov-on-Don) [9–11]. Over more than a decade of comprehensive research, it has been established that the predominant type of historical structures uncovered at both Tyritake and Tanais is irregular stone masonry. In the case of the historic walls in Kerch, we find a wide range of dates for the studied walls – from the 5th century BC to the 5th century AD. In the case of Tanais, it is between the 3rd BC and 3rd AD. These structures were built using ashlars and/or stones sourced from diverse limestone formations, typically unprocessed and unsorted, resulting in a range of structural characteristics, porosity, sedimentation levels, and absorbability – all factors that impact their moisture content (see Fig. 2 for Tanais and Fig. 3 for Tyritake). A common issue observed is the granular disintegration of the masonry stones and the poor properties of the earth-based mortar, which is composed of local soil and sand. Such walls exhibit low strength and internal coherence, leading to limited durability.

The studied walls have undergone significant degradation due to a combination of human activity and centuries of environmental exposure. Key factors include prolonged moisture contact, biological activity within the soil, and damage from rainfall. Once excavated, these structures become especially vulnerable to changing conditions and sub-zero temperatures, particularly due to the repeated freeze-thaw cycles that lead to water saturation in the masonry and mortar. Consequently, damp walls become more susceptible to deformation, losing their primary load-bearing capacity and compromising the physical properties of the materials. Additionally, water washes away the binder and loosely connected small masonry elements, resulting in rock erosion (ablation). Therefore, reconstruction is necessary, an important aspect of which is historical and aesthetic compatibility with the existing stone material.

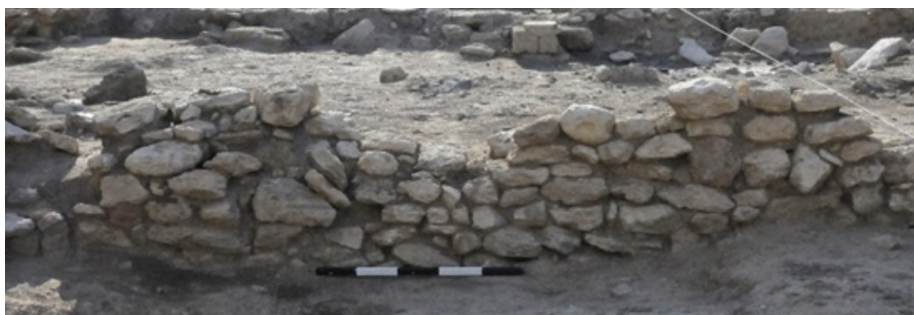
Fig. 3. View of a masonry wall on earth-based mortar, Tanis (Department of Fundamentals of Building WUT archives)

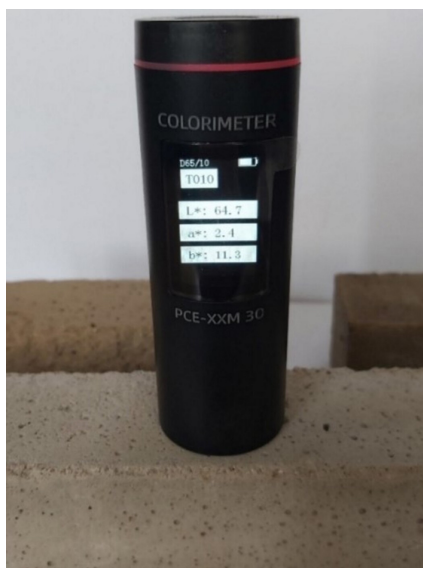
Fig. 4. Determining the colour of the reconstruction mortar using a colourimeter

Colour analysis may be performed using colourimeters or spectrophotometers [14, 15], but very often the analysis is also based on colour palettes. In the tests conducted, the assessment was made using the RAL K7 colour palette and supplemented with a PCE-XXM 30 colourimeter test. A colourimeter is a device that allows colours to be determined using numerical values in appropriate colour spaces, which eliminates the influence of the human eye on the result and the fact that the human eye is unable to notice slight differences in colours. In practice, there are several colour spaces available, but the most popular way to describe colour in various fields is the $L^*a^*b^*$ system, where L^* represents brightness and a^* and b^* are chromaticity coordinates ($+a^*$ corresponds to red, $-a^*$ to green, $+b^*$ to yellow and $-b^*$ to blue). The centre of the space is achromatic. In the $L^*a^*b^*$ colour space, the colour difference can be expressed as a single numerical value using Eq. (3.1) [11]:

The differences between the individual values of L^* , a^* , and b^* also provide a lot of valuable information. An example of colour assessment with a colourimeter is shown in Fig. 4.

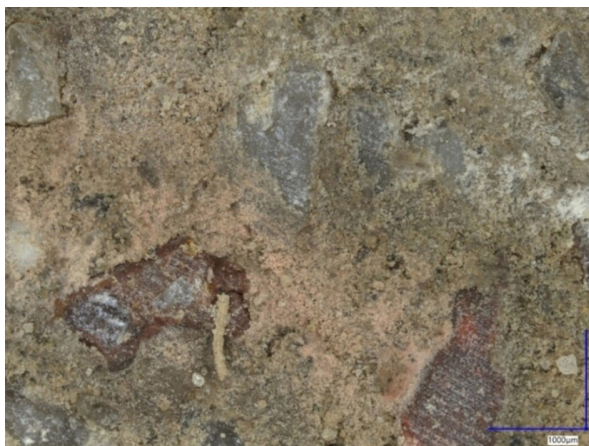
Fig. 7. Photo of a sample with a composition 3366-25C taken with a Keyence Vhx 7000 digital microscope

The results obtained using a colourimeter confirmed the analysis carried out using the colour palette. The sample that differs the least in terms of colour is sample 3366-15C, with a difference of 2.9. Its colour shows differences in the a^* and b^* values, with a deviation towards blue and green, while the L^* values (brightness) remain similar. The second place was assigned to sample 3366-25C – difference 6.26. Similar to sample 3366-15C, it shows a deviation in the a^* and b^* parameters, and additionally, a higher L^* parameter value. Sample 4060-15C-N shows the most evident deviation of all the samples tested in terms of the L^* parameter from the value for the base sample. This means that its colour has a lower brightness. Sample 2575-15C-10L shows the greatest colour difference ΔE and, in addition, a significant deviation in the L^* (brightness) and b^* (towards blue tones) parameters. This confirms the order of the samples in terms of the best colour match obtained from the primary analysis. For research purposes, photographs were taken with a Keyence Vhx 7000 digital microscope to assess the texture of mortar composition 3366-25C (a composition that meets all the strength and durability requirements analysed in earlier stages of the project [7]) and for the mortar closest in composition and texture to the original mortar used in stone structures in Black Sea Basin (to compare their texture) (Fig. 7 – mortar 3366-25C and Fig. 8 – mortar 4060). The composition 3366-25C, due to the addition of cement, has a slightly more compact structure. In contrast, composition 4060 has more loose particles (this is also a result of the preparation of the sample for testing – cutting the beam samples into 2 cm thick slices). However, it can be considered that the compatibility of the selected composition in terms of texture will be sufficient for reconstruction purposes.

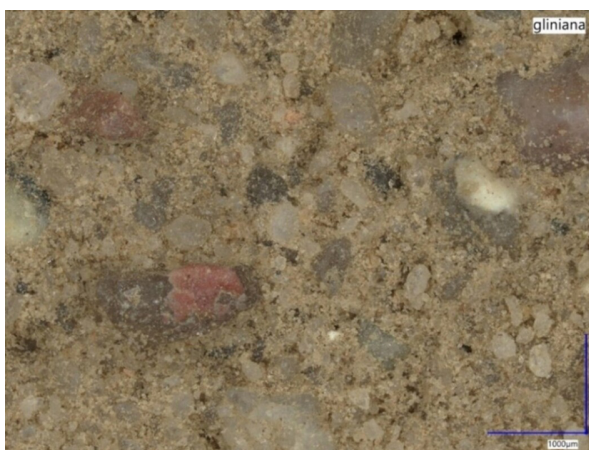
Fig. 8. Photo of a sample with a composition 4060 taken with a Keyence Vhx 7000 digital microscope

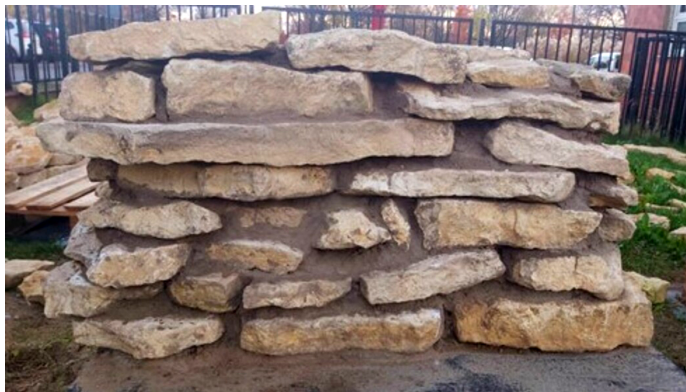
Fig. 9. Stone wall built with earth-based mortar without additives – composition 4060

As part of semi-technical research, test walls were built using Tertiary limestone available in Poland (Pińczów limestone) on selected earth-based mortar compositions in the autumn (September 2022). The first composition was earth-based mortar without additives –4060 (Fig. 9). The second application was selected mortar 3366-25C (Fig. 10). The main objectives of the test research in the context of historical and aesthetic assessment are analysis of possible changes in the colour and texture of the mortar over time due to leaching, sun exposure, wind impact, the appearance of salt efflorescence, etc. The first verification of the mortar used was carried out 6 months after the construction of the described structures (beginning of March 2023) and then every six months until July 2025. No changes in the colour and texture of the

solution used were noted for any of the analysed walls during this period. The mortar did not change colour, nor were there any visible changes in the texture or efflorescence on its surface. It can therefore be concluded that the analysis of historical and aesthetic compatibility was carried out correctly.

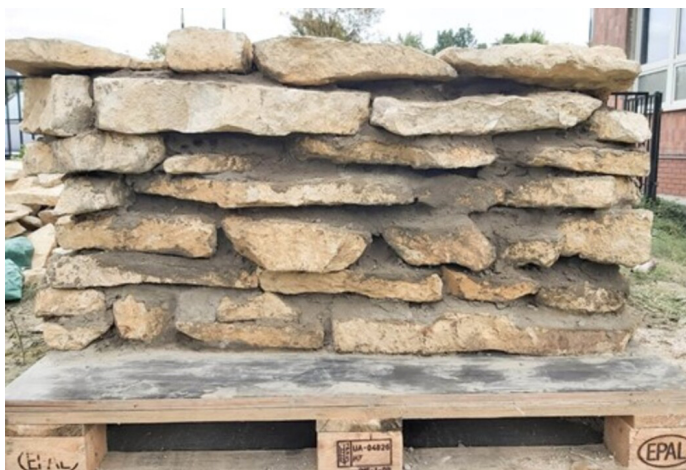
Fig. 10. Stone wall on mortar 3366-25C
