## Review paper

# Composite materials in conservation of historical buildings: examples of applications

**Keywords:** composite materials, historical buildings, structural reinforcements

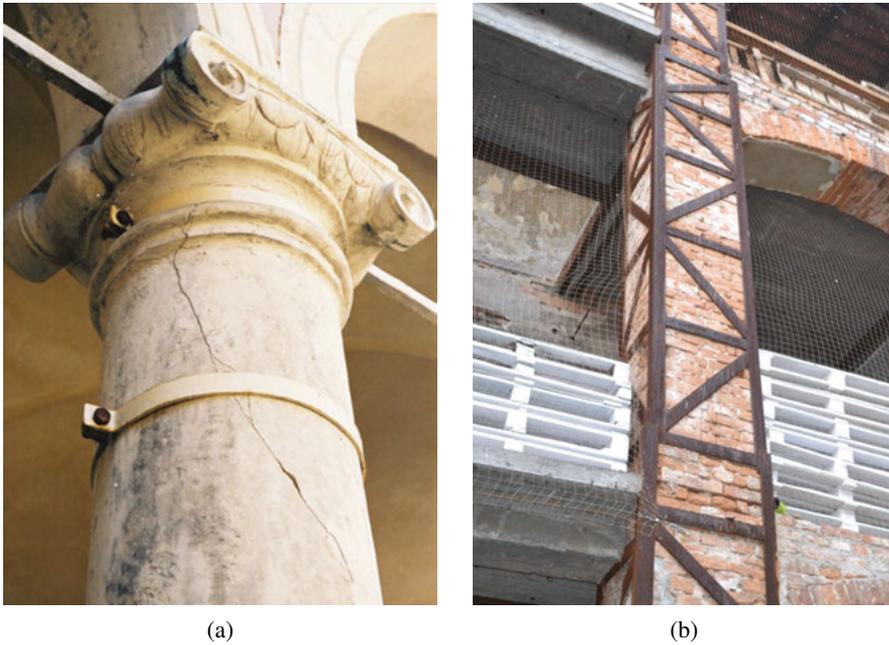
Fig. 1. Traditional reinforcements of: a) stone columns (Castle of Baranów Sandomierski), b) brick masonry pillars (gallery of tenement house in Cracow, Gołębia street)

In the past steel hoops were installed on the stone column shafts and lattices made of welded hot-rolled steel angles and flats were fixed around masonry pillars (Fig. 1).

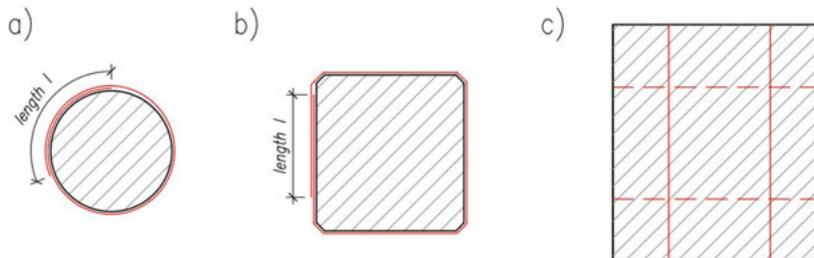
Fig. 2. Sections of stone column (a) and brick pillar (b) reinforced with composite bands (length  $l$  should ensure the continuity of fibres), section of brick pillar (c) reinforced with rebar embedded into mortar

Most of these disadvantages can be avoided by applying composite materials [13]. Stone columns of arcades in the courtyard of the Baranów Sandomierski Castle were reinforced with bands of FRP carbon fibre mesh (Fig. 2a). In such a way old unsightly hoops were eliminated. Thin composite bands were pasted in shallow furrows cut in stone. Then places of repair were filled with mortar matching the colour of the original stone. They are completely invisible now. Brick pillars with a rectangular or polygonal section may be reinforced in similar way, too (Fig. 2b). Another method of reinforcing brick masonry pillars is inserting transversal steel or composite bars (Fig. 2c). Composite bands or rebars embedded into mortar of masonry should withstand horizontal tensile stresses the value of which can be estimated from the Poisson's ratio  $\nu = 0.2$  for lime stone and brick mortar [8].

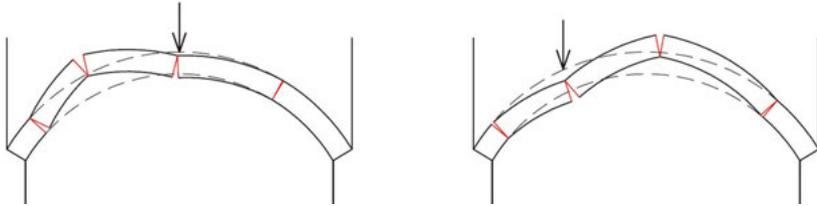
Fig. 3. When load of vault is movable cracks may occur in different zones of the upper and lower surface

vault are formed. A stable arch may develop up to three hinges, but four hinges or more will lead to collapse (Fig. 3).

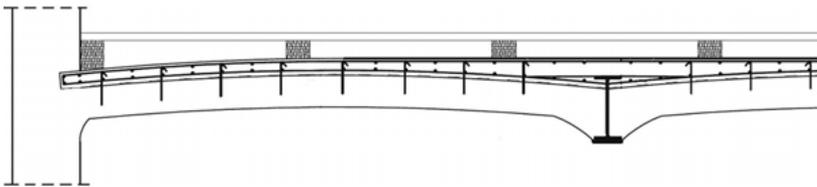
Fig. 4. School in Gorlice. Segmental barrel vault over the ground floor. First project of reinforcement with reinforced concrete slab 7 cm thick anchored to the vault

Traditional method of protecting the vault was to put a bearing reinforced concrete slab on its top and anchor it to the vault (Fig. 4). Loads of inter-storey vaults were reduced by means of additional steel and concrete floors. Both methods result not only in the growth of the load of walls and foundation but they also significantly interfere with the historical structure. Consequently, they are not willingly accepted by the conservation authorities.

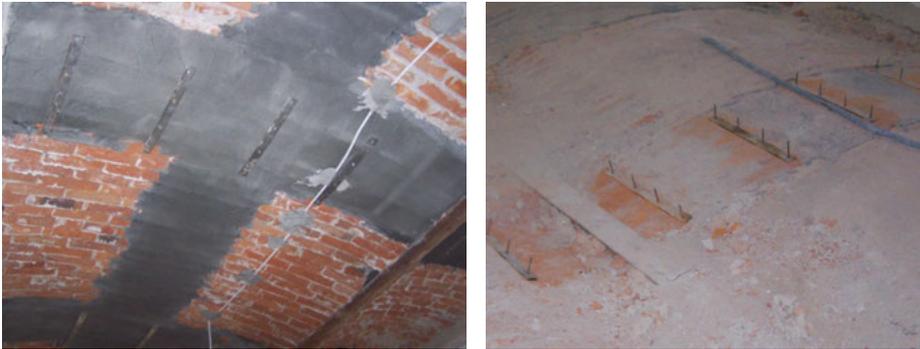
Fig. 5. School in Gorlice. Reinforcement of segmental barrel vault with FRP composite mesh. Bottom (left) and upper (right) sides of vault

Hinge and formation of cracks can be prevented and vault can be strengthened by increasing the load capacity of the vault section. Improving the tensile strength of old brick masonry is not possible, but similar effect can be obtained if the composite strong mesh is stuck on the tensioned side of the vault. Taking into consideration all combinations of loads acting on the floor mesh should be stuck on the whole upper and lower surface of vault (Fig. 3). Such way of reinforcing the segmental barrel vault was applied in a school in Gorlice where both sides of the vault were uncovered during restoration works (Fig. 5). Location of thrust line in the arch of vault and values of stresses in critical sections were found on the basis of diagrams of bending moments and axial forces. The calculations showed that reinforcing both sides of the shell with strips of composite mesh 0.5 m wide in 1.0 m spacings is sufficient. Thus the initially designed heavy reinforced concrete slab did not have to be applied. Transversal steel strips seen on Fig. 5 protect the mesh against detachment from the bottom side of the vault. Strips are connected with stainless steel screws through the vault. Currently composite bundles of fibres are available and can be used for this purpose [11].

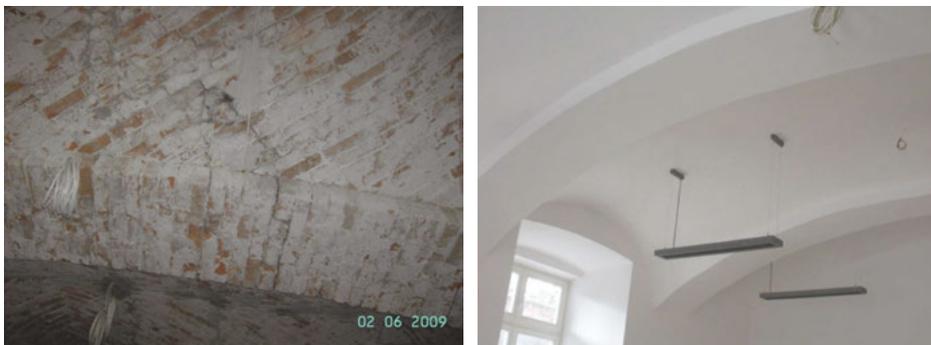
Fig. 6. Royal Palace in Łobzów, Cracow. The vault before (left) and after (right) renovation

However, there is usually only one side of the vault available for sticking the mesh either because the whole building cannot be renovated at the same time or the bottom surface of the vault is decorated with paintings or stucco. It was the case of the Royal Palace in Łobzów where the Faculty of Architecture of Cracow University of Technology is currently located. The ground floor rooms were restored only when the works on the first floor had been completed. Therefore strips of mesh were stuck crosswise the cracks only on the bottom side of the vaults. In such a way only some of the hinges in critical sections with cracks on visible side of vault were eliminated, but it turned out to be sufficient for the security of the vault. The repair was successful and cracks did not reappear (Fig. 6).

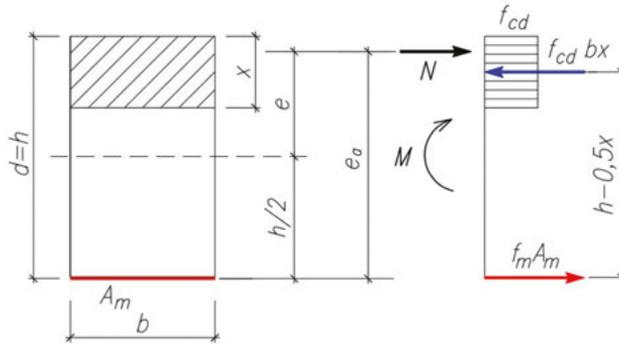
Fig. 7. Eccentrically loaded section of vault ( $e = M/N$ ) reinforced with composite

Composite reinforcement  $A_m$  of the critical section of vault and its load capacity may be found on the basis of the model of eccentrically loaded masonry section presented in Fig. 7. Strength of historical masonry  $f_{cd}$  is estimated using rules and formulas from current norm [8], tensile strength of composite system  $f_m$  depends on possibilities to anchor the fibres of mesh.

Location of neutral axis of the section is found from Eq. (4.1):

$$(4.1) \quad f_{cd}(e_a - h + 0.5x) \cdot b \cdot x - f_m \cdot A_m \cdot e_a = 0; \quad x \leq 0.5h$$

Load capacity of the strengthened section may be found using equation of balance of moments of forces relative to the axis of composite reinforcement Eq. (4.2):

$$(4.2) \quad N \cdot e_a \leq f_{cd} \cdot b \cdot x \cdot (h - 0.5x)$$

and equation of balance of forces Eq. (4.3):

$$(4.3) \quad N \leq f_{cd} \cdot b \cdot x - f_m \cdot A_m$$

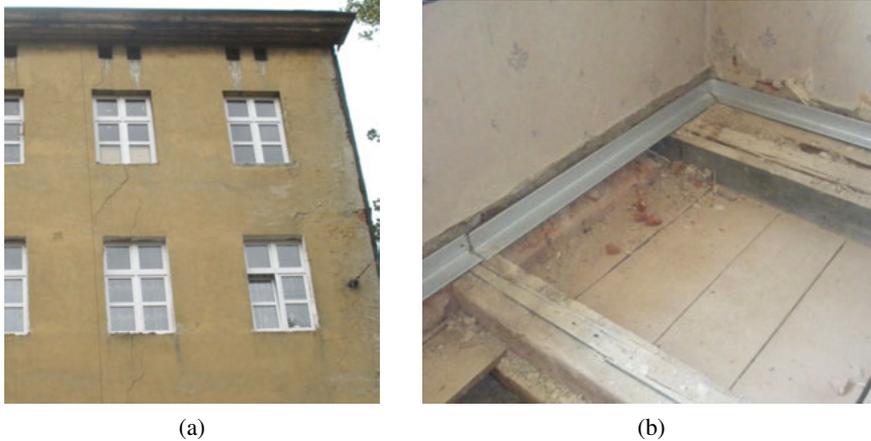
Fig. 8. Tenement house in Łódź, Żeromskiego street: a) cracks on elevation and b) steel bond beam

Walls of masonry buildings require bracings in order to withstand horizontal tensile forces from differential settlement of foundations or thrust forces of vaults. Beams surrounding the reinforced concrete floors fulfil this role in modern buildings. Traditional timber beam-framed floors are not sufficiently effective braces for masonry walls. This structural defect becomes apparent in the formation of cracks of inter-window strips (Fig. 8a). In the past during renovation works original timber floors existing in historical buildings were commonly replaced by steel and reinforced concrete floors type WPS, and later by corrugated steel floor decking with concrete topping. Such structures ensured adequate stiffening of the building. Nowadays timber floors are removed only if old beams have been completely destroyed by biological corrosion. Wooden beams can be strengthened to the assumed bearing capacity and required fire resistance provided by lightweight layers of fire-proof materials. When a major renovation of the building interior is performed additional bond beams made of steel angles may be fixed to wooden beams and walls (Fig. 8b).

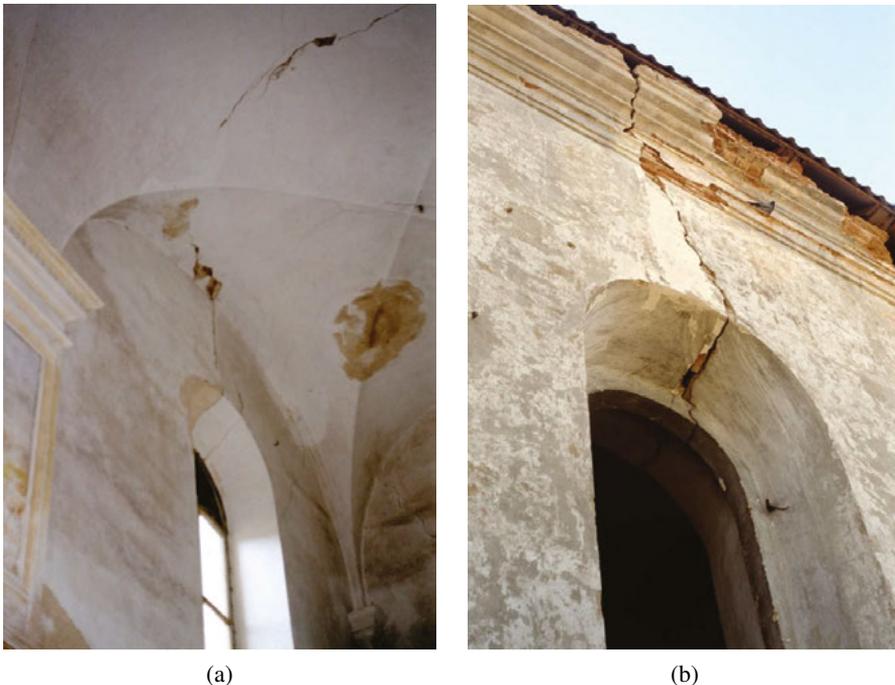
Fig. 9. Synagogue in Słonim, Belarus: a) cracks of the vault and b) the arch above window

At the beginning of 21<sup>st</sup> century design works were undertaken on conservation of synagogue in Słonim, Belarus built in 1642. The building was covered with a system of barrel and cross vaults supported on perimeter walls and central bima. The haunch of the vault was filled with brick rubble. Cracks of vaults and arches above windows (Fig. 9) showed that the thrust forces from the vault were the source of threat to the stability of the building structure.

Static calculation of the structural system of vaults with upper strip of walls above windows supporting them proved that excessive tensile stresses existed in that zone. The strengthening system which was designed consisted of two pairs of steel cables holding the walls together on the top of the inter-window pillars. Three-span brick masonry beams reinforced with composite FRP carbon fibres plates were created in each wall. Such a new static system replaced the original system of one span beams without reinforcement. Inter-window pillars were strengthened with FRP carbon fibre plates stuck on the outer side. Other FRP plates bond on the whole perimeter of building eliminated the negative impact of horizontal components of reactive forces from the vault flowing into corners (Fig. 10). In such a way, having changed the static system of the structure supporting the vault, tensile stresses causing cracking of walls were significantly reduced. Thanks to the application of small-size composite materials it was achieved with minimal structural interference in the historical wall.

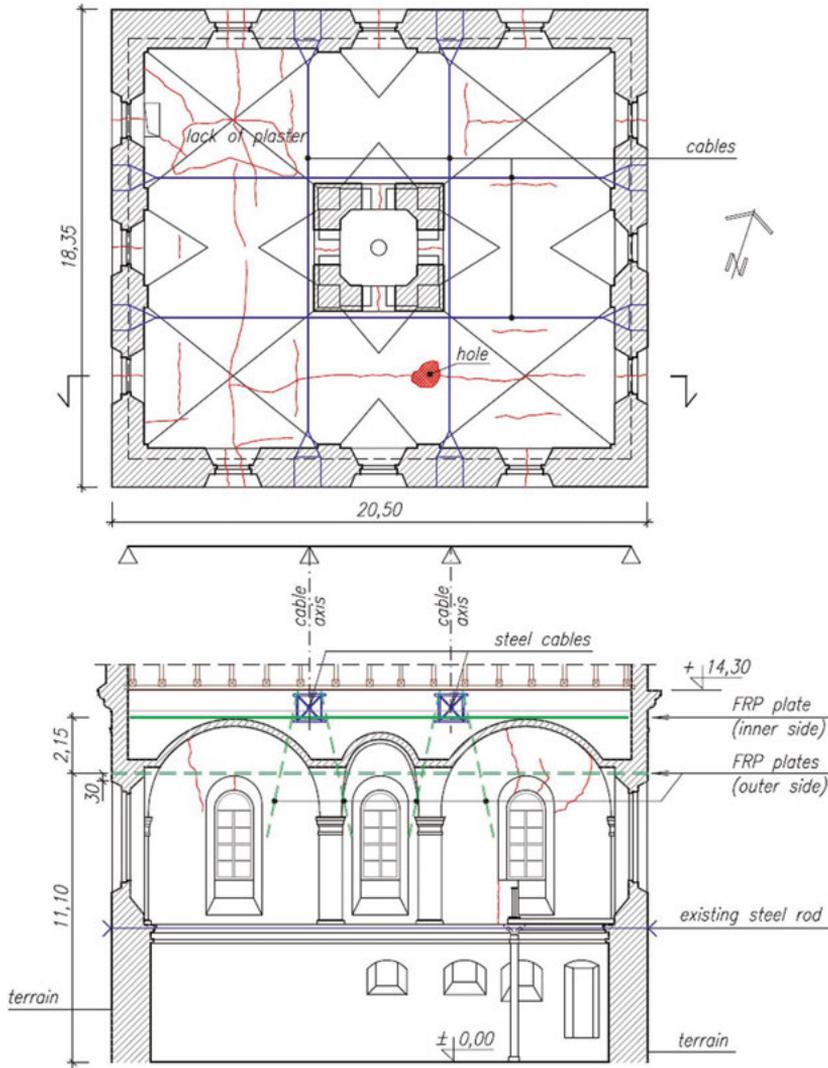
Fig. 10. Synagogue in Słonim, Belarus. Design of strengthening the structure supporting the vault

Decision concerning reinforcement of vault with composite mesh stuck on its bottom side depends on the result of investigation of polychrome decorating the vault. Whereas sticking the mesh on the upper side may be done if the brick rubble has been removed from the vault.

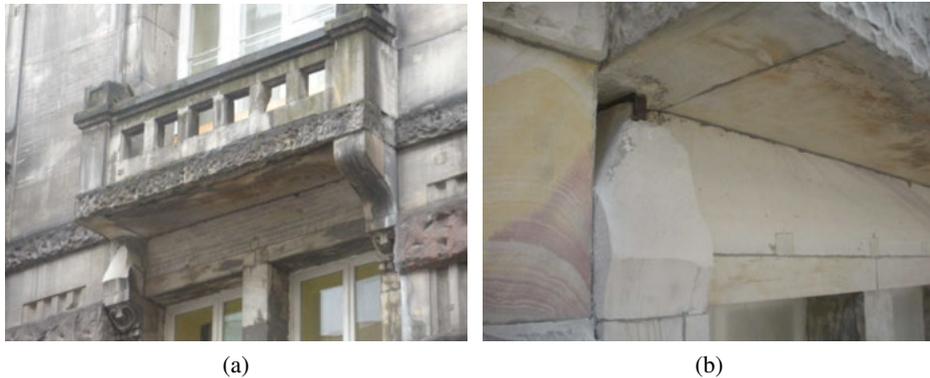
Fig. 11. Warsaw, Kredytowa street 3: a) stone balcony and b) bracket fallen down from the facade

The City Hall in Warsaw in Kredytowa street built in 1905–1909 has beautiful, richly decorated stone facades. There are six balconies of stone structure on the second and third floors (Fig. 11a). The stone slabs of the balconies have been supported with stone brackets. Only the upper floors of the building were destroyed during the Warsaw Uprising in 1944. The lower storeys with the original stonework have been preserved.

One of stone brackets from the balcony on the second floor fell down a few years ago. Damage of stone panels could be observed, too. A close inspection showed that the cause of the damage was the corrosion of steel anchors fastening stone elements to the wall (Fig. 11b).

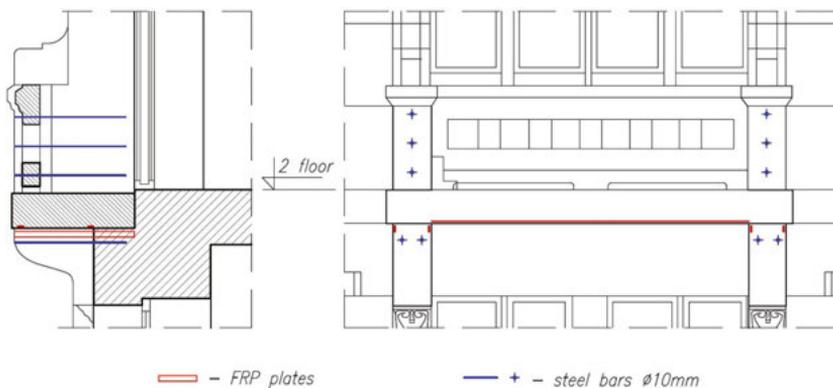
Fig. 12. Warsaw, Kredytowa street 3. Design of strengthening and protecting stone balconies. Section (left) and elevation (right) of balcony

Renovation works have been undertaken, including the facades of the building. It was of fundamental importance to ensure safety through the implementation of structural measures for durability of fastenings of wall panels and balconies. It had to take place before the actual conservation works were carried out. The first project involved dismantling the balconies and reassembling them on a new structure made of steel hot-rolled sections. Our replacement project applied FRP carbon fibre plates and steel screw bars (Figs. 12, 13). It was successfully applied as permanent protection for all balconies of the front facade. Stone cladding panels in danger of falling off were anchored to the wall with steel screw-shaped rods placed in two corners of each panel.

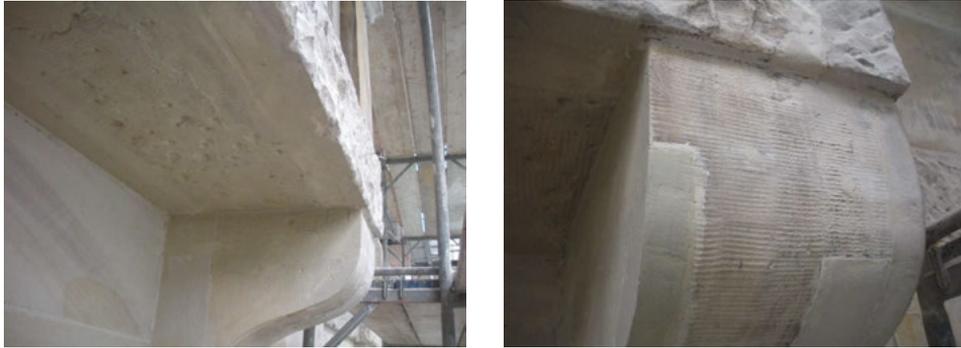
Fig. 13. Warsaw, Kredytowa street, 3. Strengthening elements covered with colour mortar

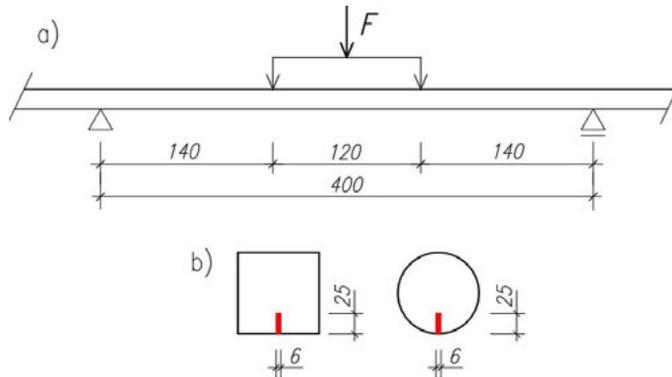
Fig. 14. Investigation of rafters from the roof of the barracks in Camp Auschwitz II – Birkenau, a) static system of the four points bending test, b) sections of the rafters reinforced with FRP carbon fibre plate

Within the framework of a research project carried out at the Cracow University of Technology non-destructive strength tests of wooden elements from historical rafter framing of the barracks for prisoners in the Auschwitz II – Birkenau Extermination Camp were carried out [24]. Beams had square and circular sections, numerous wood defects and corrosion damage. Original rafters from the roof structure were treated as historical. For this reason, bending attempts were not carried out to destruction, but only to obtain beam deflection  $1/150$  of span  $L = 4.00$  m (26.7 mm). Bearings for beams were assumed in the same points they had been supported in the original rafter framings (Fig. 14a). First, the beams were tested prior to reinforcing. The second stage of the research concerned the strengthening by sticking the carbon fibre plate in  $6 \times 25$  mm slot milled on the tensile side of original rafters (Fig. 14b).

Reinforcement caused old rafters reached the assumed deflection 26.7 mm under a load about 5% bigger than before. The effectiveness of reinforcing wooden beams with FRP plates depended very much on existing corrosion damage of wood and on the possibility of supplementing the cross-sections with additional elements. An important observation was that all carbon fibre plates did not detach from the wood.

In this case measurement of final deflections of the reinforced beams at the time of destruction was not possible. Only on the basis of the previous destructive testing the significant impact of composite reinforcement on the safety of the structure can be predicted.
