Research paper

Safety issues related to the use of closed profiles in steel girders

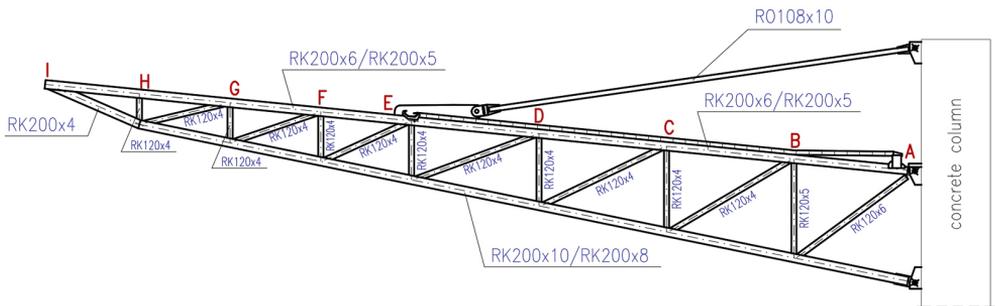
Fig. 1. Diagram of the damaged truss girder – upper chord made of square tube RK200

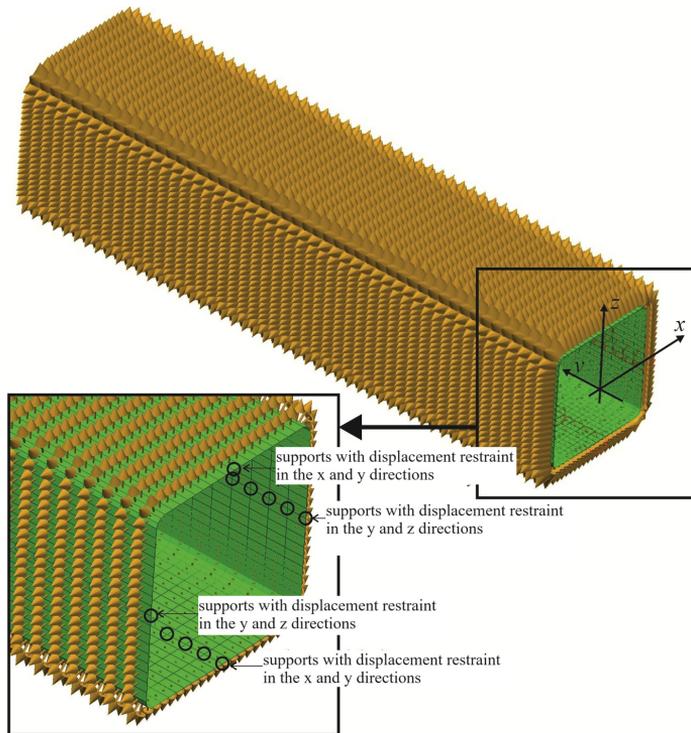
To assess the pressure effects, finite element calculations were performed (Autodesk Algor Simulation 2011 [4]). A 1-metre section of a $200 \times 200 \times 6$ cold-formed square tube was modelled and subjected to increasing internal pressure. The model is shown in Fig. 7. Shell elements modelling the pipe surface were inserted in the middle of the wall thickness. Elastic-plastic material model calculations were used, with a yield strength $f_y = 355$ MPa and a tensile strength $f_u = 490$ MPa, corresponding to S355 steel according to EC3 [5]. Based on the plasticity criterion, the material followed the plastic flow law and the kinematic hardening law. Additionally, a Young's modulus value of $E = 2.10 \cdot 10^8$ kPa and a hardening modulus of $E_t = 0.01 \cdot E$ were assumed [6].

Fig. 7. Numerical model of a rectangular tube with pressure loading and supports
