Research paper

Expansive soils as the root cause of a historic underground potable water reservoir failure

Tomasz Godlewski¹, Radosław Mieszkowski²

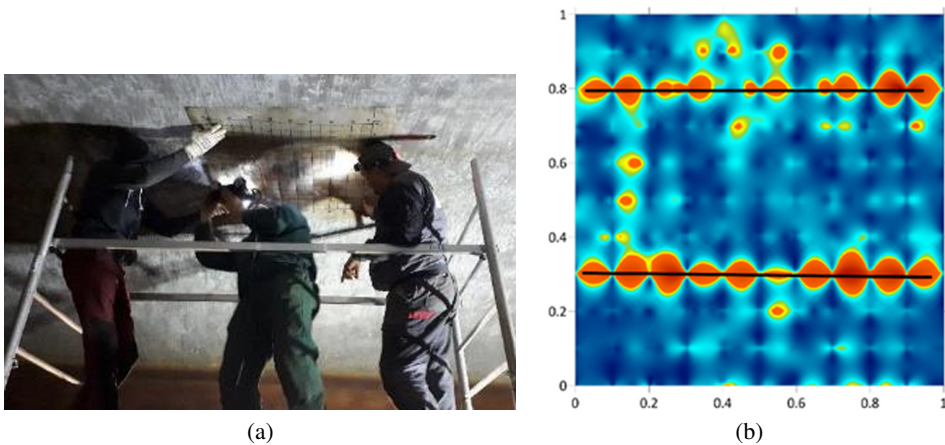
Georadar tests (GPR) were performed to verify the reinforcement rate of the structure components; for the bottom plate and the subsoil, they were meant to identify non-homogenous and excessive damping areas. The concept of the GPR method is described in detail, e.g. in [2], [5] and [8]. The signatures of GPR anomalies in the subsoil include reflective horizons, diffraction hyperbolas and areas of the recorded wave signal amplification. The GPR measurements were performed with 1.6 GHz and 750 MHz antennas all over the bottom plate's surface and in selected areas of the ceiling (vault), columns, floors and binding joists. A total of 700 GPR profiles were made in the reservoir. Three hundred had cruciform arrangements, 0.5 m spacing, and a prospection range of ca. 1.2–1.4 m (linear measurements). Four hundred profiles also had cruciform arrangements, 0.1 m spacing and a prospection range up to 0.5 m (spot measurements) – Fig. 8.

This can suggest damping of the plate and material deterioration (concrete corrosion) much more advanced than expected based on observing visible cracks. The increased dampness zone in the bottom plate overlaps with the location of the prominent cracks identified in the reservoir structure. The GPR image shows linear, regular anomalies originating from the reinforcement. The echogram interpretation revealed that the reinforcing bars are not regularly spaced. The structure is reinforced but to a minimum extent. GPR measurements indicated the reinforcement

Fig. 8. (a) View during the vault's GPR test (1.6 GHz antenna) in a cruciform arrangement, 0.1 m spacing, prospection range up to 0.5 m (spot measurements), (Photo T. Godlewski); (b) sample imaging result (prospection at 0.1 m depth) as a map of anomalies, regular anomalies (electromagnetic wave signal amplification areas) represent reinforcing elements [4]
