**Research paper****Problems in designing air domes: a lesson from
a construction disaster****Krzysztof Grzyb¹, Łukasz Drobiec², Jakub Zajac³, Olgierd Donajko⁴**

Keywords: air dome, air-supported structure, pneumatic structure, snow load, construction disaster, temporary construction

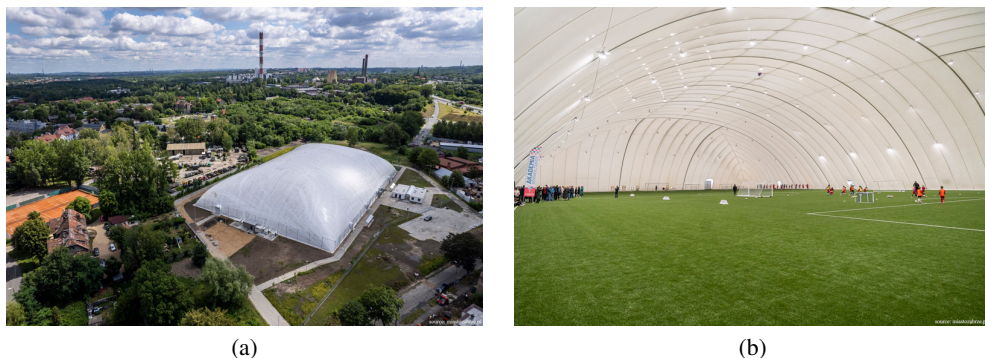
The original construction design for the investment was replaced by an alternate project design that omitted the internal emergency support structure in the form of lattice columns and steel ropes connecting them, supporting the falling coating along the hall's perimeter, which is

Fig. 3. The analysed pneumatic structure: (a) location view, (b) interior view (source: miastozabrze.pl)

inconsistent with the technical conditions. The purpose of this structure was to secure access to emergency exits when the envelope was falling, to increase the time needed to evacuate people and to provide a safe space in the areas leading to emergency exits. In addition, the diagonal mesh of steel ropes was abandoned in favour of a rope strapping system with eight transverse ropes and four ropes along the hall.
