Research paper

Reconstruction of the road bridge on Monte Cassino Avenue in Koszalin

Abstract: This article presents the process of rebuilding the bridge on Monte Cassino Avenue in Koszalin, Poland. The deterioration of the pre-cast concrete beams resulted in a decrease in the load-bearing capacity. On this basis, the decision was made to demolish and build a new structure, taking into account existing foundations and strengthening them with additional pre-cast concrete piles. However, during demolition works, the northern structure of the bridge collapsed uncontrollably. After a reanalysis of the technology and taking into account additional safety requirements, the demolition works were renewed. Due to collapse and its possible negative impact on existing piles, design changes related to the location of the pier axes were introduced. The load tests conducted on the rebuilt bridge allowed the finite element (FE) model to be verified by determining and comparing the response of the structure to static and dynamic load. The verified model, as an element of a digital twin, can be used in facility management throughout the life cycle of the structure, minimising the risk of failures

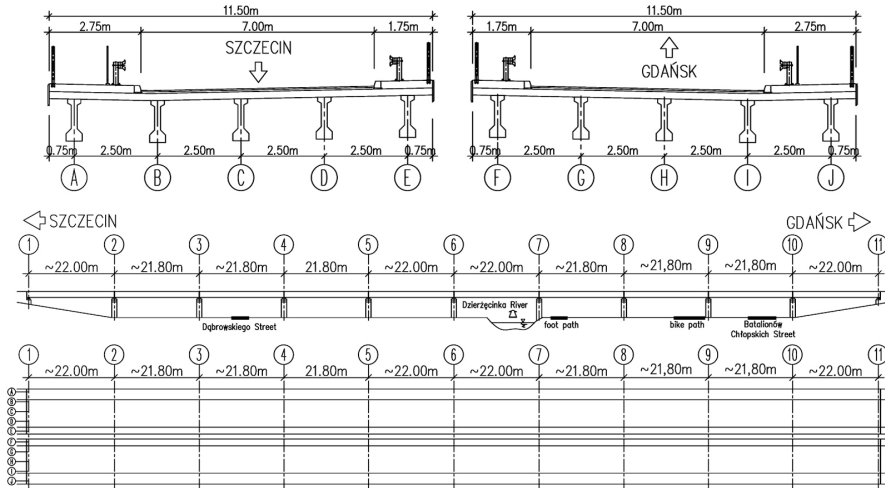
Fig. 1. Cross-section and side view of the old bridge

The old bridge on Monte Cassino Avenue in Koszalin, before rebuilding, consisted of two parallel structures of ten simply supported spans made of post-tensioned concrete WBS beams. Their effective lengths were: $22.0 + 3 \times 21.8 \text{ m} + 2 \times 22.0 \text{ m} + 3 \times 21.8 \text{ m} + 22.0 \text{ m}$ (Fig. 1).

The overall width of a single structure was 11.5 m, comprising a clear width of 7.0 m for a one-way road, in addition to two sidewalks of 2.75 m and 1.75 m width. Each superstructure had five beams spaced at 2.5 m and a 21 cm thick concrete slab. At the piers, the beams were braced with reinforced concrete crossbeams, approximately 0.3 m wide. The middle piers were designed as two columns of circular cross-section and 1.2 m diameter. According to the original documentation, the structures were supported on Franki deep foundation piles.

In 2020, an expert opinion was prepared to assess the current state of the structure, which confirmed its poor condition. On-site inspection combined with material tests, as well as static and strength analyses, showed a high risk of failure or collapse. The deterioration of pre-cast beams with a large number of inclined cracks near the anchor zones of the tendons (Fig. 2) exposed a reduced load-bearing shear capacity and indicated a prefailure condition. The damage found was a direct result of the yield strength exceedances in the stirrups and excluded the possibility of repair. Taking into account the above, the decision was made to close traffic and rebuild the bridge structure.

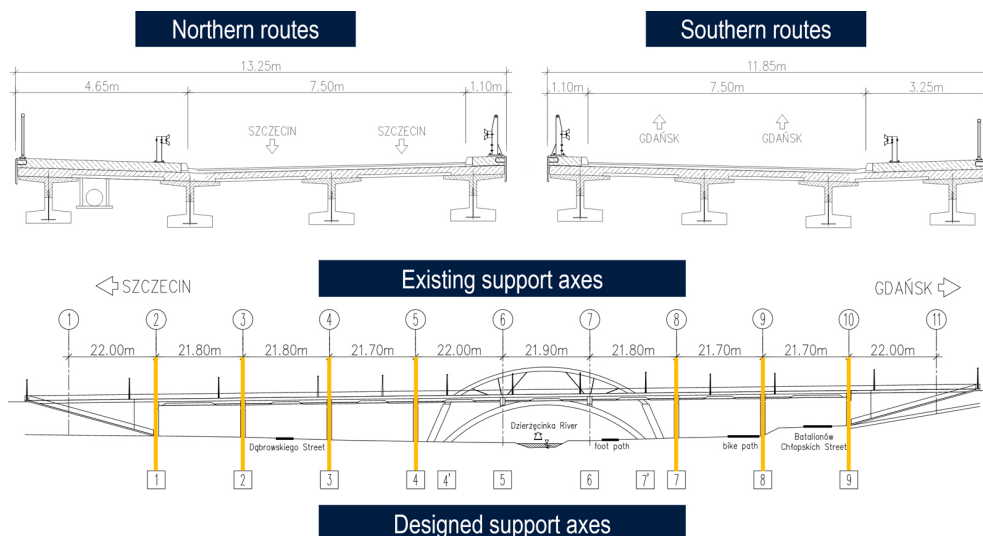
Fig. 5. Cross-section and side view of the new bridge

The new bridge was designed as a slab-and-girder structure in the form of an eight-span continuous beam with a middle frame in the shape of an arch that supports the spans over the river (Fig. 5). The existing deep foundation was planned to be reused, allowing the placement of the piers to remain unchanged. The structure was shortened by two end spans (one on each side), so the new abutments would be located on the foundations of the existing middle piers. The frame consists of two reinforced concrete arches on each side of the bridge, together with a central steel arch. The length of the arches is 50.0 m in the. The lengths of the approach spans range from 21.7 to 21.9 m. The CB-type pre-cast beams made of steel and concrete were used for the superstructure.

The load-bearing capacity of the existing piles was insufficient in each of the analysed piers. It was necessary to strengthen the foundations as proposed in Fig. 6. The original pile caps were joined and extended. The load-bearing capacity was improved by adding new pre-cast concrete driven piles.

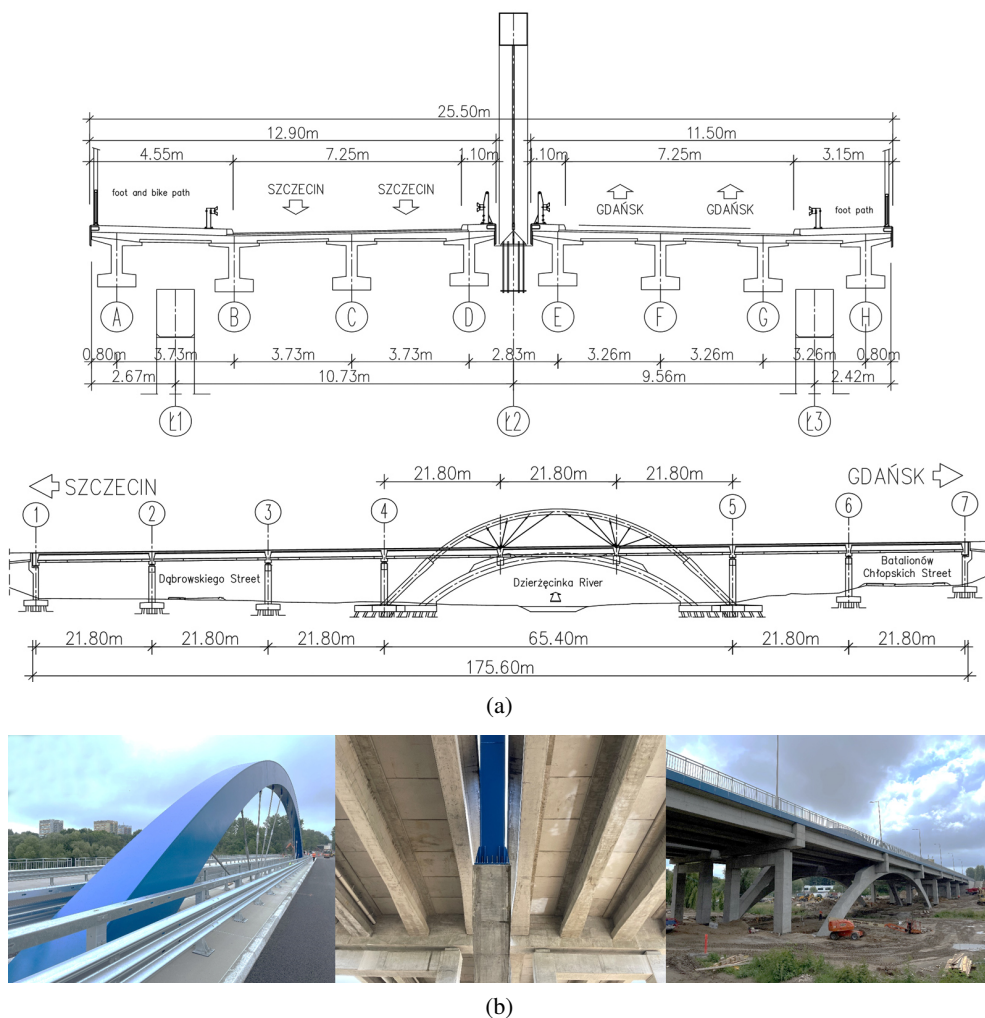
Fig. 9. Cross-section and side view of the rebuilt bridge in its final form (a) and the overview of the rebuilt bridge (b)

The analysis of the structural response from the basic arch span schemes (Fig. 11) confirmed that the code requirements were met and that the developed Finite Element (FE) model is correct. The elastic deflections of the girders were similar to those calculated theoretically in the uncracked phase and amounted on average for the S2, S3, and S4 span schemes in the relevant cross-sections to 97%, 85% and 83% of their values, respectively. Such results indicate that the stiffness of the girders is similar to the values assumed in the model analysed in the

uncracked phase. The model adopted for dimensioning provides results on the safe side and thus the load-bearing capacity that was theoretically assumed is correct. Permanent deflections are within the range of 0% to 8% of total deflections and therefore meet the code condition of not exceeding the level of 20%. Additionally, the displacements of the arches were measured during the selected load schemes. The maximum value was 1.39 mm and was slightly lower than the calculated values after updating the model (1.43 mm). The tests confirmed that the stiffness of the arches was close to that assumed theoretically.

After the demolition of the existing structures, it was necessary to change the location of the piers. Due to uncertainty regarding the condition of the old foundations after the collapse of the northern structure and the related dynamic impact, the strengthening of the old pile caps was abandoned. The rebuilt bridge consists of the northern and southern superstructures, connected by common piers in all support axes and crossbeams in the main span. They were designed as a beam-slab continuous structure made of CB-type steel-and-concrete pre-cast beams. They are supported on the bearings on the abutments and most of the piers, except the main span over the river where an arch frame was designed (Fig. 9 and 10). The frame consists of three arch structures, in which the central arch was made of steel and the remaining two of reinforced concrete. The effective lengths between the support points are 21.80 m. In the main span, the central arch was connected to the piers no. 4 and 5 and its total length is 65.40 m. The lengths of the edge arches are 50.0 m. The river span deck is connected to the central arch by steel hangers and, at the same time, lies on the lower reinforced concrete arches and the crossbeams. The pre-cast beams, pre-cast slabs used as lost formwork between the girders, and reinforced concrete arches were made of C50/60 concrete. The bridge deck and crossbeams were made of C40/50 concrete. The main arch was made of S355 steel. The abutments, designed as massive concrete bodies, and the piers, designed as double-column of rectangular cross-section, were supported on the pre-cast concrete driven piles.

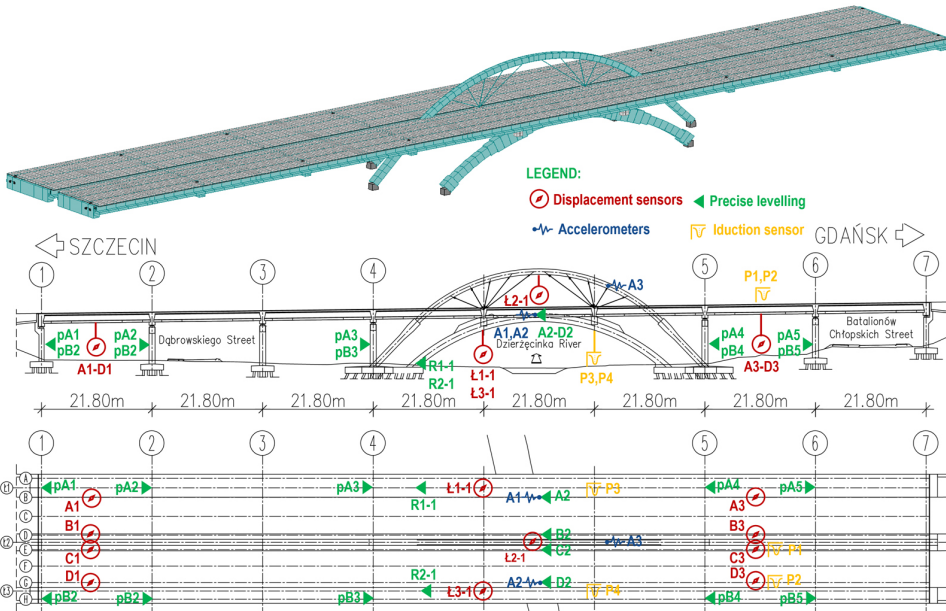
Fig. 10. The overview of the Finite Element (FE) model of the new bridge and location and labelling of the measurement points

In order to verify the model and assess the behaviour of the bridge under controlled static and dynamic load, acceptance tests were carried out on 28 June 2023. Five load schemes were provided, namely S1, S2, S3, S4, and S5. Dynamic tests included a vehicle driving in both directions up to a speed of 50 km/h and passing over an obstacle. A spatial grid model consisting of 1D and 2D shell elements was used for the design (Fig. 10). The geometric features of the prefabricated beams were assumed as composite. An orthotropic plate of actual thickness was placed on the grid, in which the stiffness in the longitudinal direction (x) was reduced. The stiffness in transverse direction remains unchanged. Displacement sensors, precise levelling, inductive sensors, and accelerometers were used for the measurements (Fig. 10).
