# Reconstruction of the road bridge on Monte Cassino Avenue in Koszalin

**Abstract:** This article presents the process of rebuilding the bridge on Monte Cassino Avenue in Koszalin, Poland. The deterioration of the pre-cast concrete beams resulted in a decrease in the load-bearing capacity. On this basis, the decision was made to demolish and build a new structure, taking into account existing foundations and strengthening them with additional pre-cast concrete piles. However, during demolition works, the northern structure of the bridge collapsed uncontrollably. After a reanalysis of the technology and taking into account additional safety requirements, the demolition works were renewed. Due to collapse and its possible negative impact on existing piles, design changes related to the location of the pier axes were introduced. The load tests conducted on the rebuilt bridge allowed the finite element (FE) model to be verified by determining and comparing the response of the structure to static and dynamic load. The verified model, as an element of a digital twin, can be used in facility management throughout the life cycle of the structure, minimising the risk of failures of strate

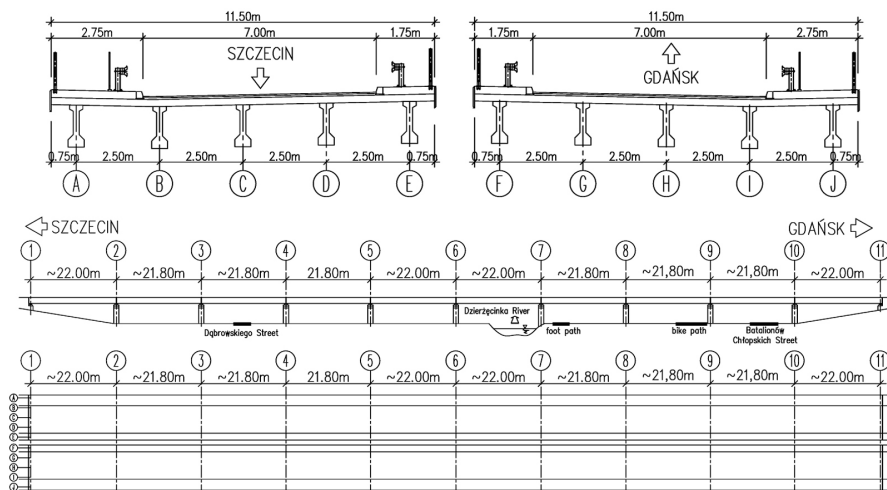
Fig. 1. Cross-section and side view of the old bridge

The old bridge on Monte Cassino Avenue in Koszalin, before rebuilding, consisted of two parallel structures of ten simply supported spans made of post-tensioned concrete WBS beams. Their effective lengths were:  $22.0 + 3 \times 21.8 \text{ m} + 2 \times 22.0 \text{ m} + 3 \times 21.8 \text{ m} + 22.0 \text{ m}$  (Fig. 1).

The overall width of a single structure was 11.5 m, comprising a clear width of 7.0 m for a one-way road, in addition to two sidewalks of 2.75 m and 1.75 m width. Each superstructure had five beams spaced at 2.5 m and a 21 cm thick concrete slab. At the piers, the beams were braced with reinforced concrete crossbeams, approximately 0.3 m wide. The middle piers were designed as two columns of circular cross-section and 1.2 m diameter. According to the original documentation, the structures were supported on Franki deep foundation piles.

In 2020, an expert opinion was prepared to assess the current state of the structure, which confirmed its poor condition. On-site inspection combined with material tests, as well as static and strength analyses, showed a high risk of failure or collapse. The deterioration of pre-cast beams with a large number of inclined cracks near the anchor zones of the tendons (Fig. 2) exposed a reduced load-bearing shear capacity and indicated a prefailure condition. The damage found was a direct result of the yield strength exceedances in the stirrups and excluded the possibility of repair. Taking into account the above, the decision was made to close traffic and rebuild the bridge structure.

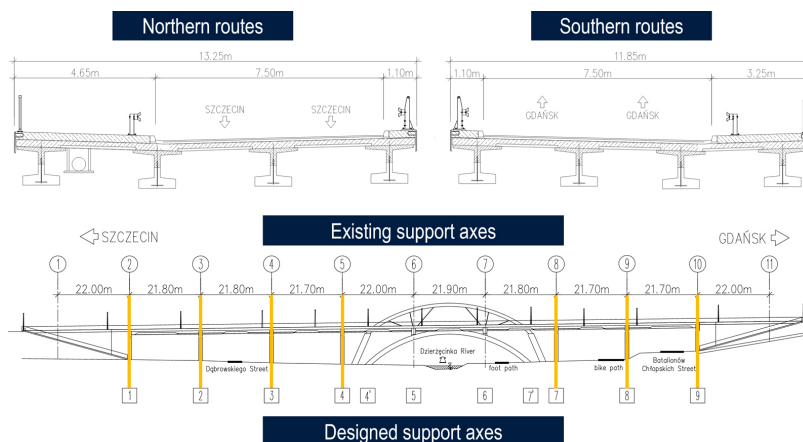
Fig. 5. Cross-section and side view of the new bridge

The new bridge was designed as a slab-and-girder structure in the form of an eight-span continuous beam with a middle frame in the shape of an arch that supports the spans over the river (Fig. 5). The existing deep foundation was planned to be reused, allowing the placement of the piers to remain unchanged. The structure was shortened by two end spans (one on each side), so the new abutments would be located on the foundations of the existing middle piers. The frame consists of two reinforced concrete arches on each side of the bridge, together with a central steel arch. The length of the arches is 50.0 m in the. The lengths of the approach spans range from 21.7 to 21.9 m. The CB-type pre-cast beams made of steel and concrete were used for the superstructure.

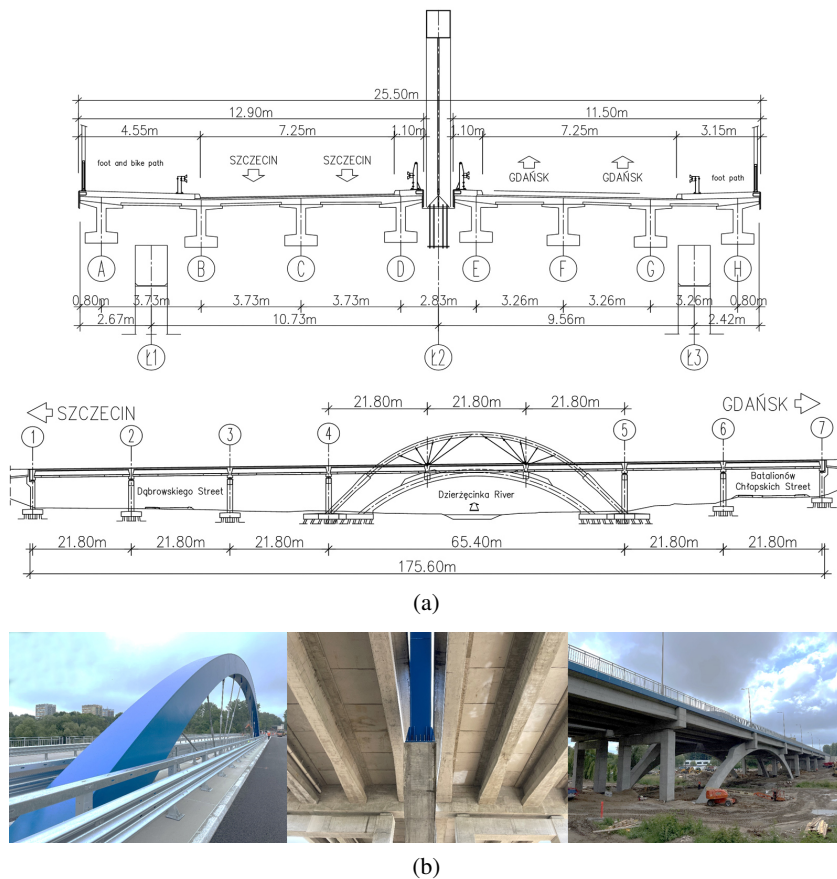
Fig. 9. Cross-section and side view of the rebuilt bridge in its final form (a) and the overview of the rebuilt bridge (b)

After the demolition of the existing structures, it was necessary to change the location of the piers. Due to uncertainty regarding the condition of the old foundations after the collapse of the northern structure and the related dynamic impact, the strengthening of the old pile caps was abandoned. The rebuilt bridge consists of the northern and southern superstructures, connected by common piers in all support axes and crossbeams in the main span. They were designed as a beam-slab continuous structure made of CB-type steel-and-concrete pre-cast beams. They are supported on the bearings on the abutments and most of the piers, except

the main span over the river where an arch frame was designed (Fig. 9 and 10). The frame consists of three arch structures, in which the central arch was made of steel and the remaining two of reinforced concrete. The effective lengths between the support points are 21.80 m. In the main span, the central arch was connected to the piers no. 4 and 5 and its total length is 65.40 m. The lengths of the edge arches are 50.0 m. The river span deck is connected to the central arch by steel hangers and, at the same time, lies on the lower reinforced concrete arches and the crossbeams. The pre-cast beams, pre-cast slabs used as lost formwork between the girders, and reinforced concrete arches were made of C50/60 concrete. The bridge deck and crossbeams were made of C40/50 concrete. The main arch was made of S355 steel. The abutments, designed as massive concrete bodies, and the piers, designed as double-column of rectangular cross-section, were supported on the pre-cast concrete driven piles.
