# Reconstruction of the road bridge on Monte Cassino Avenue in Koszalin

**Abstract:** This article presents the process of rebuilding the bridge on Monte Cassino Avenue in Koszalin, Poland. The deterioration of the pre-cast concrete beams resulted in a decrease in the load-bearing capacity. On this basis, the decision was made to demolish and build a new structure, taking into account existing foundations and strengthening them with additional pre-cast concrete piles. However, during demolition works, the northern structure of the bridge collapsed uncontrollably. After a reanalysis of the technology and taking into account additional safety requirements, the demolition works were renewed. Due to collapse and its possible negative impact on existing piles, design changes related to the location of the pier axes were introduced. The load tests conducted on the rebuilt bridge allowed the finite element (FE) model to be verified by determining and comparing the response of the structure to static and dynamic load. The verified model, as an element of a digital twin, can be used in facility management throughout the life cycle of the structure, minimising the risk of failures of strate

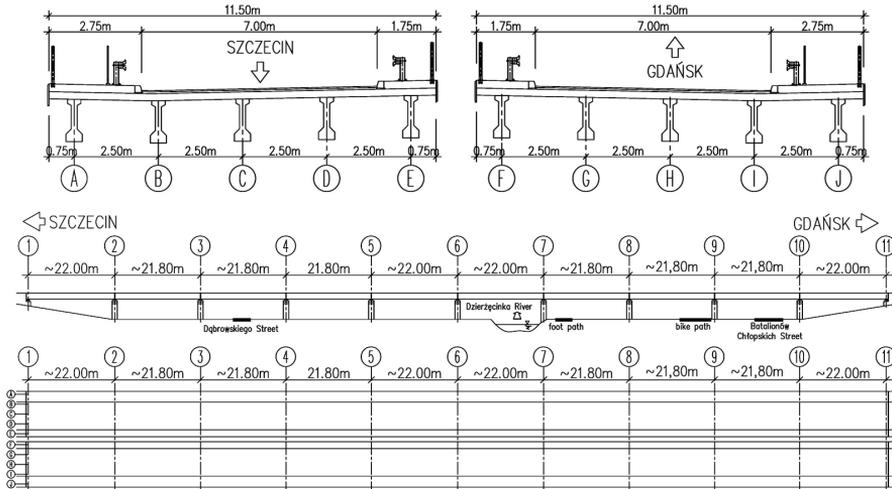
Fig. 1. Cross-section and side view of the old bridge

The overall width of a single structure was 11.5 m, comprising a clear width of 7.0 m for a one-way road, in addition to two sidewalks of 2.75 m and 1.75 m width. Each superstructure had five beams spaced at 2.5 m and a 21 cm thick concrete slab. At the piers, the beams were braced with reinforced concrete crossbeams, approximately 0.3 m wide. The middle piers were designed as two columns of circular cross-section and 1.2 m diameter. According to the original documentation, the structures were supported on Franki deep foundation piles.

In 2020, an expert opinion was prepared to assess the current state of the structure, which confirmed its poor condition. On-site inspection combined with material tests, as well as static and strength analyses, showed a high risk of failure or collapse. The deterioration of pre-cast beams with a large number of inclined cracks near the anchor zones of the tendons (Fig. 2) exposed a reduced load-bearing shear capacity and indicated a prefailure condition. The damage found was a direct result of the yield strength exceedances in the stirrups and excluded the possibility of repair. Taking into account the above, the decision was made to close traffic and rebuild the bridge structure.

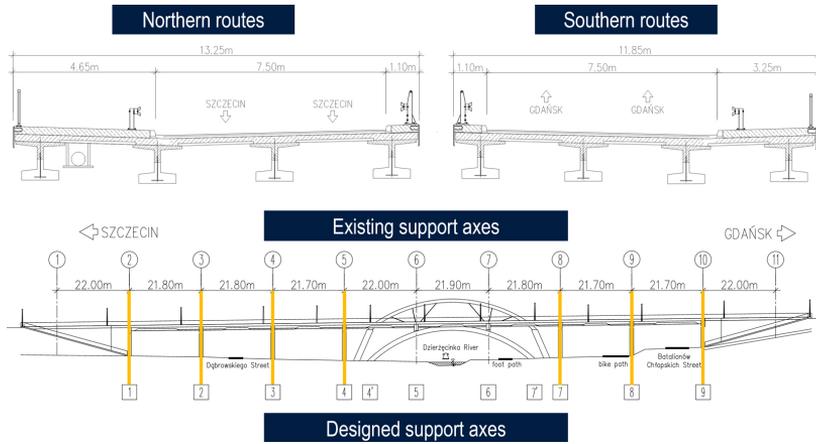
Fig. 5. Cross-section and side view of the new bridge

The new bridge was designed as a slab-and-girder structure in the form of an eight-span continuous beam with a middle frame in the shape of an arch that supports the spans over the river (Fig. 5). The existing deep foundation was planned to be reused, allowing the placement of the piers to remain unchanged. The structure was shortened by two end spans (one on each side), so the new abutments would be located on the foundations of the existing middle piers. The frame consists of two reinforced concrete arches on each side of the bridge, together with a central steel arch. The length of the arches is 50.0 m in the. The lengths of the approach spans range from 21.7 to 21.9 m. The CB-type pre-cast beams made of steel and concrete were used for the superstructure.

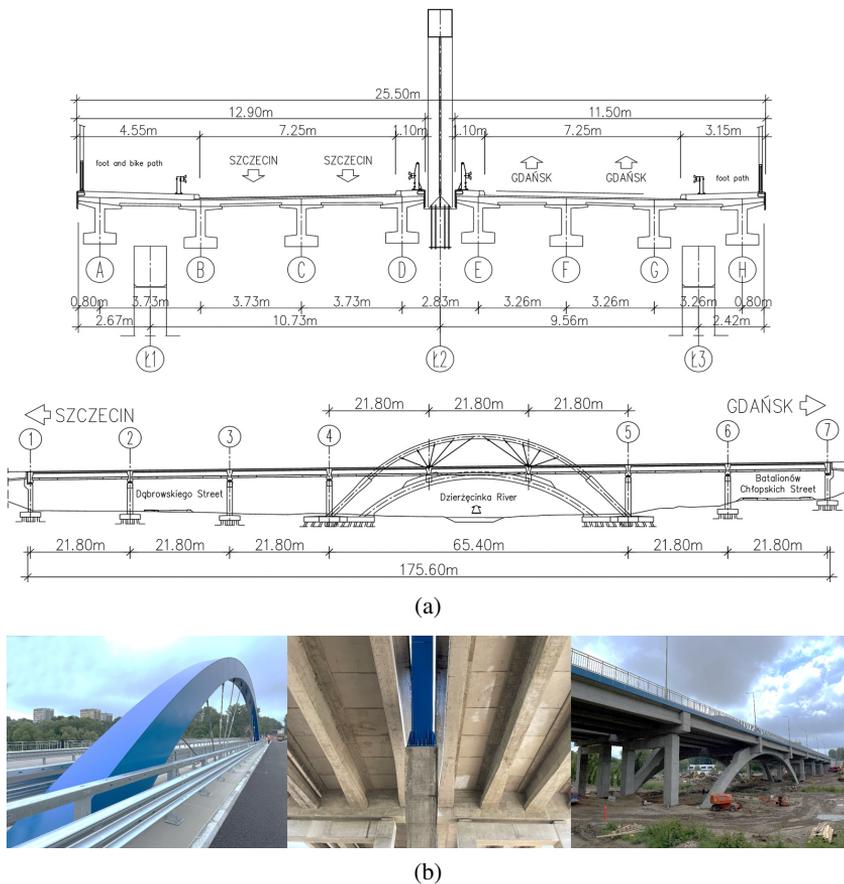
Fig. 9. Cross-section and side view of the rebuilt bridge in its final form (a) and the overview of the rebuilt bridge (b)

After the demolition of the existing structures, it was necessary to change the location of the piers. Due to uncertainty regarding the condition of the old foundations after the collapse of the northern structure and the related dynamic impact, the strengthening of the old pile caps was abandoned. The rebuilt bridge consists of the northern and southern superstructures, connected by common piers in all support axes and crossbeams in the main span. They were designed as a beam-slab continuous structure made of CB-type steel-and-concrete pre-cast beams. They are supported on the bearings on the abutments and most of the piers, except

the main span over the river where an arch frame was designed (Fig. 9 and 10). The frame consists of three arch structures, in which the central arch was made of steel and the remaining two of reinforced concrete. The effective lengths between the support points are 21.80 m. In the main span, the central arch was connected to the piers no. 4 and 5 and its total length is 65.40 m. The lengths of the edge arches are 50.0 m. The river span deck is connected to the central arch by steel hangers and, at the same time, lies on the lower reinforced concrete arches and the crossbeams. The pre-cast beams, pre-cast slabs used as lost formwork between the girders, and reinforced concrete arches were made of C50/60 concrete. The bridge deck and crossbeams were made of C40/50 concrete. The main arch was made of S355 steel. The abutments, designed as massive concrete bodies, and the piers, designed as double-column of rectangular cross-section, were supported on the pre-cast concrete driven piles.

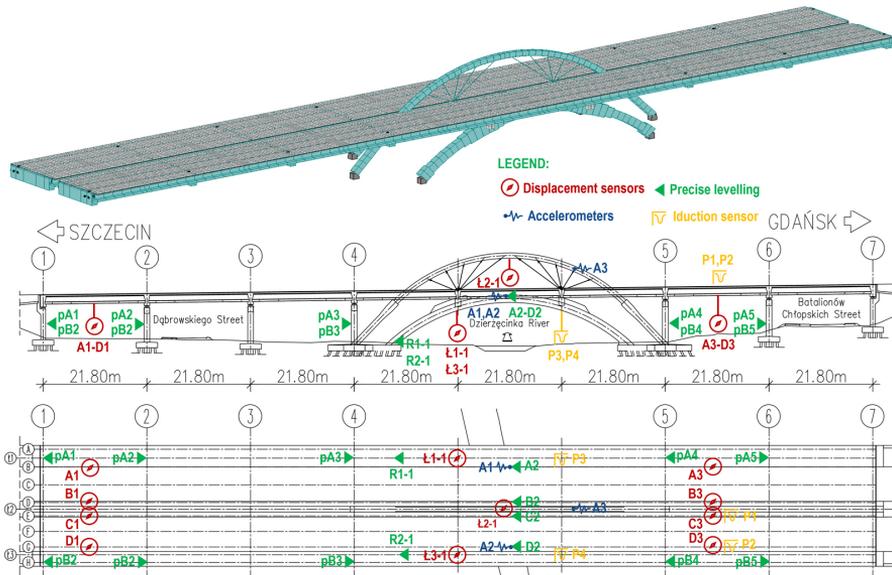
Fig. 10. The overview of the Finite Element (FE) model of the new bridge and location and labelling of the measurement points

In order to verify the model and assess the behaviour of the bridge under controlled static and dynamic load, acceptance tests were carried out on 28 June 2023. Five load schemes were provided, namely S1, S2, S3, S4, and S5. Dynamic tests included a vehicle driving in both directions up to a speed of 50 km/h and passing over an obstacle. A spatial grid model consisting of 1D and 2D shell elements was used for the design (Fig. 10). The geometric features of the prefabricated beams were assumed as composite. An orthotropic plate of actual thickness was placed on the grid, in which the stiffness in the longitudinal direction ( $x$ ) was reduced. The stiffness in transverse direction remains unchanged. Displacement sensors, precise levelling, inductive sensors, and accelerometers were used for the measurements (Fig. 10).

The analysis of the structural response from the basic arch span schemes (Fig. 11) confirmed that the code requirements were met and that the developed Finite Element (FE) model is correct. The elastic deflections of the girders were similar to those calculated theoretically in the uncracked phase and amounted on average for the S2, S3, and S4 span schemes in the relevant cross-sections to 97%, 85% and 83% of their values, respectively. Such results indicate that the stiffness of the girders is similar to the values assumed in the model analysed in the uncracked phase. The model adopted for dimensioning provides results on the safe side and thus the load-bearing capacity that was theoretically assumed is correct. Permanent deflections are within the range of 0% to 8% of total deflections and therefore meet the code condition of
