Research paper

Floods – a permanent threat to building structures on the example of the Odra River basin

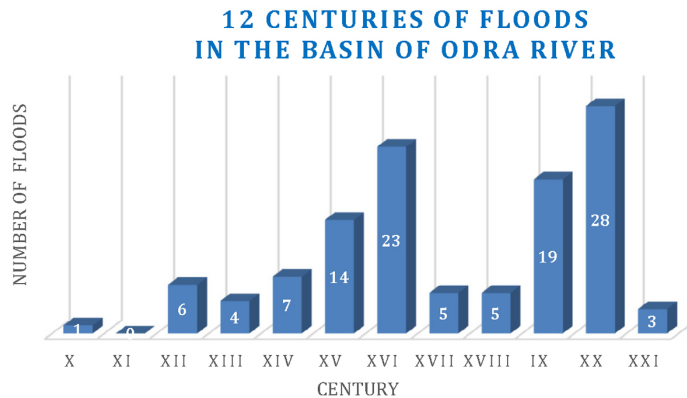
Fig. 3. History of catastrophic floods in the upper Odra River basin

Currently, the causes and extent of flooding are often attributed to global climate warming. But is this truly the case? Fig. 3 presents a graph showing the frequency of such catastrophes over the past 12 centuries, with the highest number of floods occurring in the 15th, 16th, 19th, and 20th centuries.
