PULL-OFF ADHESION STRENGTH OF POLY-P-PHENYLENE BENZOBISOXAZOLE (PBO) – REINFORCED TIMBER

P. K. SOKOŁOWSKI¹, P. G. KOSSAKOWSKI²

The article discusses results of pull-off adhesion strength tests on poly-p-phenylene benzobisoxazole (PBO) mesh bonded to fir timber beams using epoxy resin. The tests were performed in accordance with the PN-EN 1542 standard. Timber elements reinforced with PBO fibres were subjected to pull-off tests to measure the adhesive strength of the mesh to the beams. The factors occurring during the test were also characterized, which may affect its results such as the method of application of the tearing force, selection of epoxy glue, surface preparation of the tested elements, occurrence of material defects in the wood and types of substrate destruction. The experimental data show that failure of the timber layer was not observed in all the specimens tested.

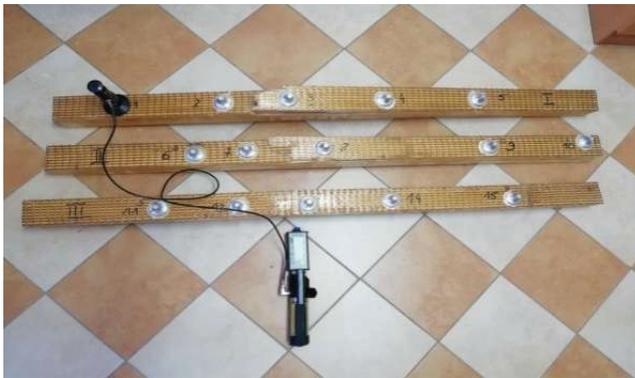
Fig. 2. View of the tested samples.

The PN-EN 1542 [23] standard specifies the number and placement of samples. According to the standard, at least one sample of the product or repair system is required, to be tested at least 5 times. Due to the fact that the timber beams had been subjected to a destructive test aimed at estimating their load capacity, it was decided to randomly arrange the samples for this test, as well as to deliberately distribute the samples in places of material defects and PBO mesh cracks (Figs. 1 and 2), located and described in Table 2.
