# Experimental and numerical verification of the standard procedure for determining the load capacity of GFRP composite lighting columns

Mirosław Broniewicz<sup>1</sup>, Filip Broniewicz<sup>2</sup>, Elżbieta Broniewicz<sup>3</sup>

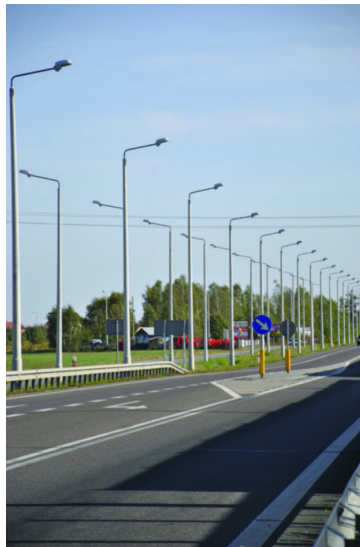
Fig. 1. Composite circular GFRP lighting poles [2]

It was necessary to introduce new, secure, and environmentally friendly technological and material solutions in response to the increasing demand for column load-bearing structures in the energy, road, and railway industries that better functional properties would distinguish. Traditional building materials, like wood, steel and concrete, which have been used for many years to construct transmission and lighting poles, only partially meet the criteria for sustainable development and environmental preservation [1]. Over the last 25 years, significant progress has been made in introducing lighting and transmission poles made of polymer composites reinforced with various fibres (FRP) to the energy market. FRP fibre-reinforced composite poles represent a modern engineering solution where sustainability plays an important role (Fig. 1).
